**Tree Inventory and Preservation Plan Report  
109 Cartwright Avenue & 130 Bentworth Avenue  
Toronto, Ontario**

6 March 2023, revised 11 May 2023, 2 June 2025, and 15 September 2025

KUNTZ FORESTRY CONSULTING INC. Project P3663

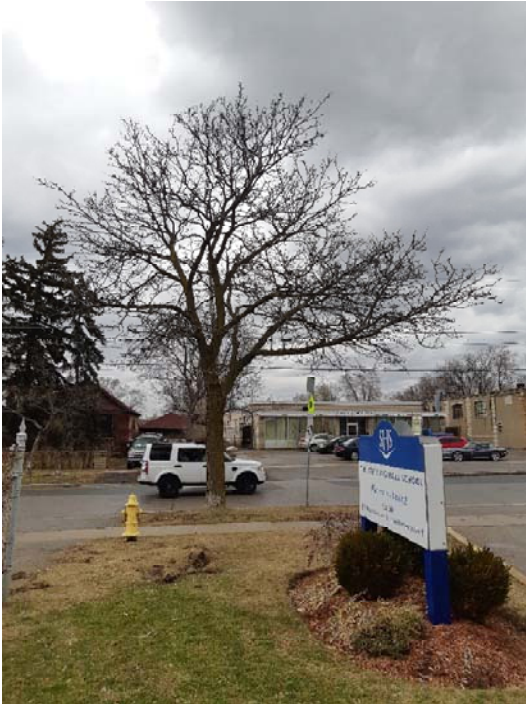
Image 1. Tree 1

| Tree # | Common Name | Scientific Name | DBH | TI | CS | CV | DL | CDB | mTPZ | Cat. | Comments | Action |
|---|---|---|---|---|---|---|---|---|---|---|---|---|
| 1 | Honey Locust (shademaster) | <i>Gleditsia triacanthos 'inermis'</i> | 43 | G | G | G | 11.5 | | 3 | 5 | Co-dominance at 3m, pruning wounds (L) | Retain |

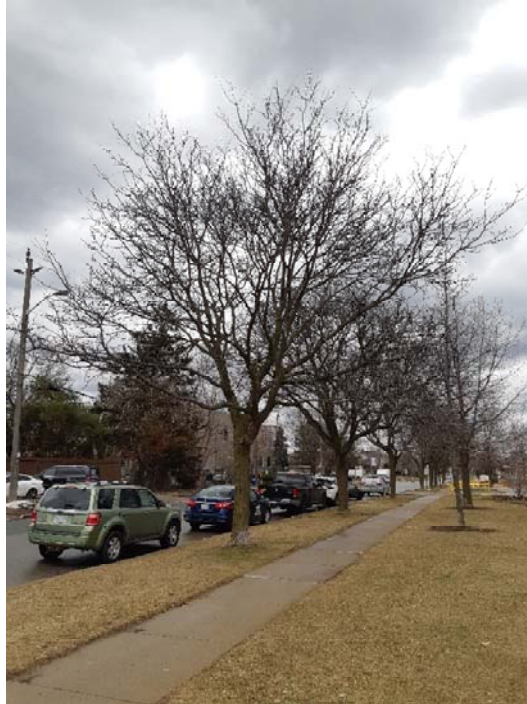
Image 2. Tree 2

| Tree # | Common Name | Scientific Name | DBH | TI | CS | CV | DL | CDB | mTPZ | Cat. | Comments | Action |
|---|---|---|---|---|---|---|---|---|---|---|---|---|
| 2 | Honey Locust (shademaster) | <i>Gleditsia triacanthos 'inermis'</i> | 40 | FG | G | FG | 8.0 | | 3 | 5 | Co-dominance at 2m, exposed roots (L), epicormic branching (M), pruning wounds (L) | Retain |

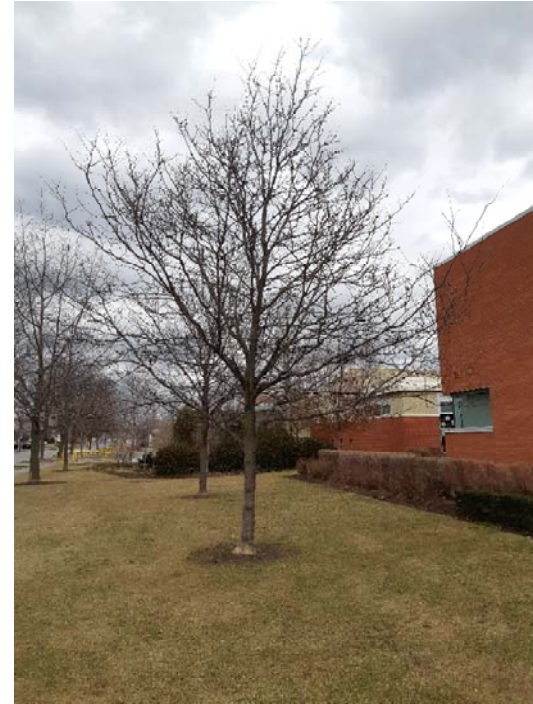
Image 3. Tree 3

| Tree # | Common Name | Scientific Name | DBH | TI | CS | CV | DL | CDB | mTPZ | Cat. | Comments | Action |
|---|---|---|---|---|---|---|---|---|---|---|---|---|
| 3 | Honey Locust (shademaster) | <i>Gleditsia triacanthos 'inermis'</i> | 21 | FG | G | FG | 6.0 | | 1.8 | - | Exposed roots (M) with mechanical damage, stem wound (L), epicormic branching (L), branch wound (L) | Retain |

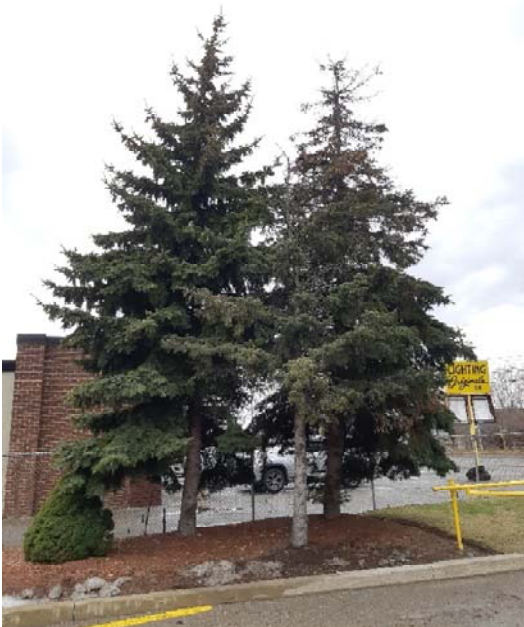
Image 4. Trees 4-6 (right to left)

| Tree # | Common Name | Scientific Name | DBH | TI | CS | CV | DL | CDB | mTPZ | Cat. | Comments | Action |
|---|---|---|---|---|---|---|---|---|---|---|---|---|
| 4 | Blue Spruce | <i>Picea pungens</i> | 32 | G | FG | FG | 4.0 | 5 | 2.4 | 1 | Sparse crown (L), chlorosis (L), asymmetrical crown (L) | Remove |
| 5 | Blue Spruce | <i>Picea pungens</i> | 20 | G | F | F | 2.5 | 15 | 1.8 | - | Sparse crown (M), dead top, asymmetrical crown (M) | Remove |
| 6 | Blue Spruce | <i>Picea pungens</i> | 27 | G | G | G | 4.0 | | 1.8 | - | Asymmetrical crown (VL) | Retain |

The removal of ten trees, including Trees 4, 5, 12-15 and 17-20 is required to accommodate the proposed development. Trees 4 and 5 have minimum tree protection zone encroachment for the surrounding parking areas. Trees 12-15 and 17-20 directly conflict with the proposed two-storey addition or hardscaping.

Tree 4 is located on the subject property and is greater than 30cm DBH (Category 1 tree). A permit is required prior to its removal. All other trees subject to removal are located within the boundaries of the subject property and are less than 30cm DBH. A permit is not required prior to the removal of these trees.

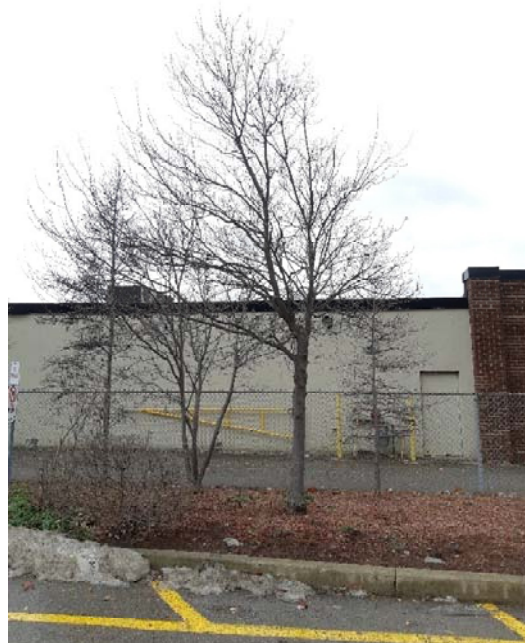
Image 5. Tree 7

| Tree # | Common Name | Scientific Name | DBH | TI | CS | CV | DL | CDB | mTPZ | Cat. | Comments | Action |
|---|---|---|---|---|---|---|---|---|---|---|---|---|
| 7 | Silver Maple | <i>Acer saccharinum</i> | 15 | FG | FG | G | 4.0 | | 1.8 | - | Basal swell (L), pruning wounds (L), asymmetrical crown (L) | Retain |

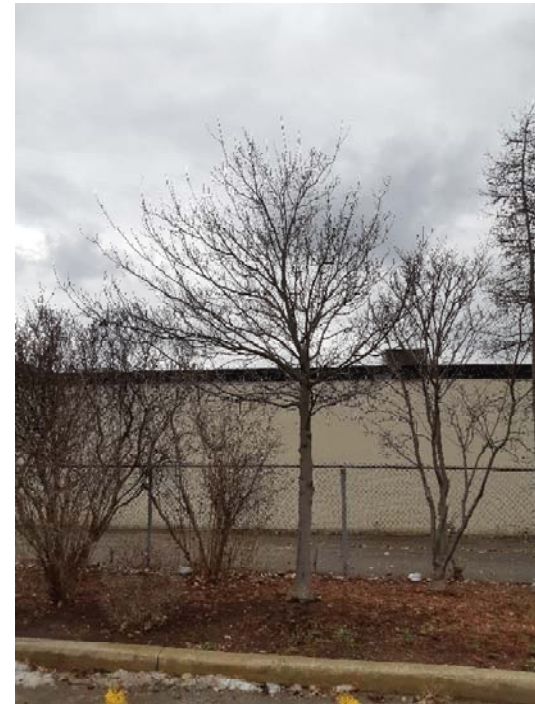
Image 6. Tree 8

| Tree # | Common Name | Scientific Name | DBH | TI | CS | CV | DL | CDB | mTPZ | Cat. | Comments | Action |
|---|---|---|---|---|---|---|---|---|---|---|---|---|
| 8 | Silver Maple | <i>Acer saccharinum</i> | 16.5 | G | FG | G | 4.5 | | 1.8 | - | Pruning wounds (L), asymmetrical crown (L) | Retain |

There is existing asphalt within the minimum tree protection zones (mTPZs) of Trees 8, 10, 11, and 21 that will be removed. The asphalt within the mTPZ's of these trees must be removed carefully, by hand or using small equipment (ie. a skidsteer) and must be supervised by a certified Arborist. Any roots encountered within the subsurface should be left intact wherever possible. If they require severance, they must be pruned in accordance with Good Arboricultural Standards. The areas can then be amended using topsoil/sod as required.

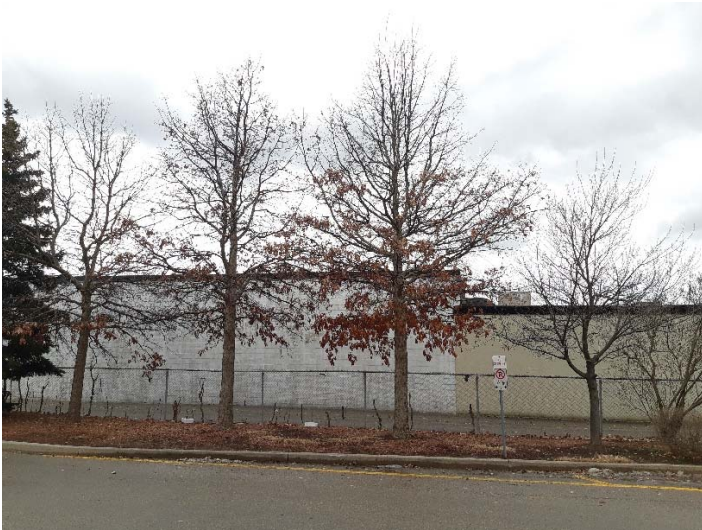
Image 7. Trees 9-12 (Right to left)

| Tree # | Common Name | Scientific Name | DBH | TI | CS | CV | DL | CDB | mTPZ | Cat. | Comments | Action |
|---|---|---|---|---|---|---|---|---|---|---|---|---|
| 9 | Silver Maple | <i>Acer saccharinum</i> | 19.5 | FG | G | G | 6.0 | | 1.8 | - | Exposed roots (L), stem wound (L), asymmetrical crown (L) | Retain |
| 10 | Swamp White Oak | <i>Quercus bicolor</i> | 31 | FG | G | G | 8.0 | | 2.4 | 1 | Girdling root (L) | Retain |
| 11 | Swamp White Oak | <i>Quercus bicolor</i> | 29.5 | G | G | FG | 7.0 | | 2.4 | - | Epicormic branching (L) | Retain |
| 12 | Swamp White Oak | <i>Quercus bicolor</i> | 25 | G | G | G | 7.0 | | 1.8 | - | Pruning wounds (L) | Remove |

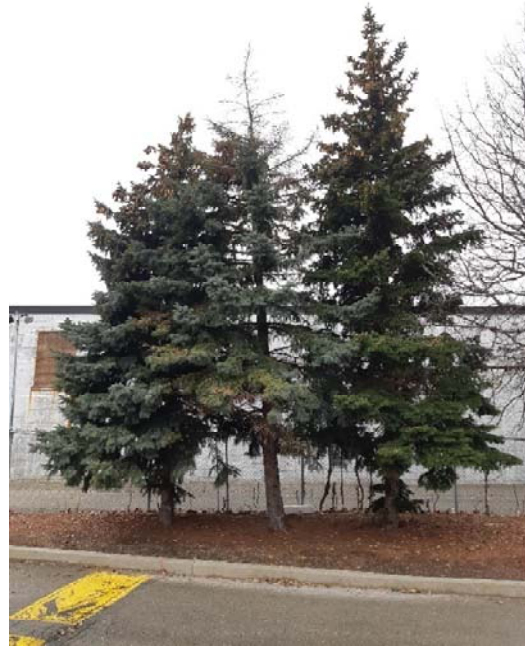
Image 8. Trees 13-15 (right to left)

| Tree # | Common Name | Scientific Name | DBH | TI | CS | CV | DL | CDB | mTPZ | Cat. | Comments | Action |
|---|---|---|---|---|---|---|---|---|---|---|---|---|
| 13 | Blue Spruce | <i>Picea pungens</i> | 22.5 | G | FG | G | 3.5 | | 1.8 | - | Sparse crown (L) | Remove |
| 14 | Blue Spruce | <i>Picea pungens</i> | 25.5 | G | FG | FG | 3.0 | 10 | 1.8 | - | Sparse crown (M), lean (L) east | Remove |
| 15 | Blue Spruce | <i>Picea pungens</i> | 22 | G | G | G | 4.5 | | 1.8 | - | | Remove |

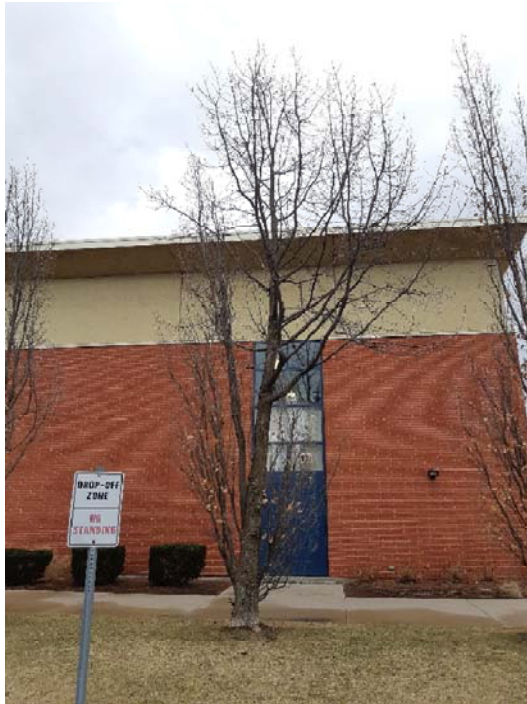
Image 9. Tree 16

| Tree # | Common Name | Scientific Name | DBH | TI | CS | CV | DL | CDB | mTPZ | Cat. | Comments | Action |
|---|---|---|---|---|---|---|---|---|---|---|---|---|
| 16 | Columnar English Oak | <i>Quercus robur 'Fastigiata'</i> | ~24 | FG | G | G | 5.0 | | 1.8 | - | Pruning wounds (L) | Retain |

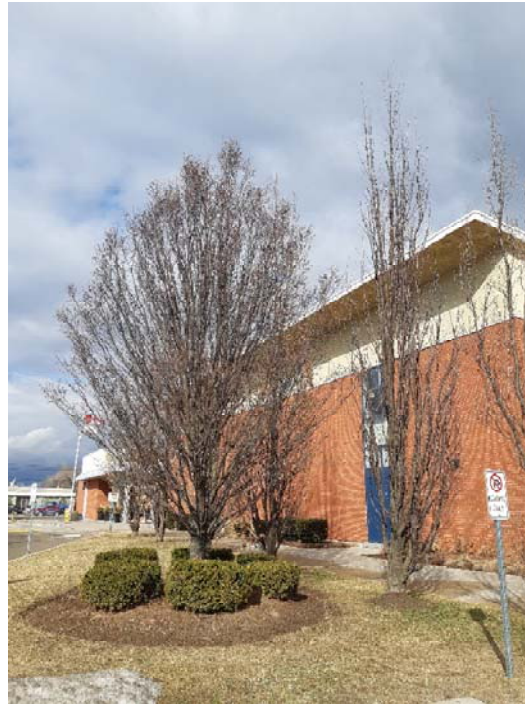
Image 10. Tree 17 (left) and 18 (right)

| Tree # | Common Name | Scientific Name | DBH | TI | CS | CV | DL | CDB | mTPZ | Cat. | Comments | Action |
|---|---|---|---|---|---|---|---|---|---|---|---|---|
| 17 | Serviceberry | <i>Amelanchier spp.</i> | ~15 | FG | G | G | 4.5 | | 1.8 | - | Co-dominance at 1m with included bark | Remove |
| 18 | Columnar English Oak | <i>Quercus robur 'Fastigiata'</i> | ~15 | G | G | G | 1.5 | | 1.8 | - | Pruning wounds (L) | Remove |

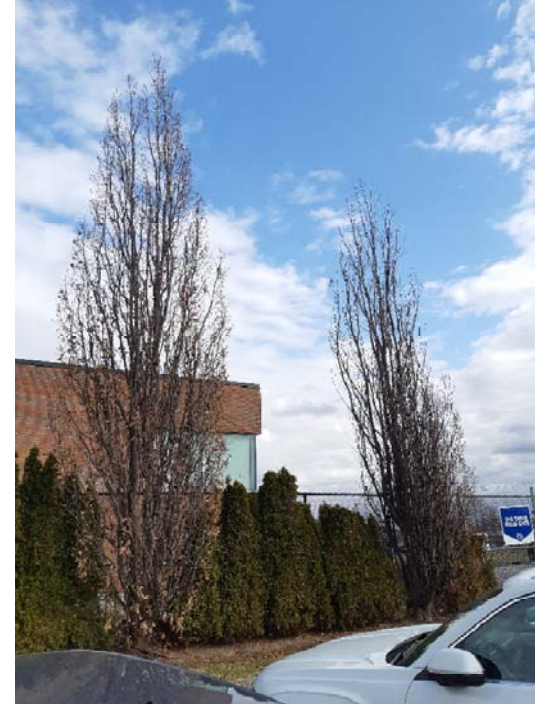
Image 11. Tree 19 (left) and 20 (right)

| Tree # | Common Name | Scientific Name | DBH | TI | CS | CV | DL | CDB | mTPZ | Cat. | Comments | Action |
|---|---|---|---|---|---|---|---|---|---|---|---|---|
| 19 | Columnar English Oak | <i>Quercus robur 'Fastigiata'</i> | ~15 | G | G | G | 2.5 | | 1.8 | - | | Remove |
| 20 | Columnar English Oak | <i>Quercus robur 'Fastigiata'</i> | ~19 | G | G | FG | 1.5 | 5 | 1.8 | - | Pruning wounds (L) | Remove |

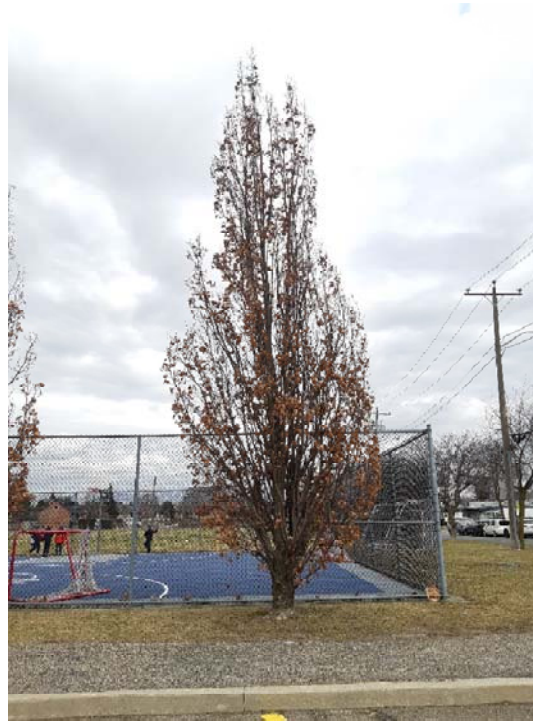
Image 13. Tree 21

| 21 | Columnar English Oak | <i>Quercus robur</i> 'Fastigiata' | 18 | G | G | G | 3.0 | | 1.8 | - | | Retain (injure) |

Excavation within the mTPZ of Tree 21 is required to accommodate the new asphalt. Excavation at this limit should occur by hand or using air spading technology and be supervised by a certified Arborist. Any roots exposed must be pruned in accordance with Good Arboricultural Standards.

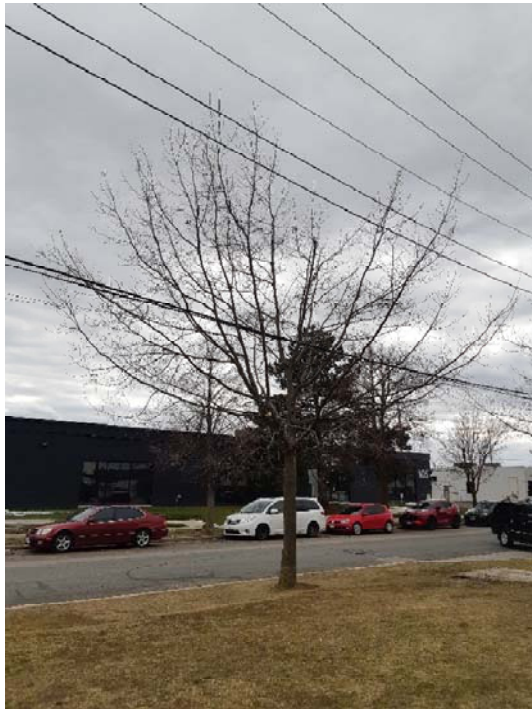
Image 14. Tree 22

| 22 | Red Oak | <i>Quercus rubra</i> | 27 | G | G | G | 8.0 | | 1.8 | 5 | Frost crack (L), power lines through crown | Retain |

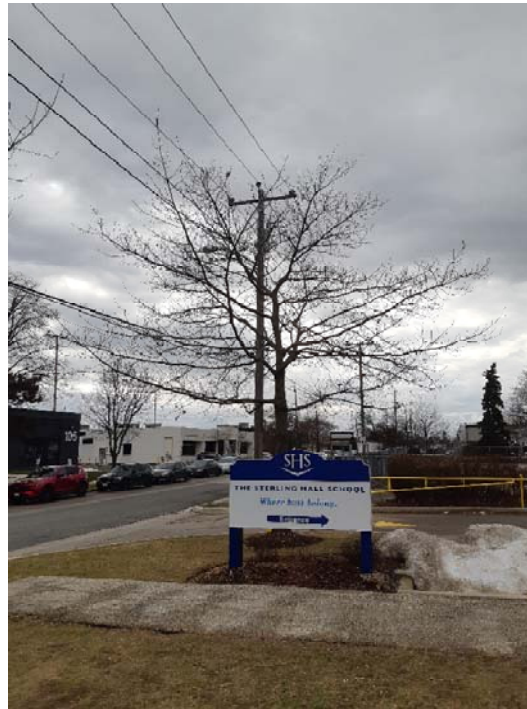
Image 15. Tree 23

| 23 | Red Oak | <i>Quercus rubra</i> | 25 | G | G | G | 9.0 | | 1.8 | - | | Retain |

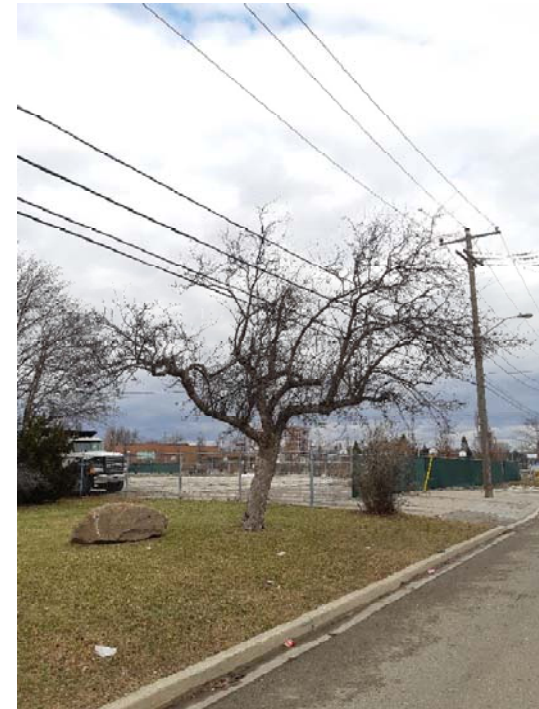
Image 16. Tree 24

| 24 | Apple species | <i>Malus sp.</i> | 40.5 | FG | FG | F | 10.5 | | 3 | 5 | Pruning wounds (H) with cavity, epicormic branching (H), co-dominance at 2m (3 stems), cavity (L), lean (L) east, power lines through crown | Retain |

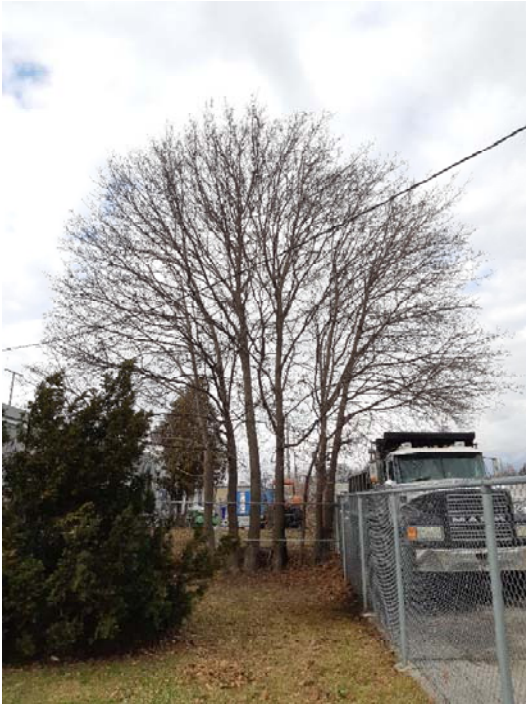
Image 17. Tree polygon P25

| P25 | Norway Maple | <i>Acer platanoides</i> | ~7-23<br>Avg. 20 | FG | FG | G | Avg. 7 | | 1.8 | - | 7 trees. Exposed roots (M), girdling root (L), included fence (M), bow (L), asymmetrical crown (M) | Retain |
