# **Hazardous Building Materials Assessment**

99 Cartwright Avenue, Toronto,  
Ontario

**Sterling Hall School**  
99 Cartwright Avenue  
Toronto, Ontario, M6A 1V2

December 19, 2014

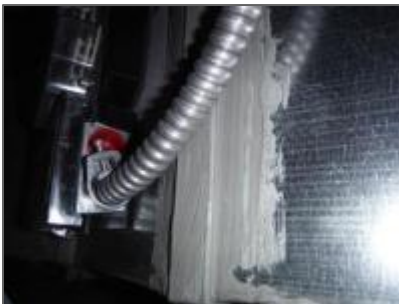
Grey duct mastic is present on the ducts within the Hallway of the school. Three samples of the mastic (samples 0005A-C) were collected and it was determined that the grey mastic is non-asbestos.

Non-asbestos grey duct mastic.

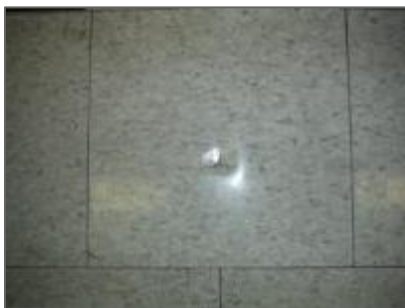
| Size, Pattern, Colour and Photo Number | Locations (Quantity) | Sample Number | Asbestos Type (tile) | Asbestos Type (mastic) |
|---|---|---|---|---|
| 12" x 12" beige with grey flecks | Classroom 35 (250SF), Classroom 36 (350SF) and Hallway (500SF) | 0002A-C | None | None |

Non-asbestos 12" x 12" beige with grey flecks vinyl floor tiles

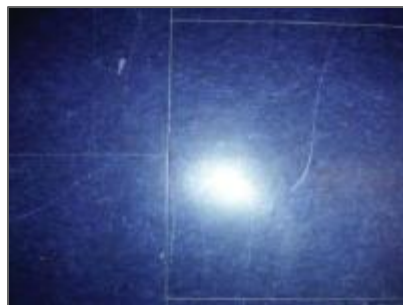
| Size, Pattern, Colour and Photo Number | Locations (Quantity) | Sample Number | Asbestos Type (tile) | Asbestos Type (mastic) |
|---|---|---|---|---|
| 12" x 12" blue | Stage (250SF) | 0006A-C | None | None |

Non-asbestos 12" x 12" blue vinyl floor tiles

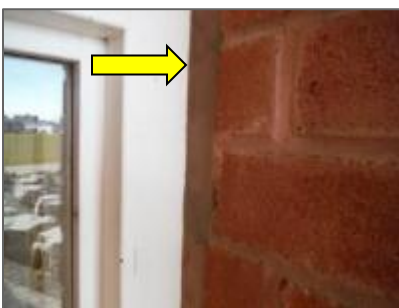
Brown caulking at exterior doors contains was sampled and determined to be non-asbestos (samples 0008A-C).

Non-asbestos exterior brown caulking.

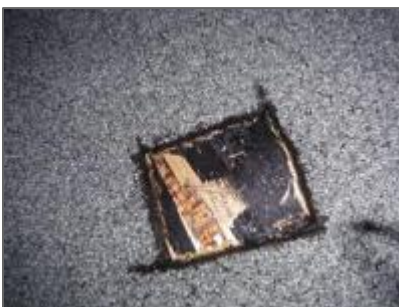
Built-up roofing is present on the roof over the port-a-pack. The built up roofing material was sampled (samples 0010A-C). The built up roofing materials was found to be non-asbestos.

Non-asbestos built-up roofing.
