**2022 RE-ASSESSMENT SURVEY  
FOR ASBESTOS - CONTAINING MATERIALS**

**THE STERLING HALL SCHOOL  
99 CARTWRIGHT AVENUE  
TORONTO, ONTARIO**

**Date Issued: February 20, 2022**

**DEI Project Number: 21311**

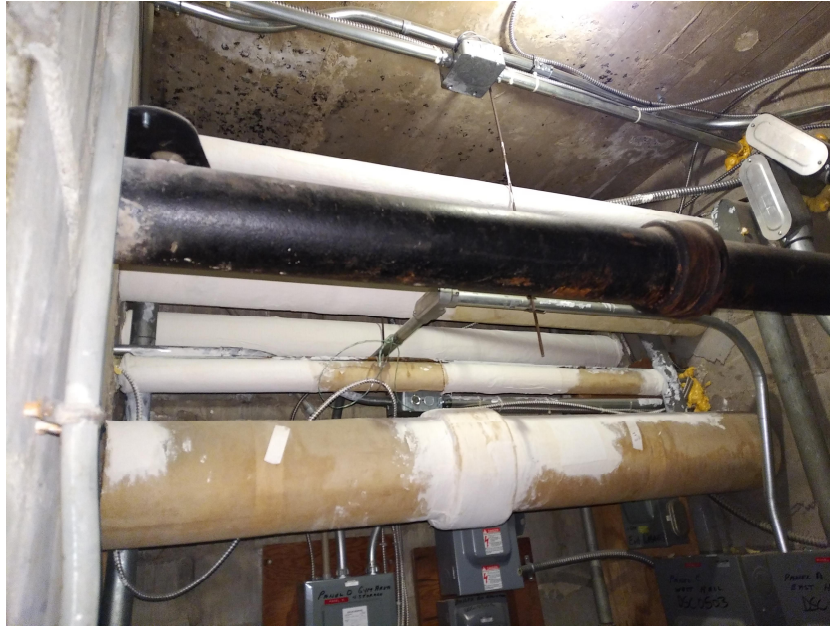
As indicated in the previous survey report, mechanical pipe straight insulation identified within the entrance to the Basement Boiler Room was sampled and found to contain **60% Chrysotile** asbestos. The pipe insulation identified was observed in Good condition and thus assigned as **Priority 2**.

| Location Description | Material | Quantity | Priority | Type(s) of Asbestos | Friable (Y/N) | Photograph |
|---|---|---|---|---|---|---|
| Basement Area<br>(Boiler Room and Entrance area) | Pipe Straight Insulation | 35 Lnft | 2 | <i>Chrysotile</i> | Y | 1 |

**Photograph 01:** View of mechanical pipe straight insulation identified within the entrance to the Basement Boiler Room found to contain **60% Chrysotile** asbestos. The pipe insulation identified was observed in Good condition and thus assigned as **Priority 2**.

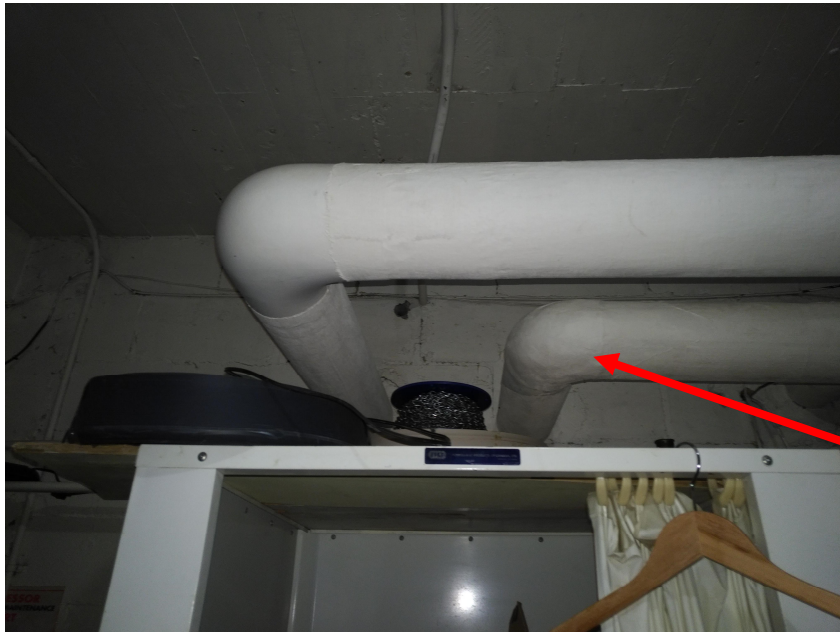
As indicated in the previous survey report, mechanical pipe fitting insulation identified within the entrance to the Basement Boiler Room was sampled and found to contain **70% Chrysotile** asbestos. The pipe fitting insulation identified was observed in Good condition and thus assigned as **Priority 2**.

| Location Description | Material | Quantity | Priority | Type(s) of Asbestos | Friable (Y/N) | Photograph |
|---|---|---|---|---|---|---|
| | Pipe Fitting Insulation | 10 units | 2 | <i>Chrysotile</i> | Y | 2 |

**Photograph 02:** View of mechanical pipe fitting insulation identified within the entrance to the Basement Boiler Room found to contain **70% Chrysotile** asbestos. The pipe fitting insulation identified was observed in Good condition and thus assigned as **Priority 2**.

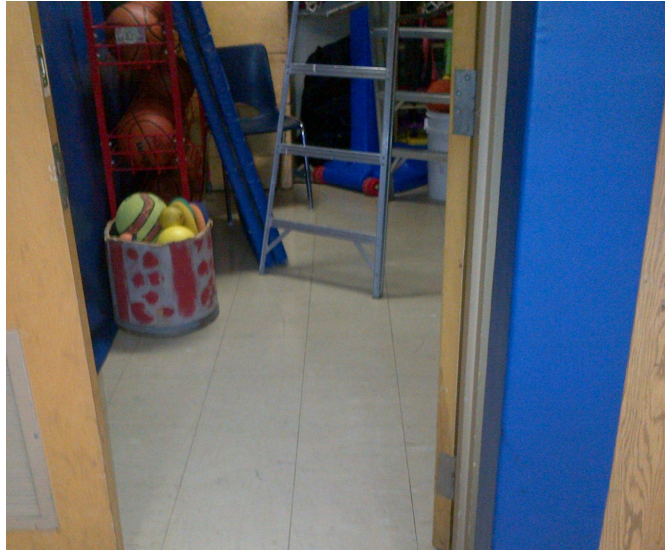
As indicated in the previous DEI Asbestos Bulk Sample Report dated March 2013, 12x12 beige vinyl floor tiles identified within the Gym Equipment Room were sampled and found to contain **2% Chrysotile** asbestos. The vinyl floor tiles identified were observed in Good condition and thus assigned as **Priority 2**.

| Location Description | Material | Quantity | Priority | Type(s) of Asbestos | Friable (Y/N) | Photograph |
|---|---|---|---|---|---|---|
| Gymnasium Storage Room | 12x12 Beige Vinyl Floor Tile | 85 sqft | 2 | <i>Chrysotile</i> | N | 3 |

**Photograph 03:** View of 12x12 beige vinyl floor tiles identified within the Gym Equipment Room found to contain **2% *Chrysotile*** asbestos. The vinyl floor tiles identified were observed in Good condition and thus assigned as **Priority 2**.

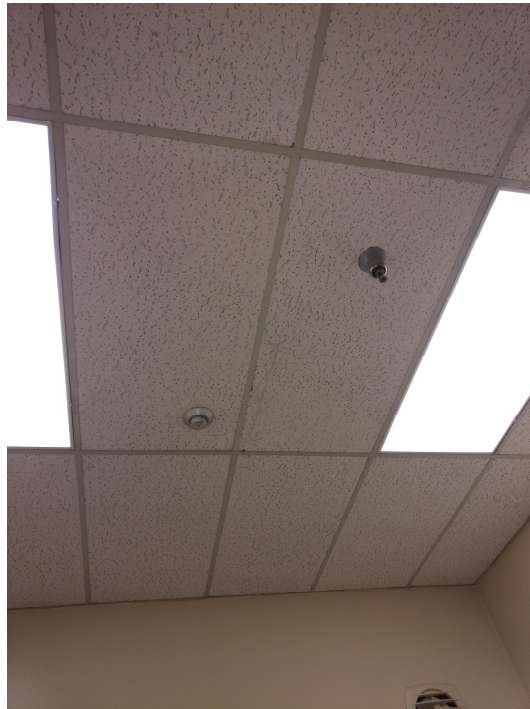
As indicated in the previous survey report, 2x4 random large horizontal fissure w/ pinhole ceiling tiles identified within the Main Office area were sampled and found to contain **3% Chrysotile** asbestos. The ceiling tiles identified were observed in Good condition and thus assigned as **Priority 2**.

| Location Description | Material | Quantity | Priority | Type(s) of Asbestos | Friable (Y/N) | Photograph |
|---|---|---|---|---|---|---|
| Main Office Area | 2x4 Random Large Horizontal Fissure w/ Pinhole Ceiling Tiles | 550 sqft | 2 | <i>Chrysotile</i> | Semi | 4 |

**Photograph 04:** View of 2x4 random large horizontal fissure w/ pinhole ceiling tiles identified within the Main Office area found to contain **3% *Chrysotile*** asbestos. The ceiling tiles identified were observed in Good condition and thus assigned as **Priority 2**.
