PHASE ONE
ENVIRONMENTAL SITE ASSESSMENT
109 CARTWRIGHT AVENUE AND 130 BENTWORTH AVENUE
TORONTO, ONTARIO

Prepared for: **The Sterling Hall School**
99 Cartwright Avenue
Toronto, Ontario, M6A 1V4

File No.: 02210387.000
January 12, 2023
©Terraprobe Inc.

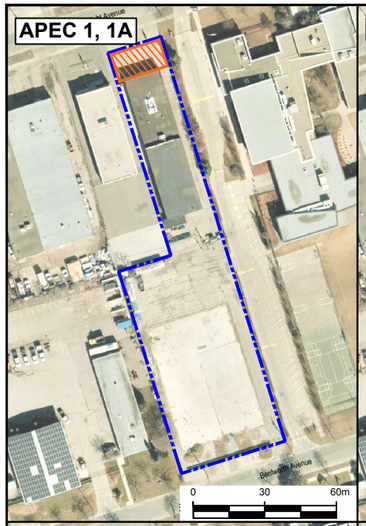
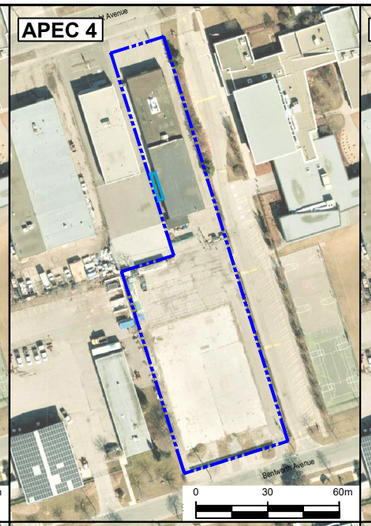
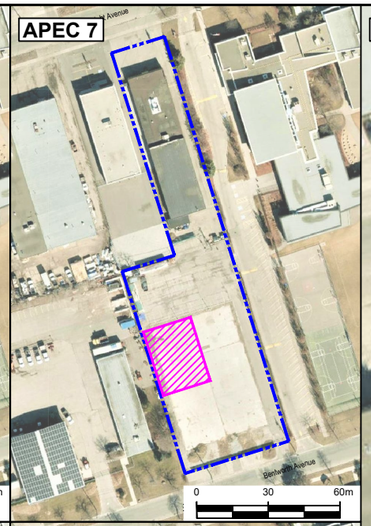
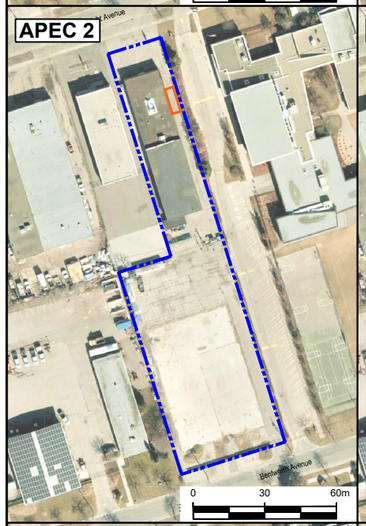
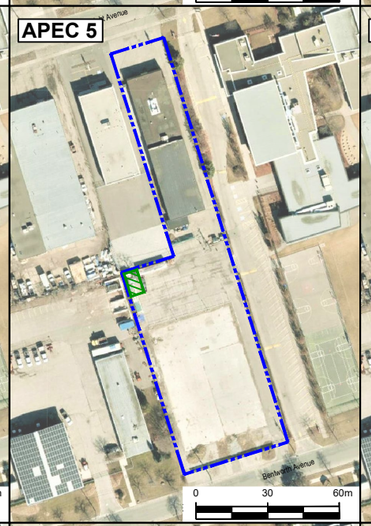
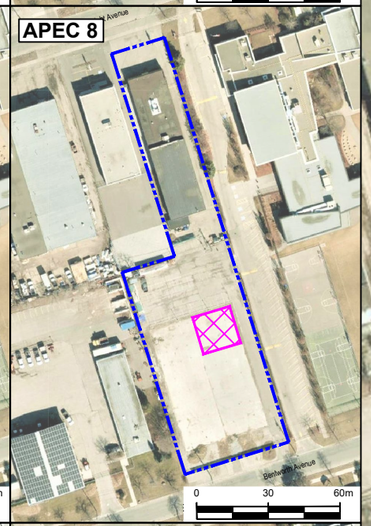
Figure Title:
PCA Locations

The following Potentially Contaminating Activities (PCAs) were observed during the site inspection.

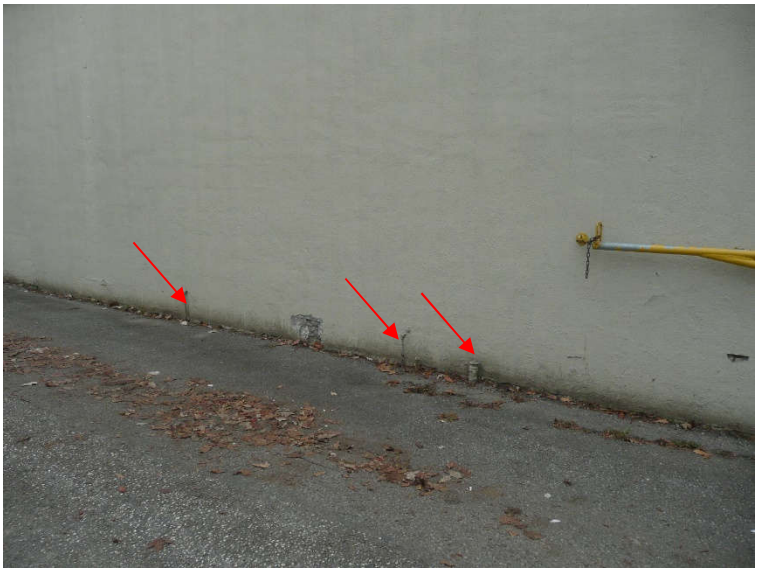
Photograph 5

Abandoned fuel oil supply and return piping was observed exterior to the building at 109 Cartwright Avenue, where a suspected buried fuel oil tank remains. No other evidence of USTs was observed on the Property.

Location:	Phase One Property
Viewing:	East side
Description:	Piping lines for suspect fuel oil UST at 109 Cartwright.
