PROJECT: OUR LADY OF VICTORY
CATHOLIC ELEMENTARY SCHOOL
ADDITION & RENOVATION

BINDER: **C** ARCHITECTURAL DETAILS,
GEOTECHNICAL REPORT &
DESIGNATED SUBSTANCE REPORT

SPECIFICATIONS BINDER “C”

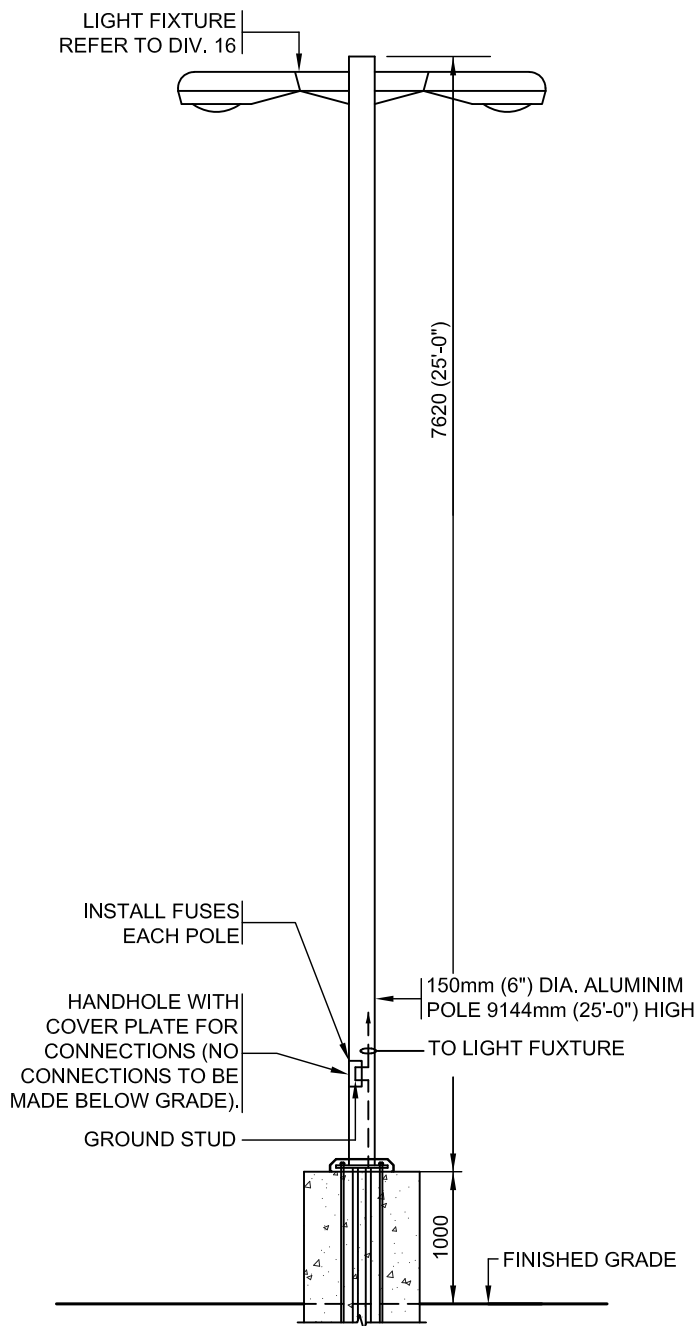
AD
213

LIGHT STANDARD

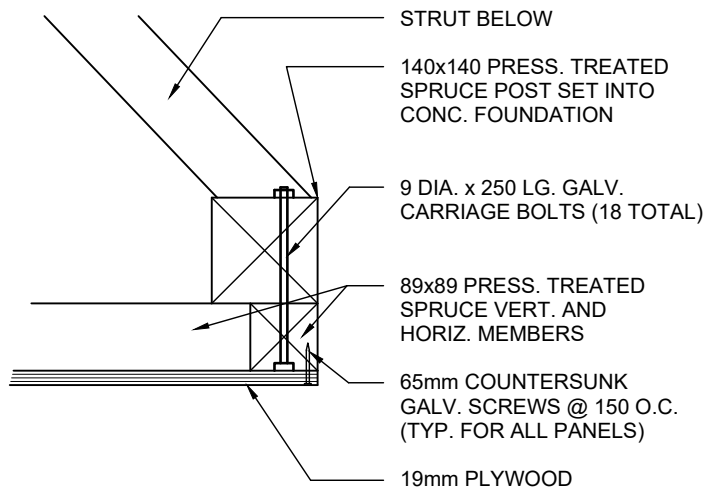
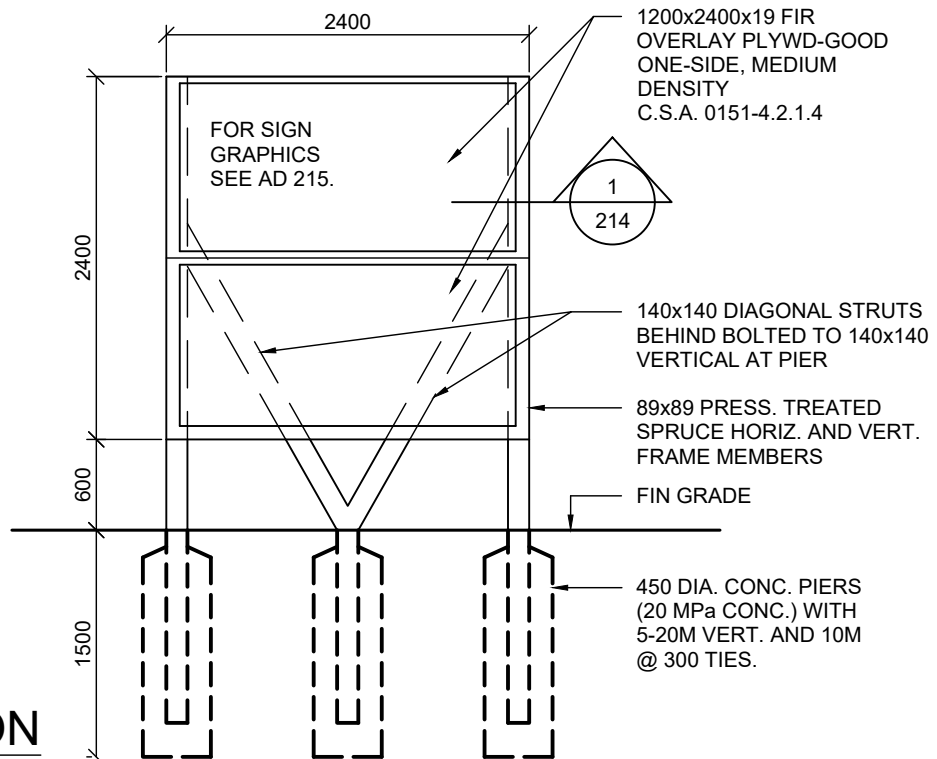
AD
214

SECTION 1
SCALE: 1:5

ELEVATION
SCALE: 1:50

JOB SITE SIGN

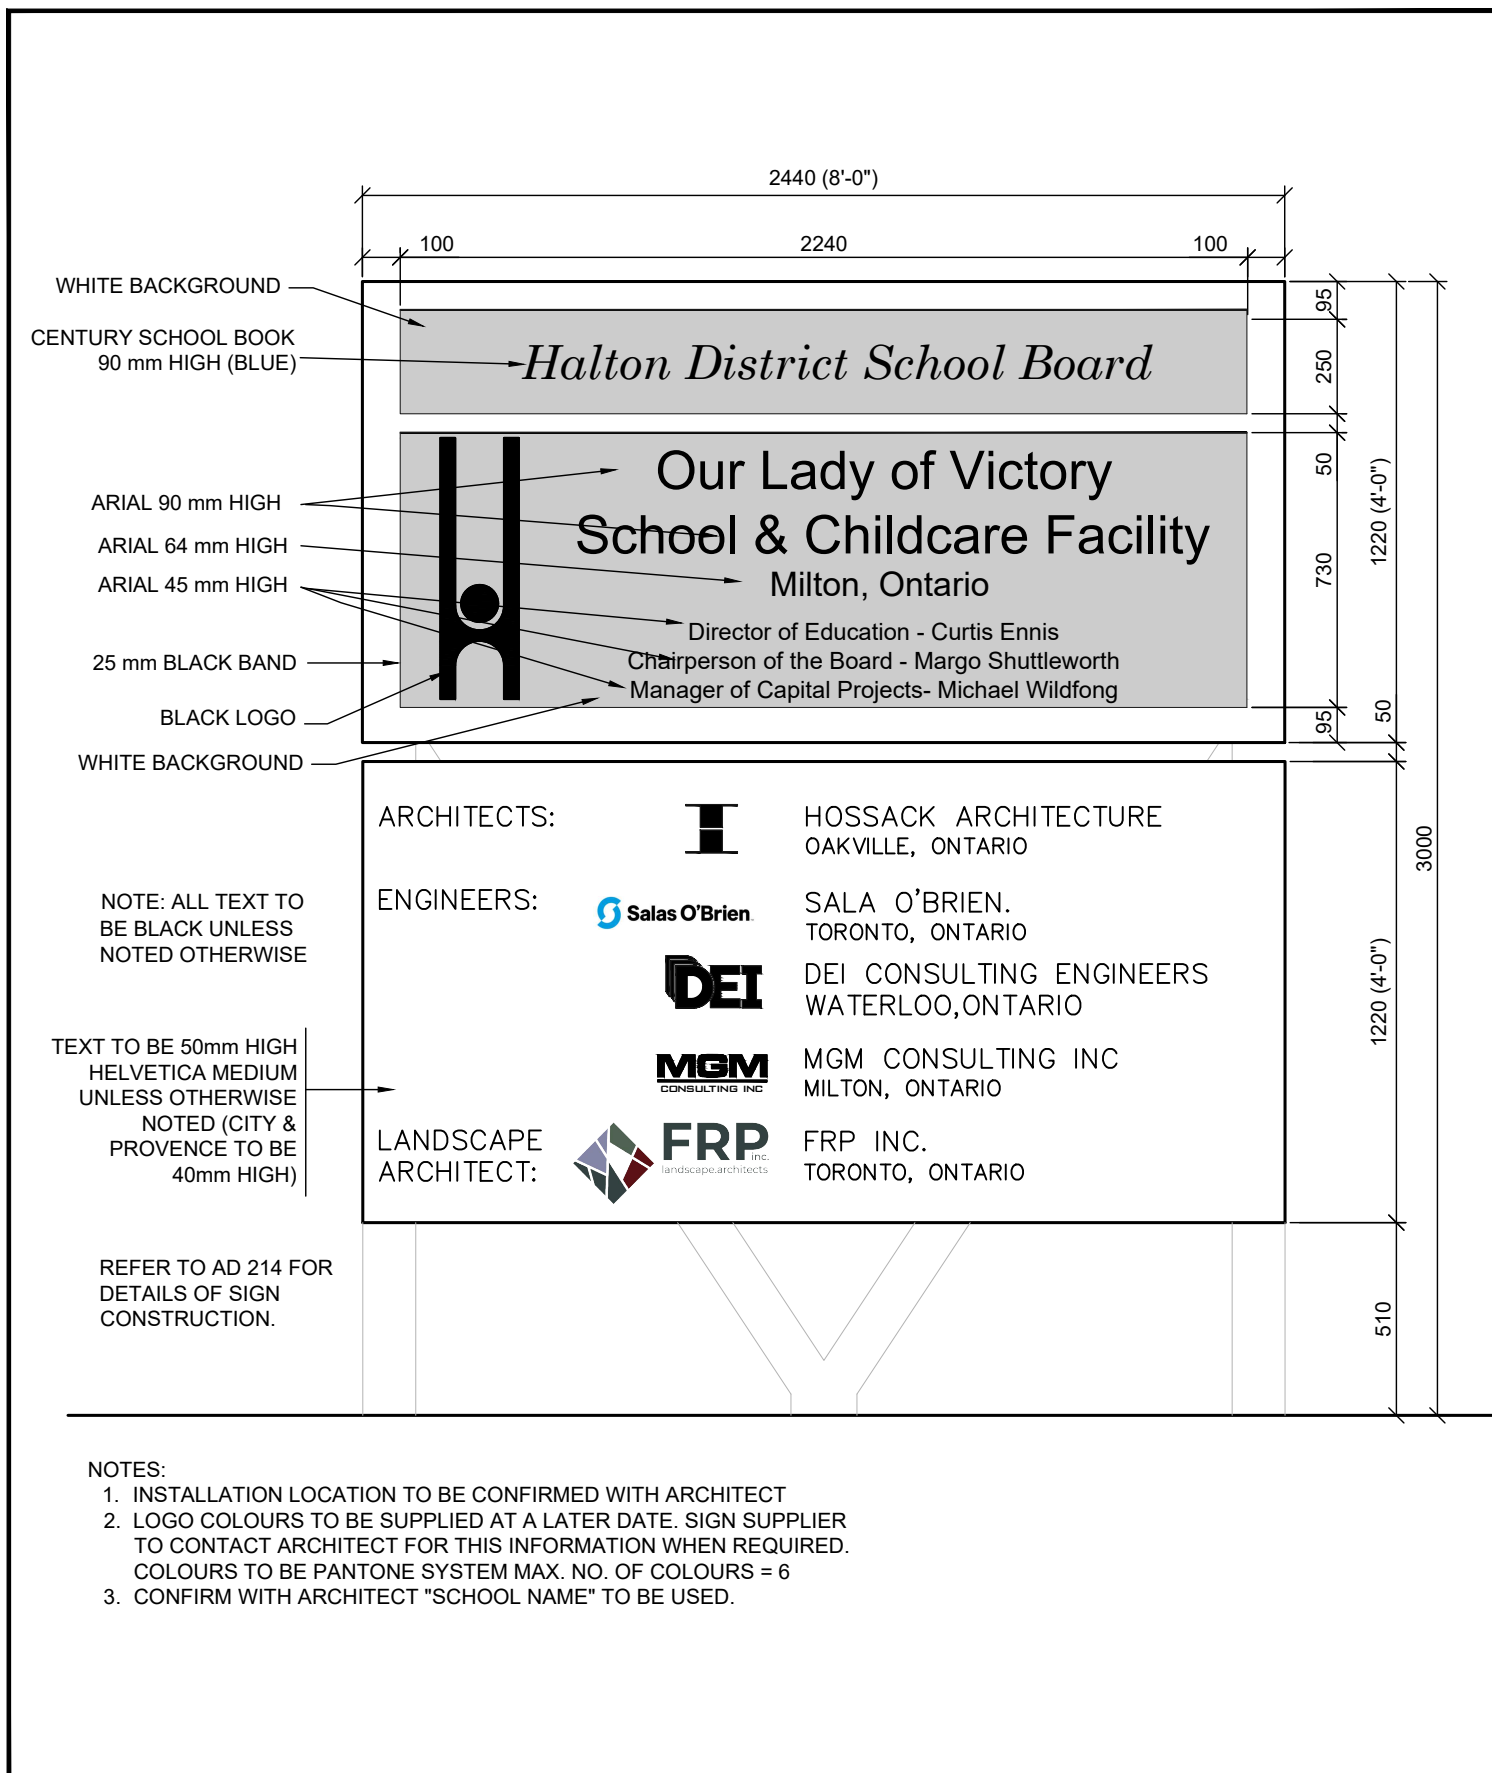
AD
215

JOB SITE SIGN

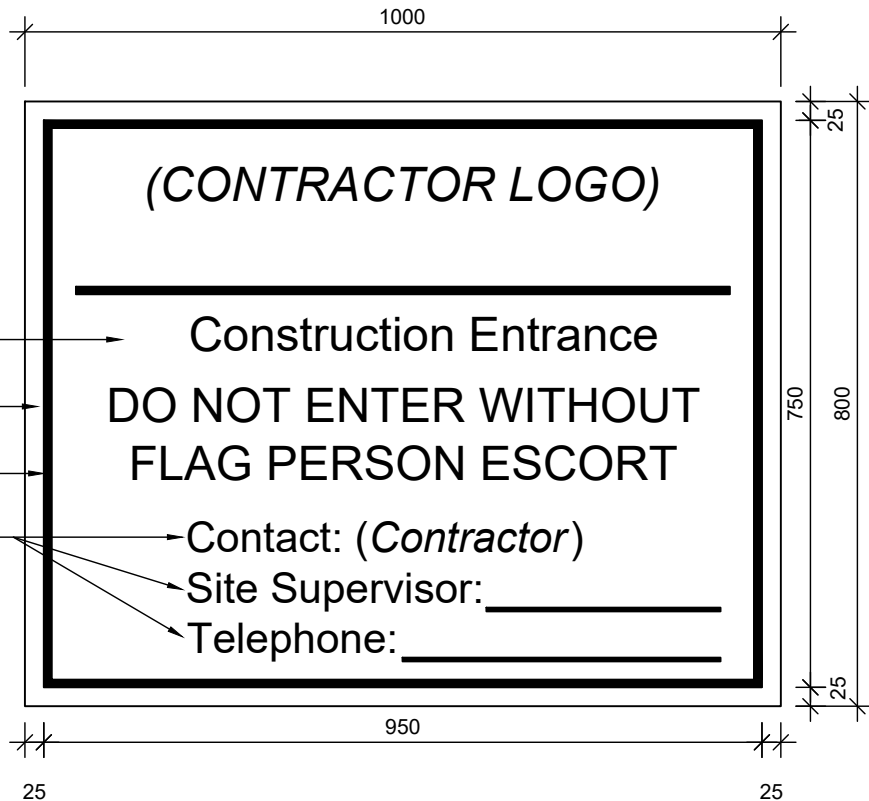
AD
257A

- Arial 45 mm high (black)
- Arial 45 mm high
- 15mm black band
- Arial 40 mm high

- 10mm black band
- Arial 50 mm high
- Arial 40 mm high (black)
- Arial 40 mm high (black)
- Arial 40 mm high

JOB SITE SIGNAGE

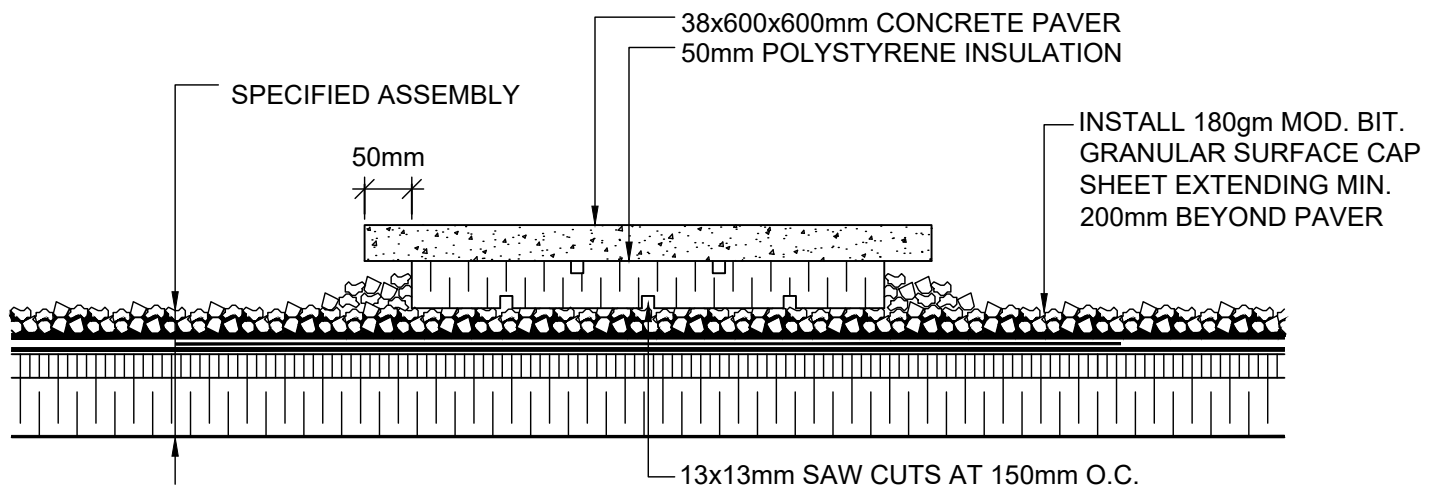
AD
302

ROOF CONCRETE PAVER DETAIL

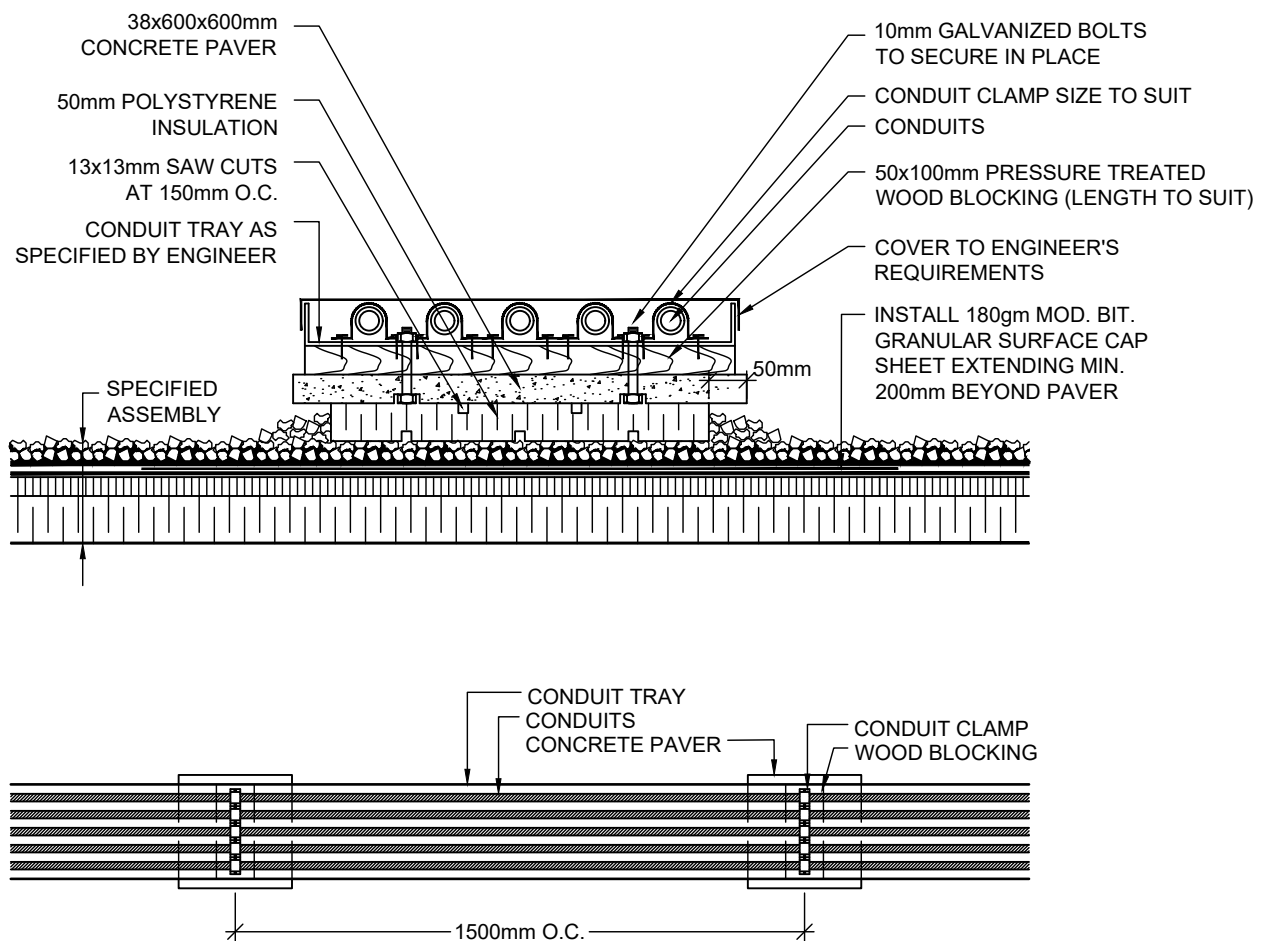
AD
303

CONDUIT ROOF PAVER DETAIL

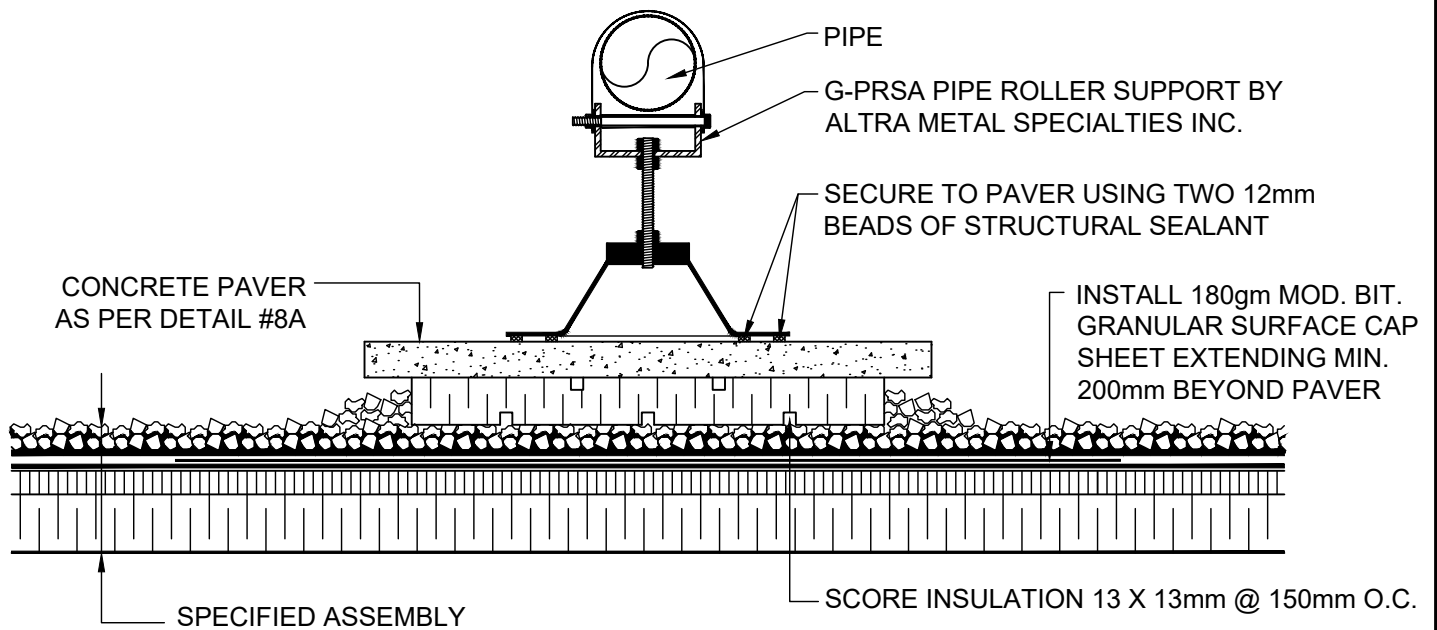
AD
304

1. THIS DETAIL APPLIES FOR PIPES UP TO 100mm IN DIAMETER ONLY.

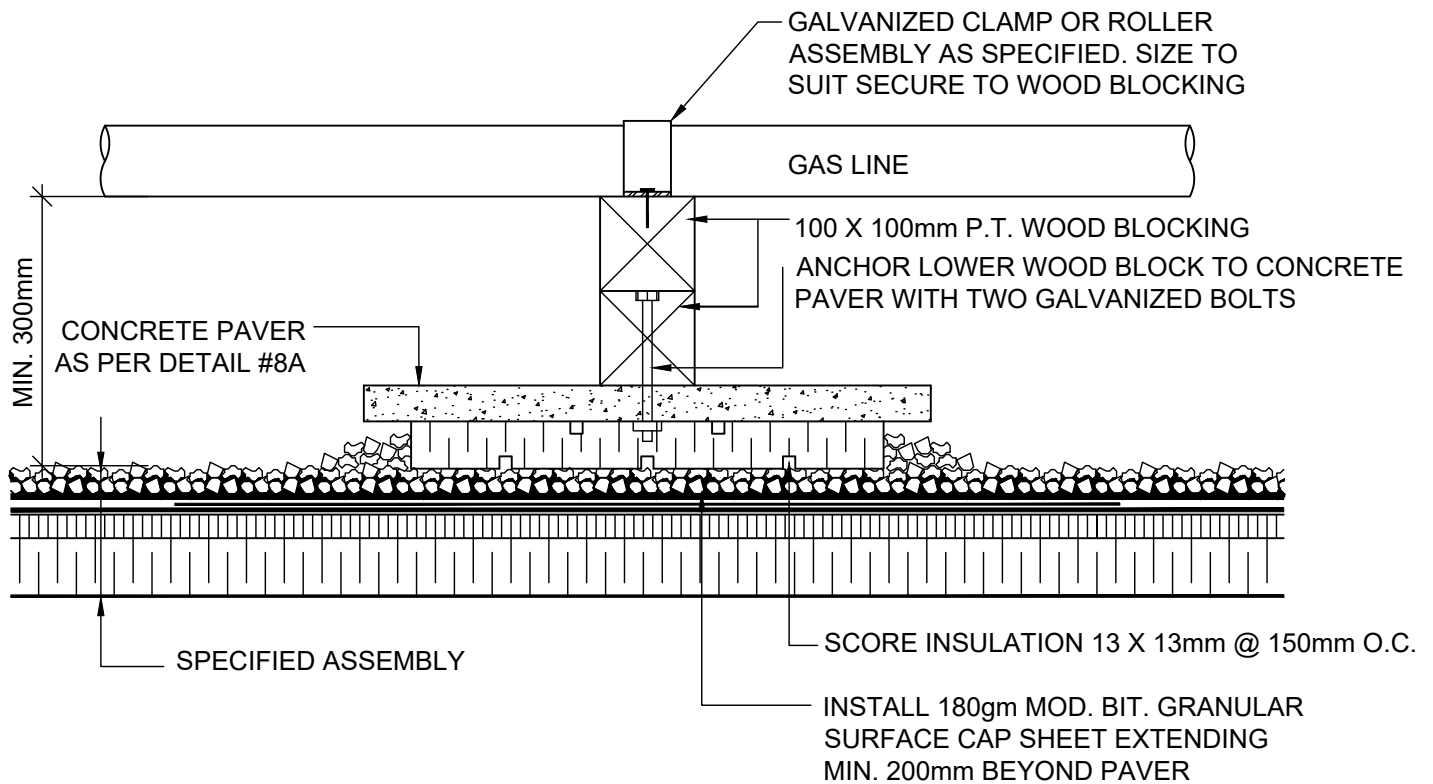
AD
305

PIPE SUPPORT ROOF PAVER DETAIL

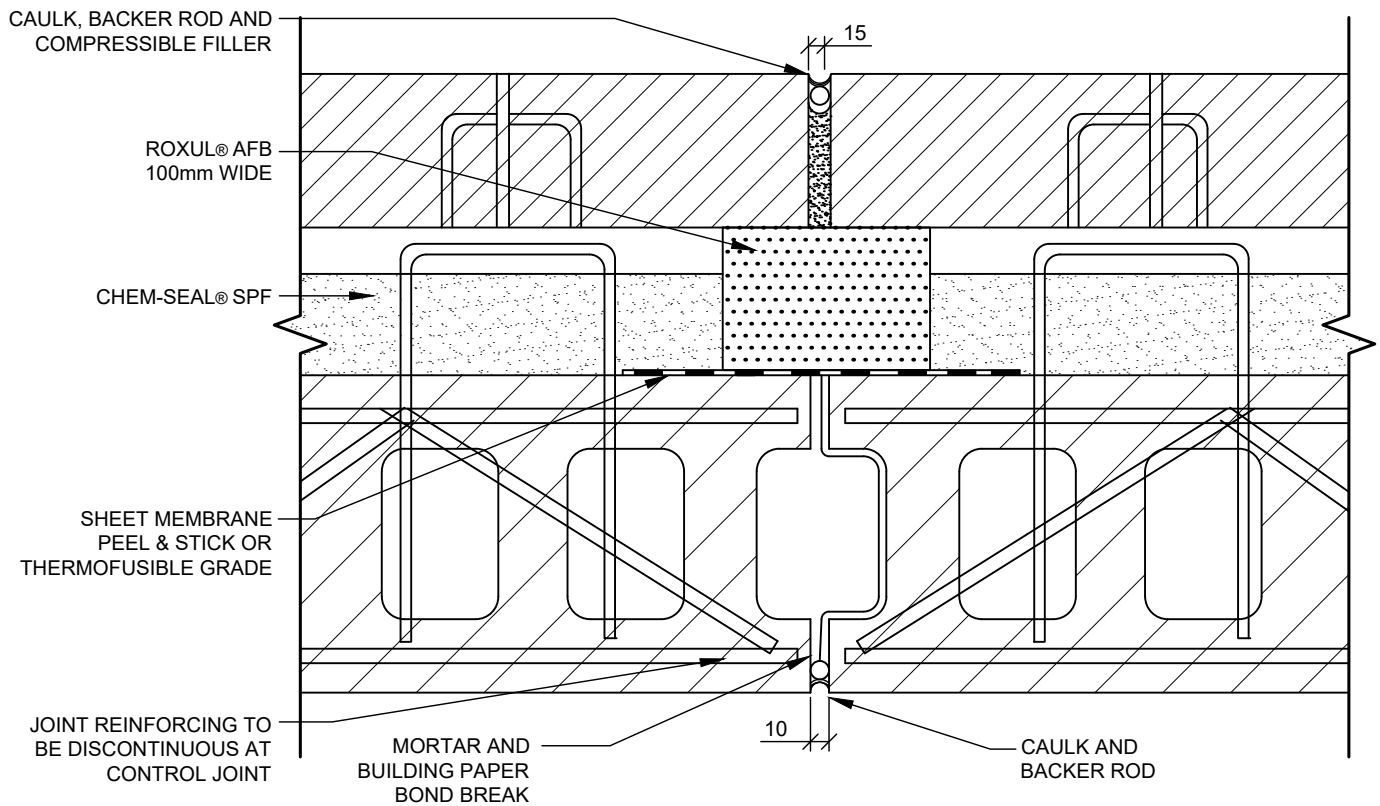
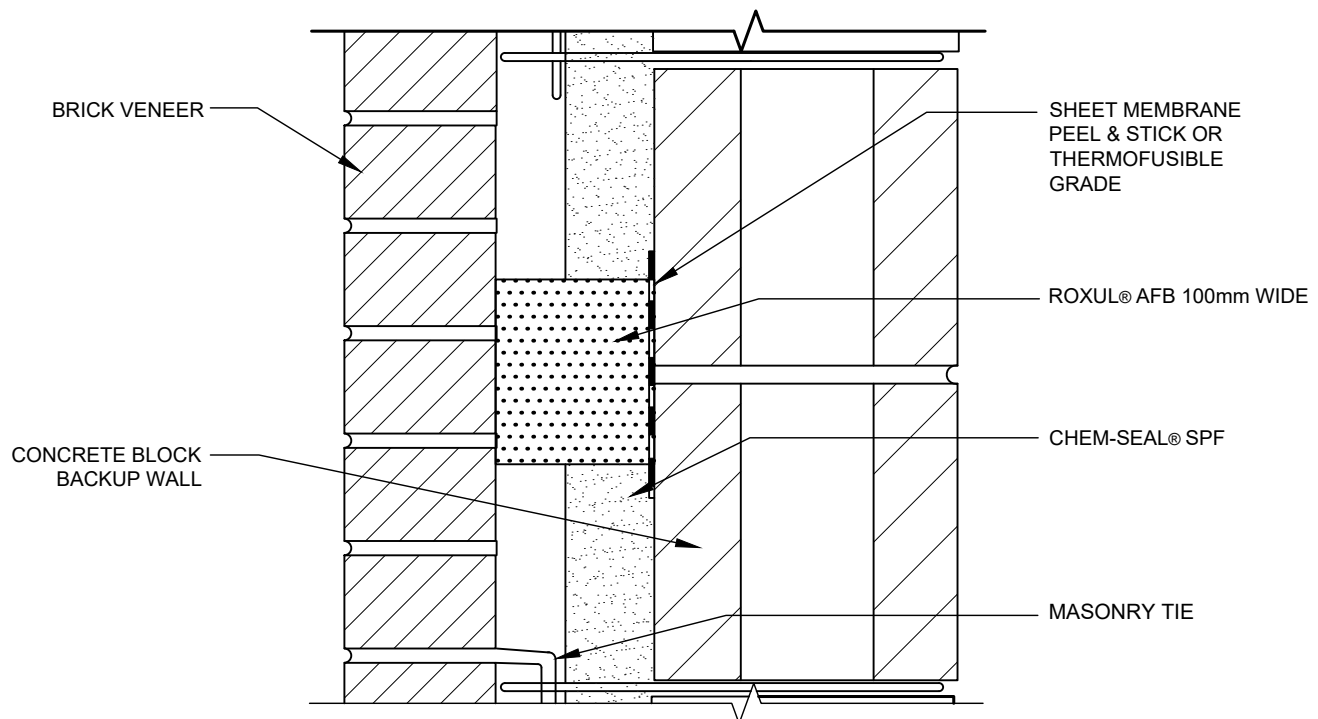
AD
400

VERTICAL FIRE STOPPING

HORIZONTAL FIRE STOPPING

FIRESTOPPING DETAIL AT CAVITY WALL

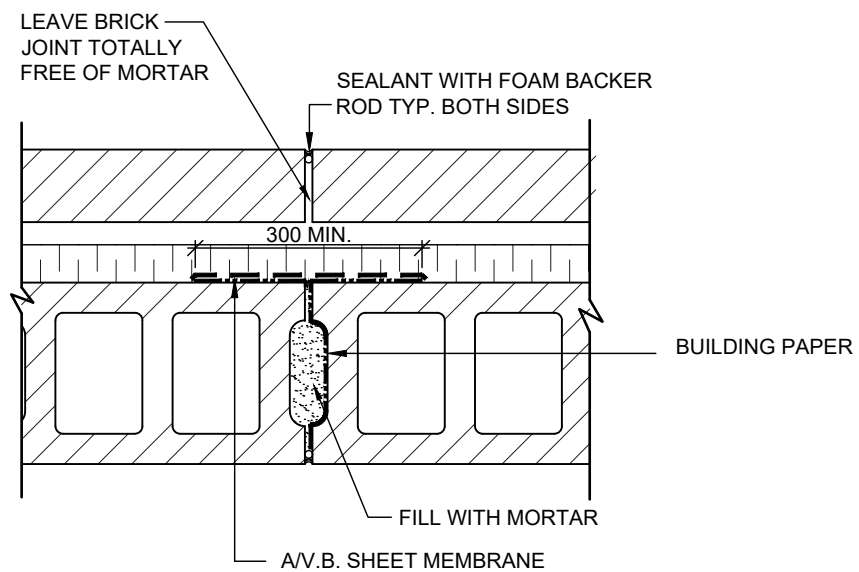
AD
410

WALL CONSTRUCTION:
FACE BRICK
AIR SPACE
INSULATION
CONC. BLOCK

EXTERIOR CAVITY WALL CONTROL JOINT DETAIL

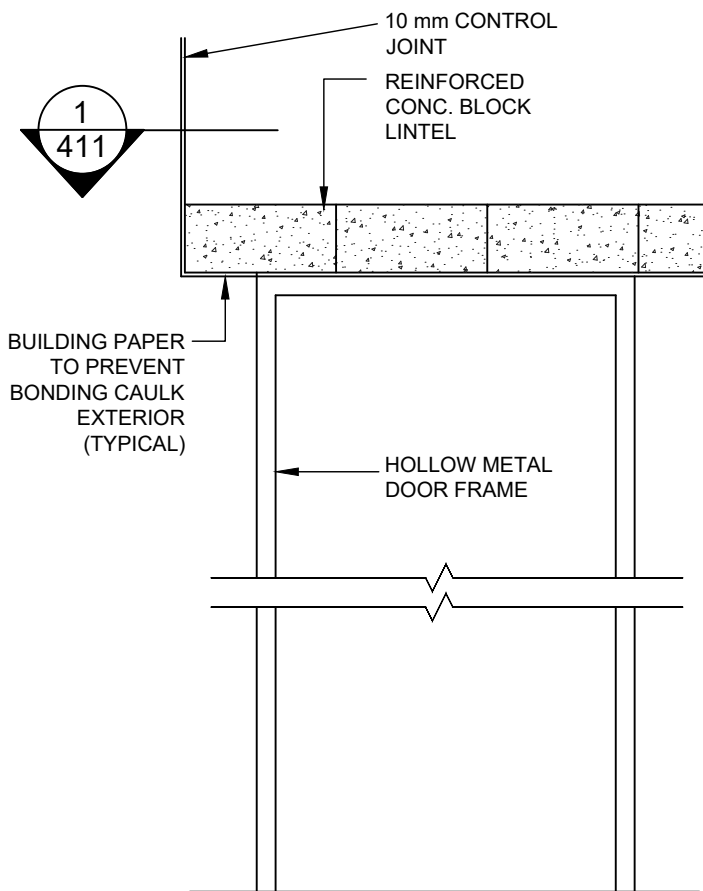
1 DOOR CONTROL JOINT
AD411 SCALE 1:20

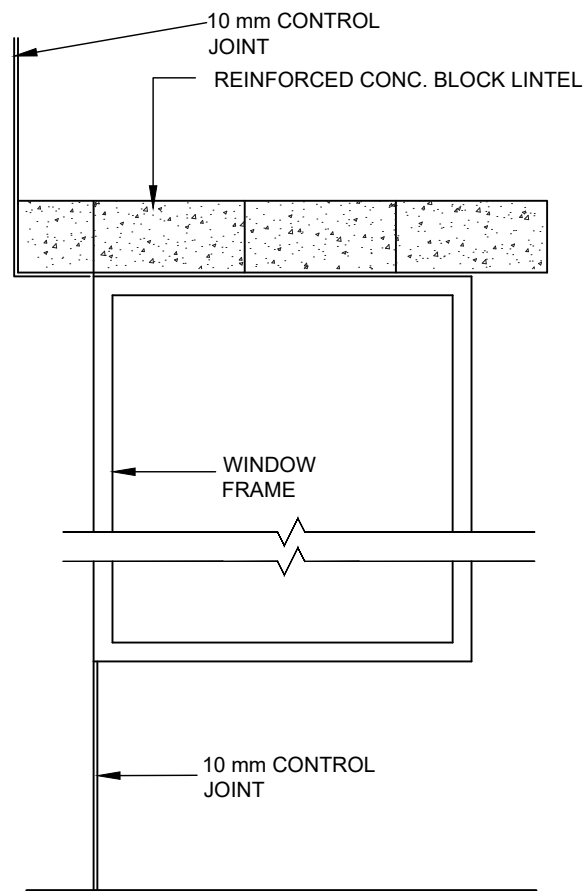
2 WINDOW CONTROL JOINT
AD411 SCALE 1:20

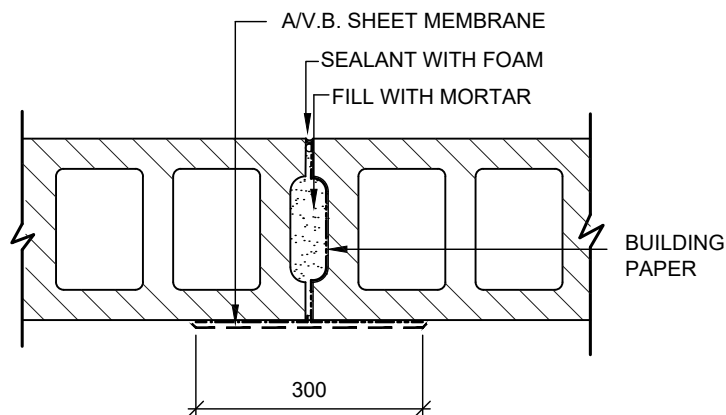
3 PLAN DETAIL
AD411 SCALE 1:10

WALL CONTROL JOINT DETAILS INTERIOR SIDE

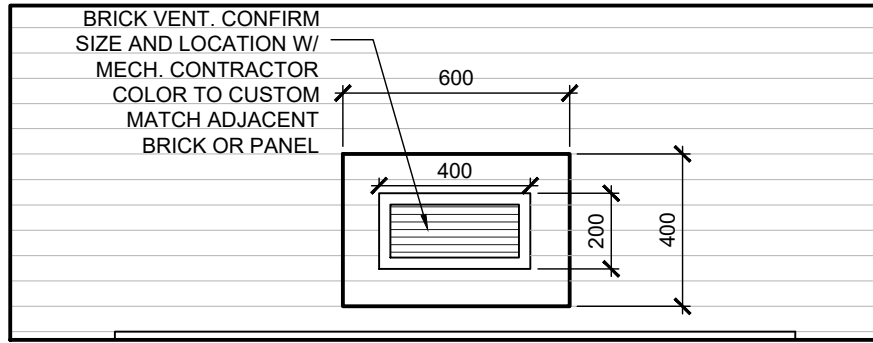
1 BRICK VENT DETAIL
AD412

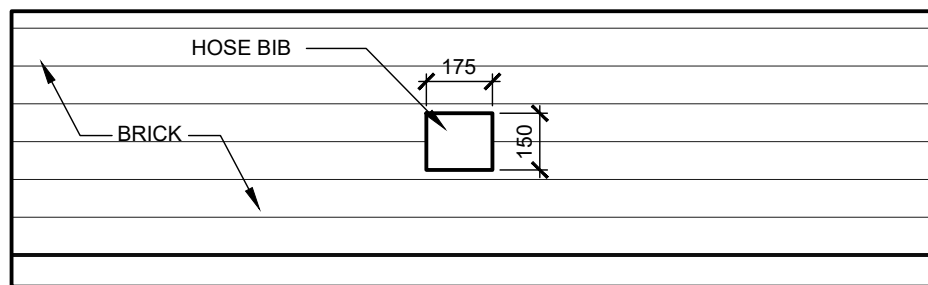
2 HOSE BIB DETAIL
AD412

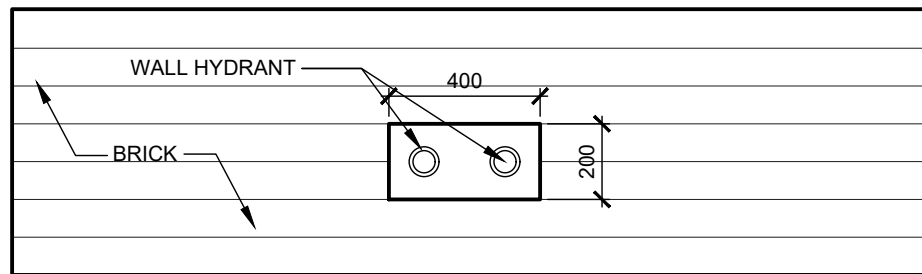
3 WALL HYDRANT DETAIL
AD412

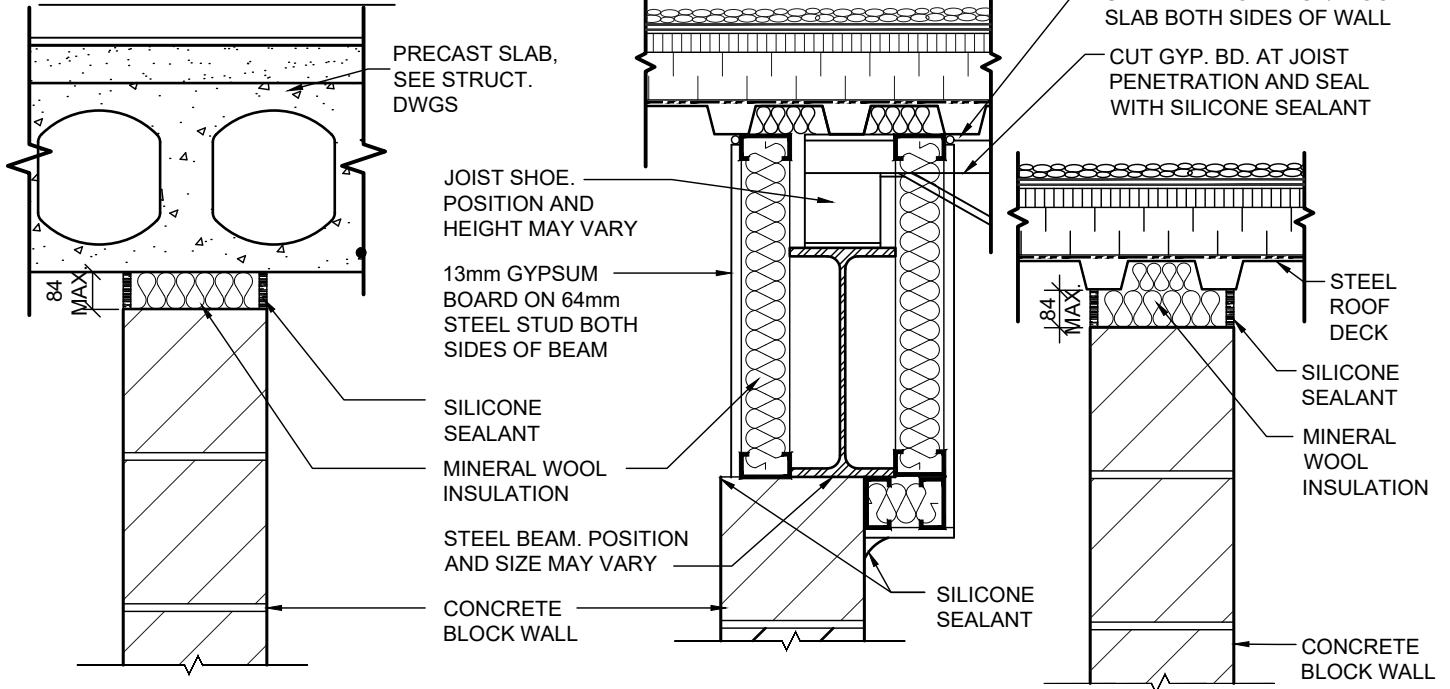
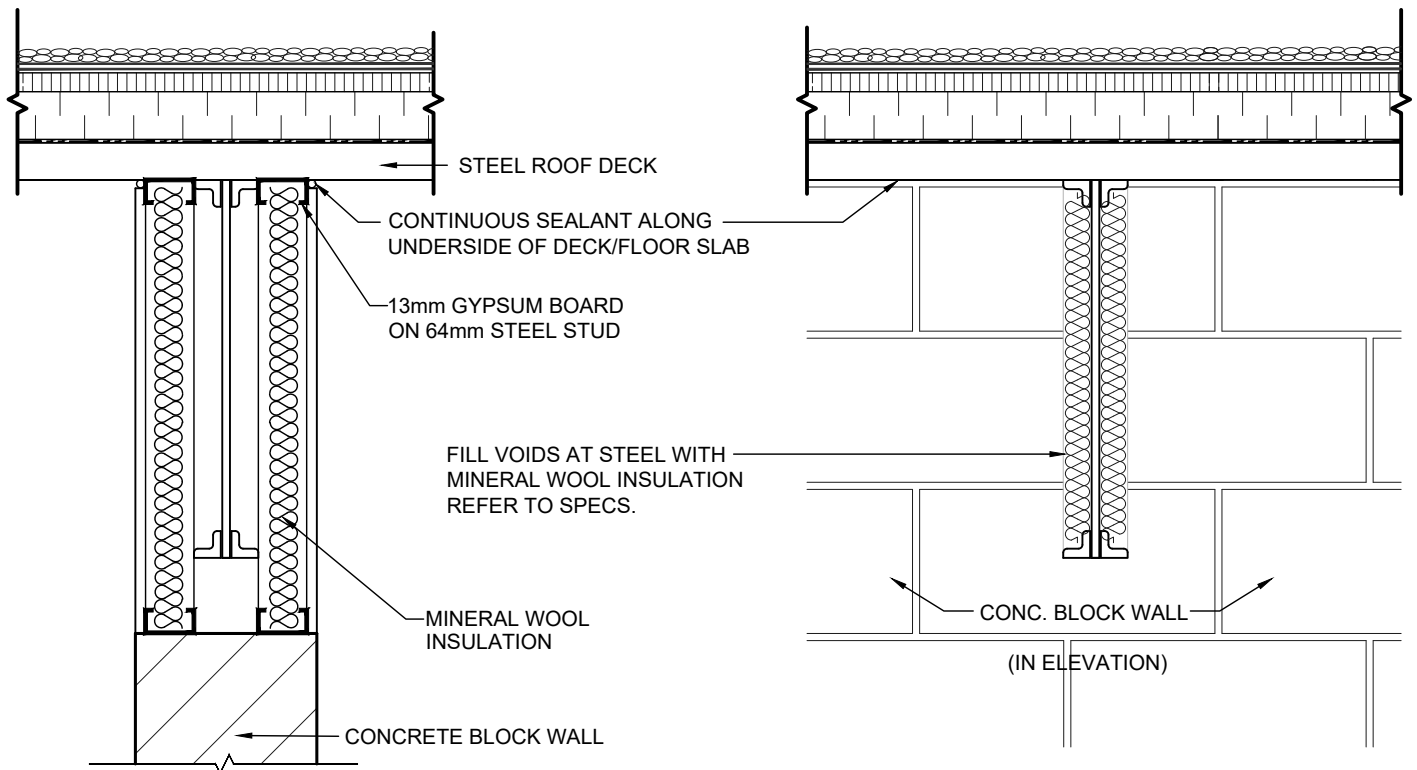
AD
450

CONDITION AT OFFSET BEAM / JOIST AT ROOF

CONDITION AT FLOOR

CONDITION AT ROOF

CONDITION AT PARALLEL JOIST OR BEAM

NOTE: ADJUST STEEL STUD SIZES TO SUIT BLOCK WALL CONDITION.
MIN. 64mm STUD AT MAX. 400 O.C.
REF. SPECS FOR FIRE-RATED SEALANTS

CONDITION AT PERPENDICULAR JOIST OR BEAM

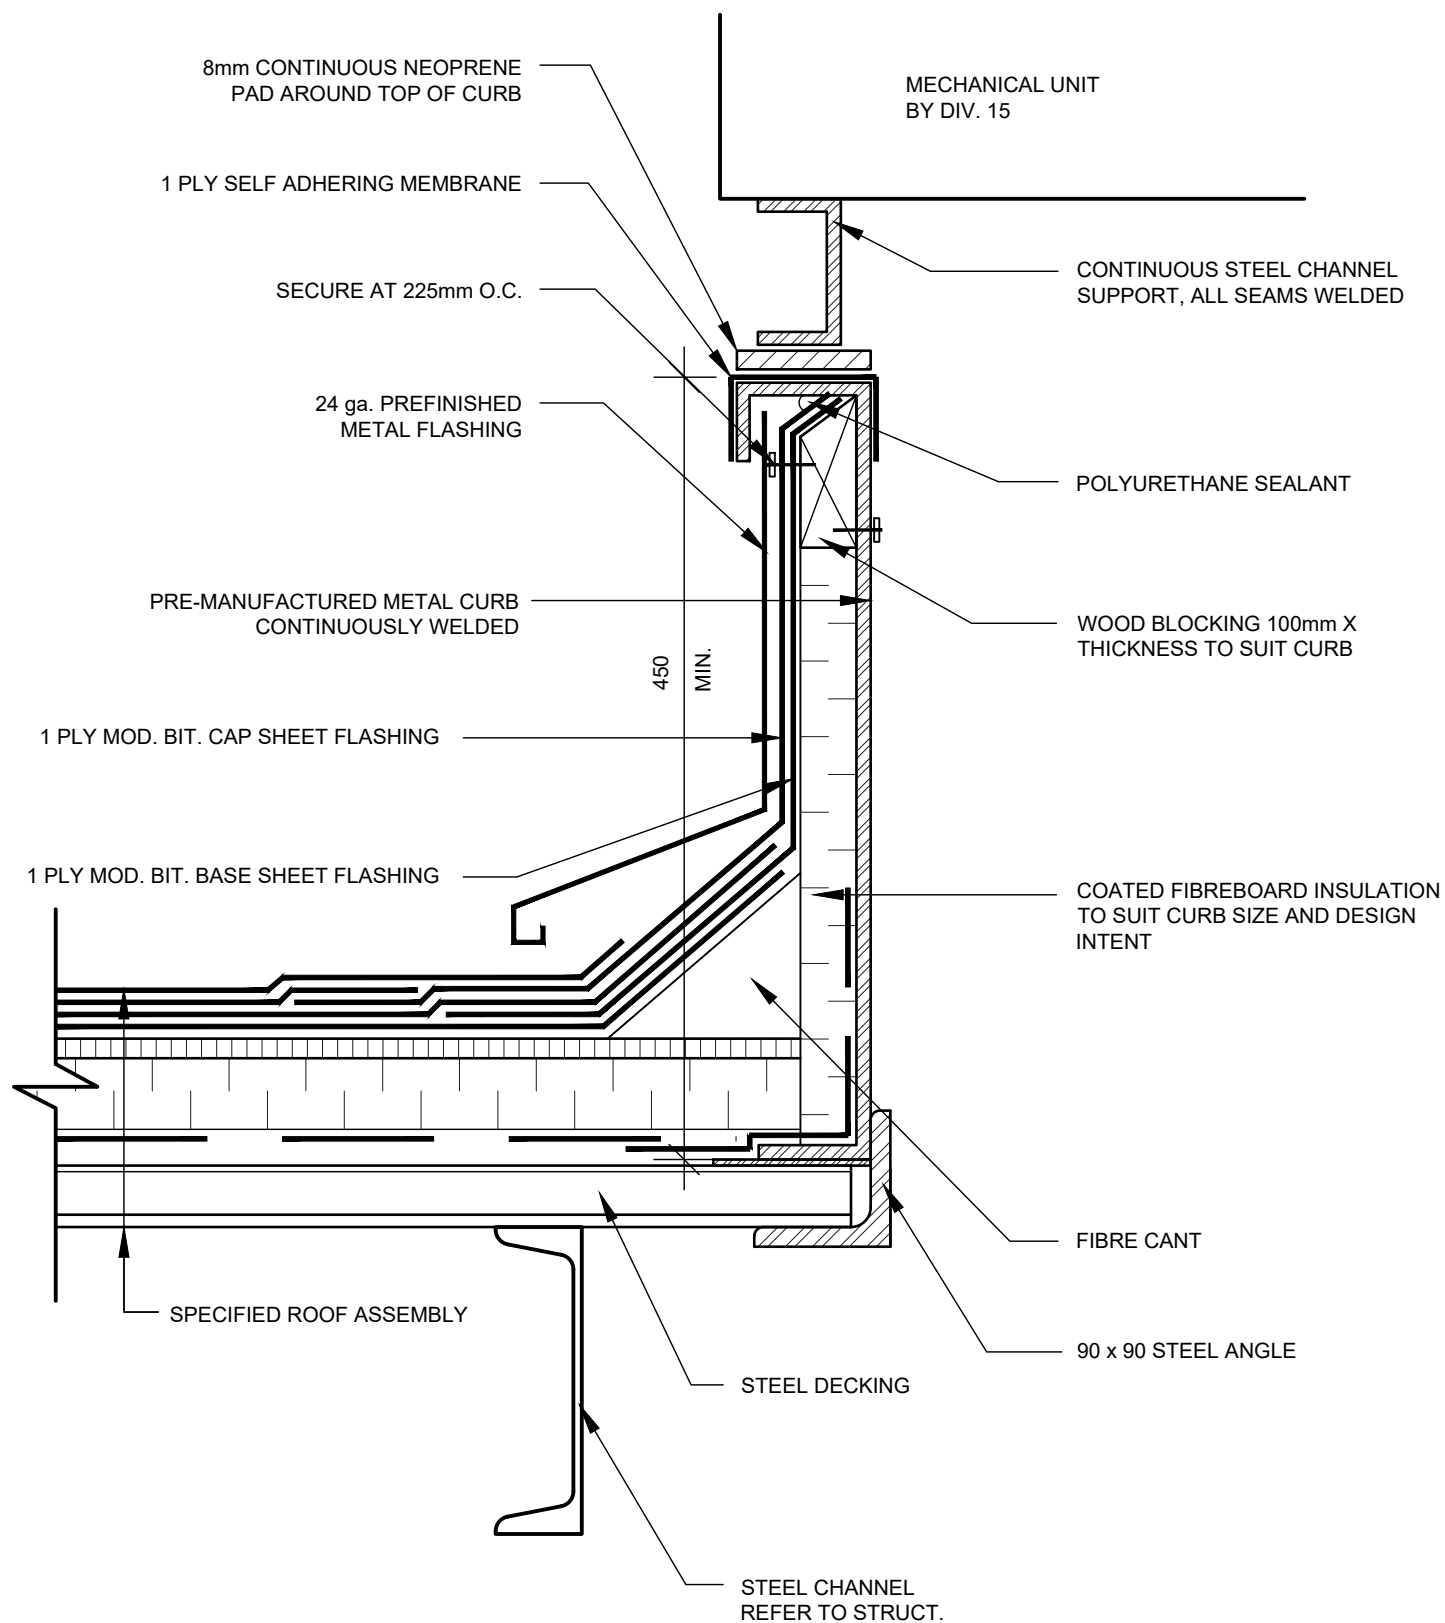
MECHANICAL CURB

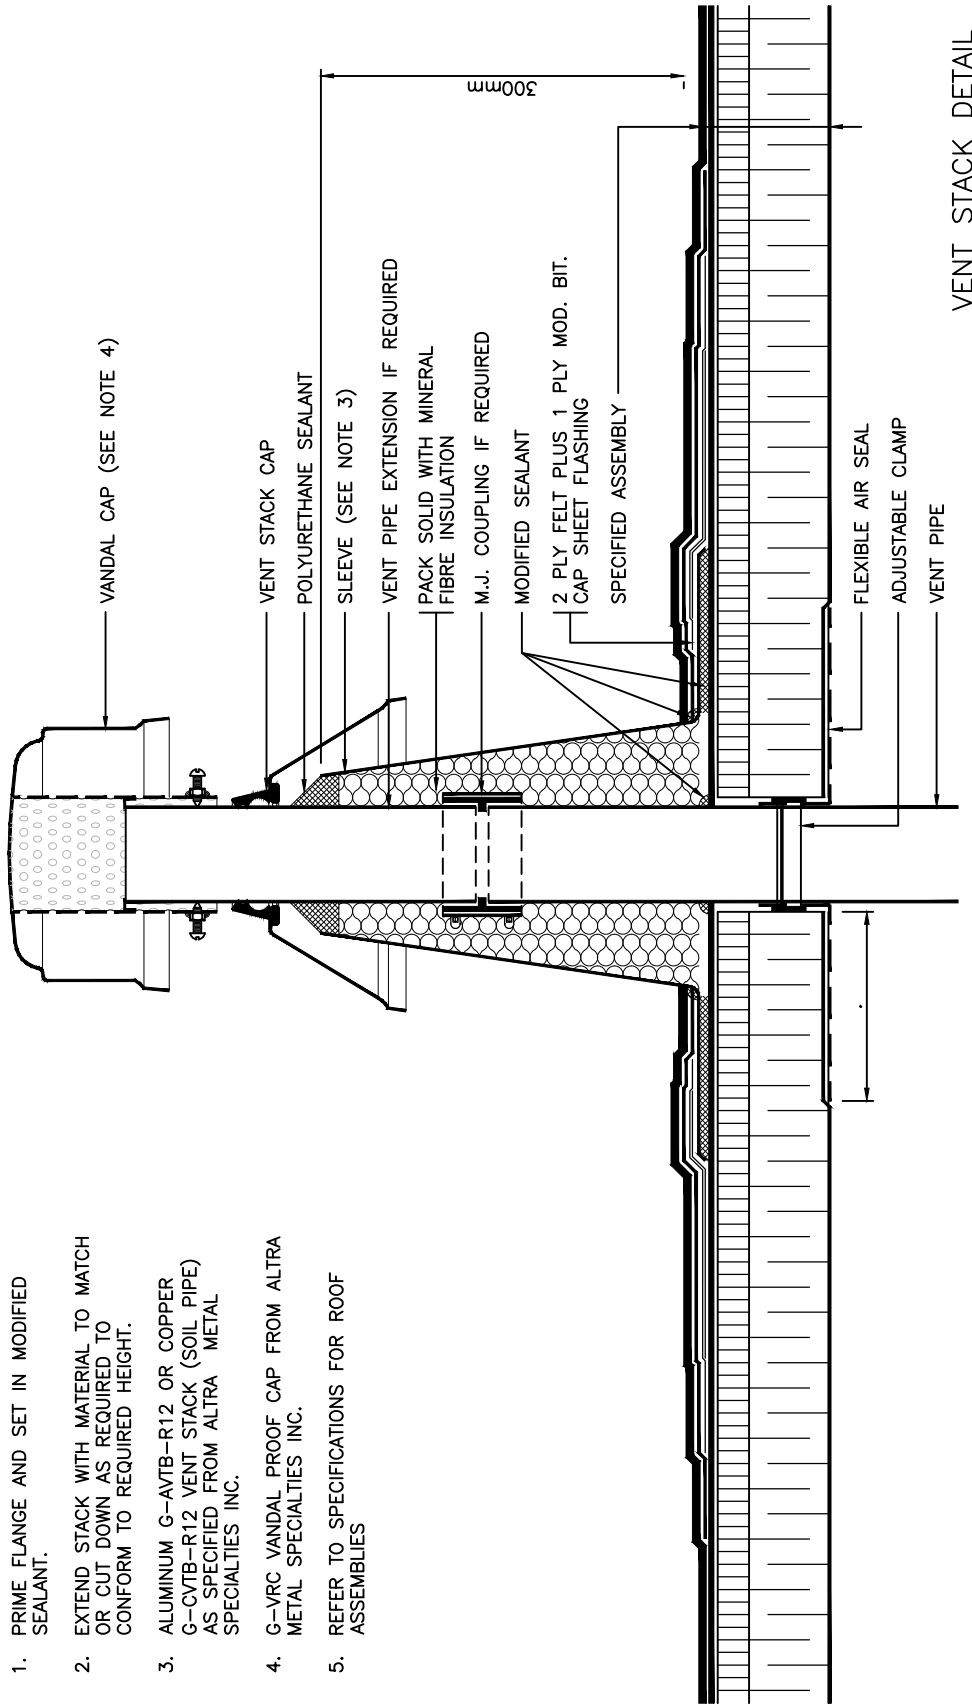
AD
459

1. PRIME FLANGE AND SET IN MODIFIED SEALANT.
2. EXTEND STACK WITH MATERIAL TO MATCH OR CUT DOWN AS REQUIRED TO CONFORM TO REQUIRED HEIGHT.
3. ALUMINUM G-AVTB-R12 OR COPPER G-CVTB-R12 VENT STACK (SOIL PIPE) AS SPECIFIED FROM ALTRA METAL SPECIALTIES INC.
4. G-VRC VANDAL PROOF CAP FROM ALTRA METAL SPECIALTIES INC.
5. REFER TO SPECIFICATIONS FOR ROOF ASSEMBLIES

VENT STACK DETAIL

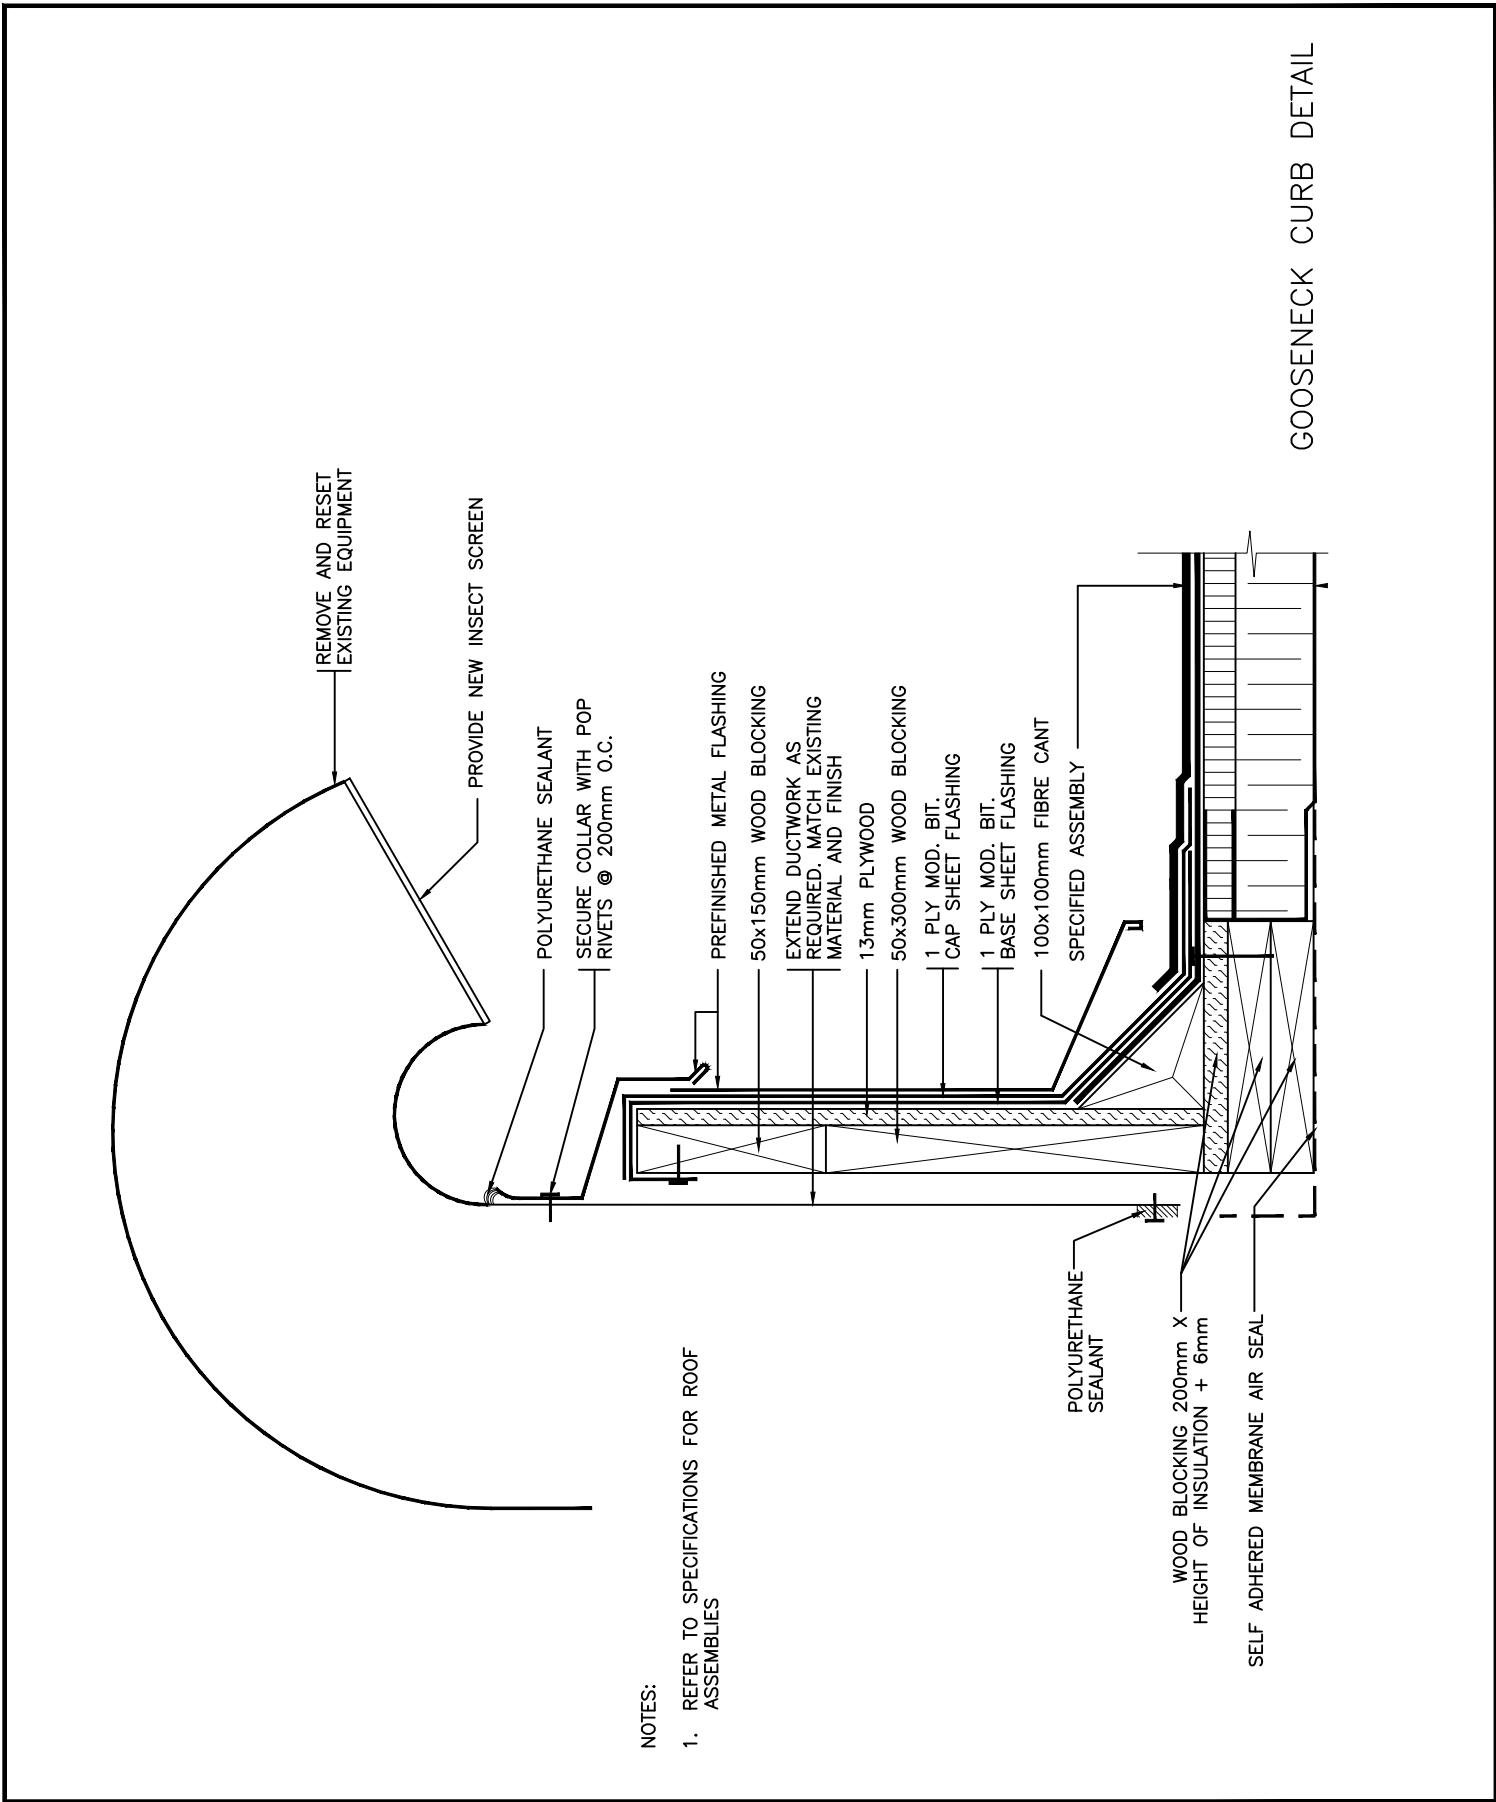
GOOSENECK CURB DETAIL
