PROJECT: OUR LADY OF VICTORY
CATHOLIC ELEMENTARY SCHOOL
ADDITION & RENOVATION

BINDER: **C** ARCHITECTURAL DETAILS,
GEOTECHNICAL REPORT &
DESIGNATED SUBSTANCE REPORT

SPECIFICATIONS BINDER “C”

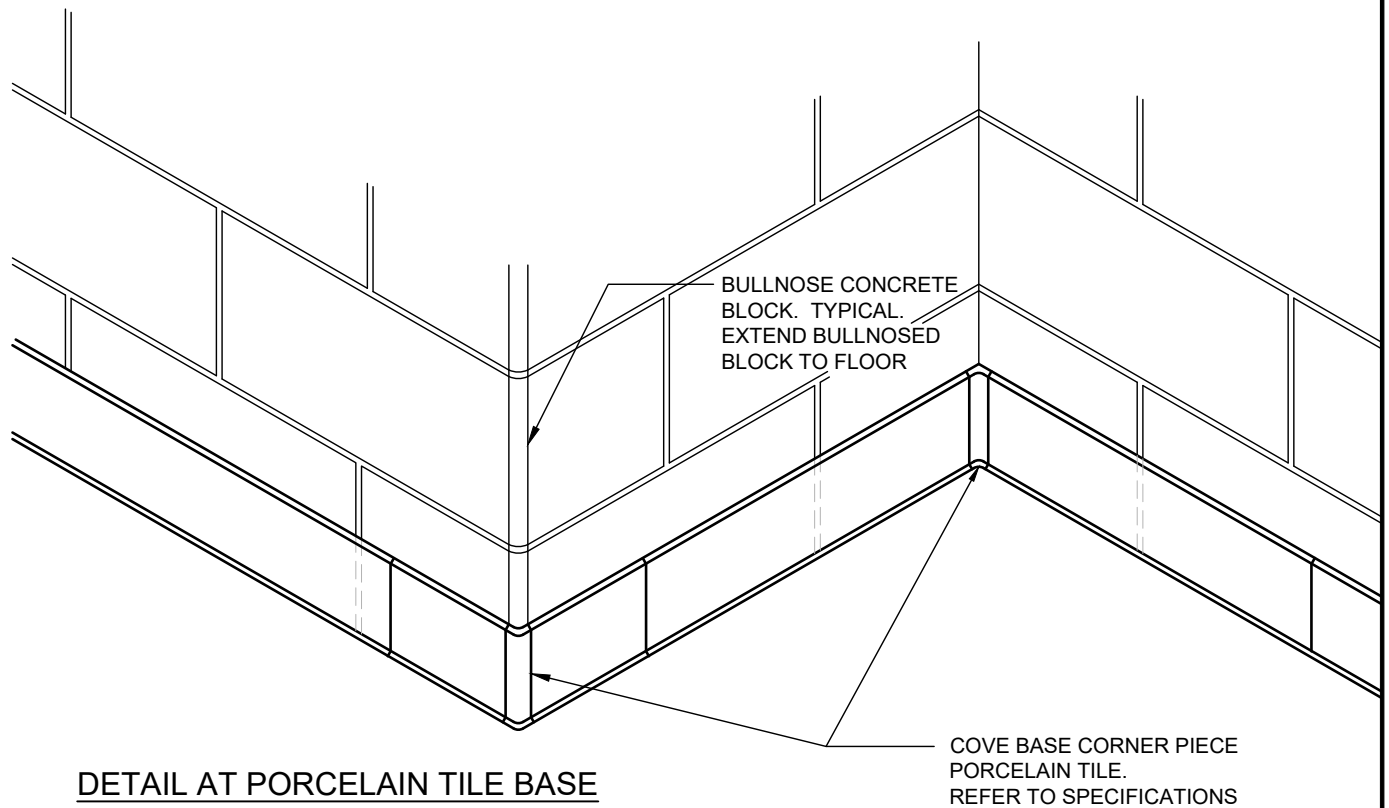
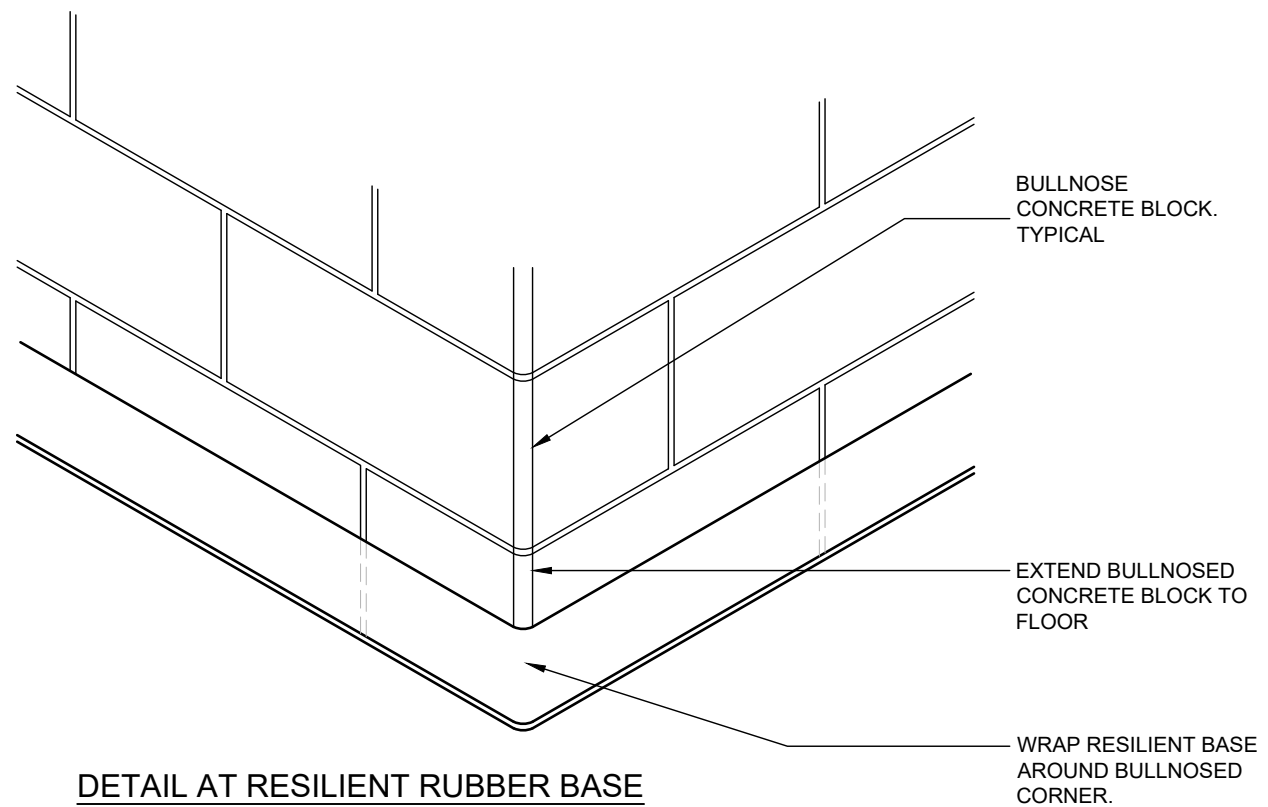
AD
 501

PORCELAIN TILE BASE

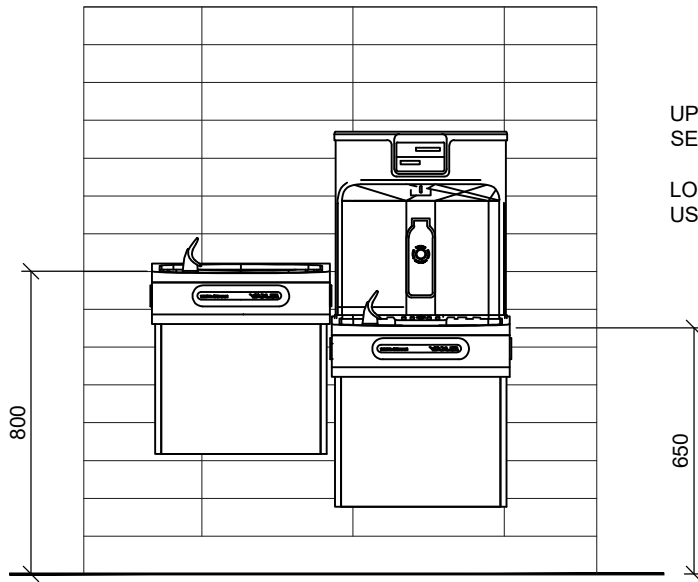
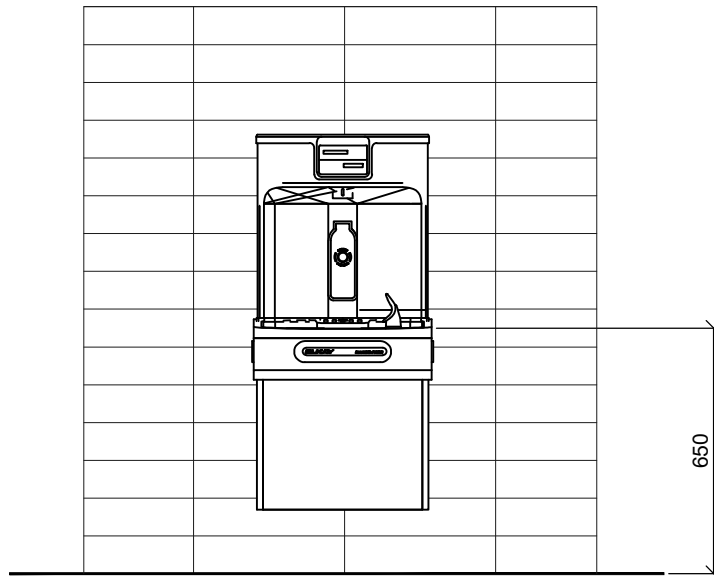
AD
517

UPPER DRINKING FOUNTAIN HEIGHT
SET FOR BARRIER FREE

LOWER DRINKING FOUNTAIN IS FOR
USE BY SMALL CHILDREN

FRONT ELEVATION 1

FRONT ELEVATION 2

DRINKING FOUNTAINS MOUNTING HEIGHTS

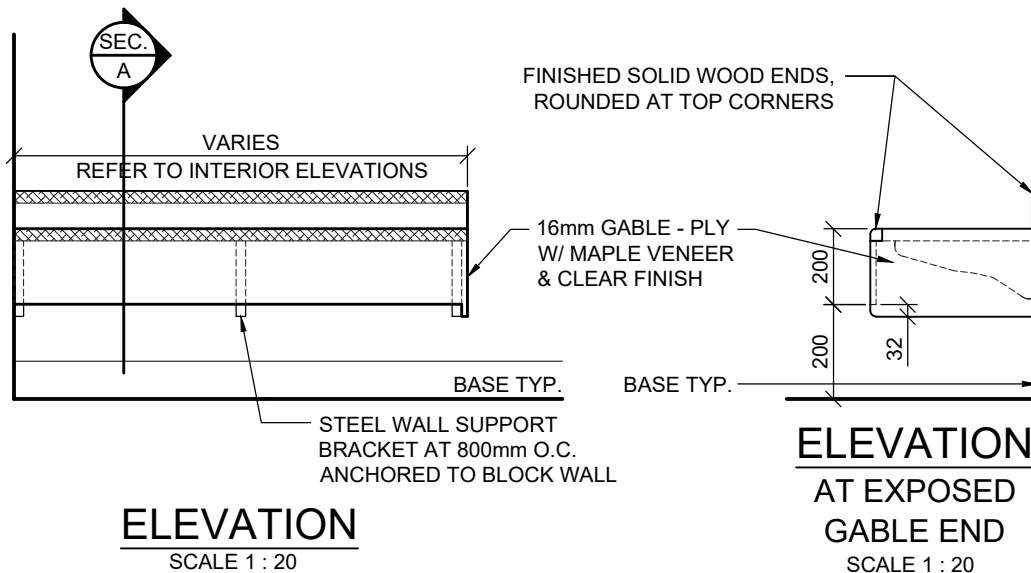
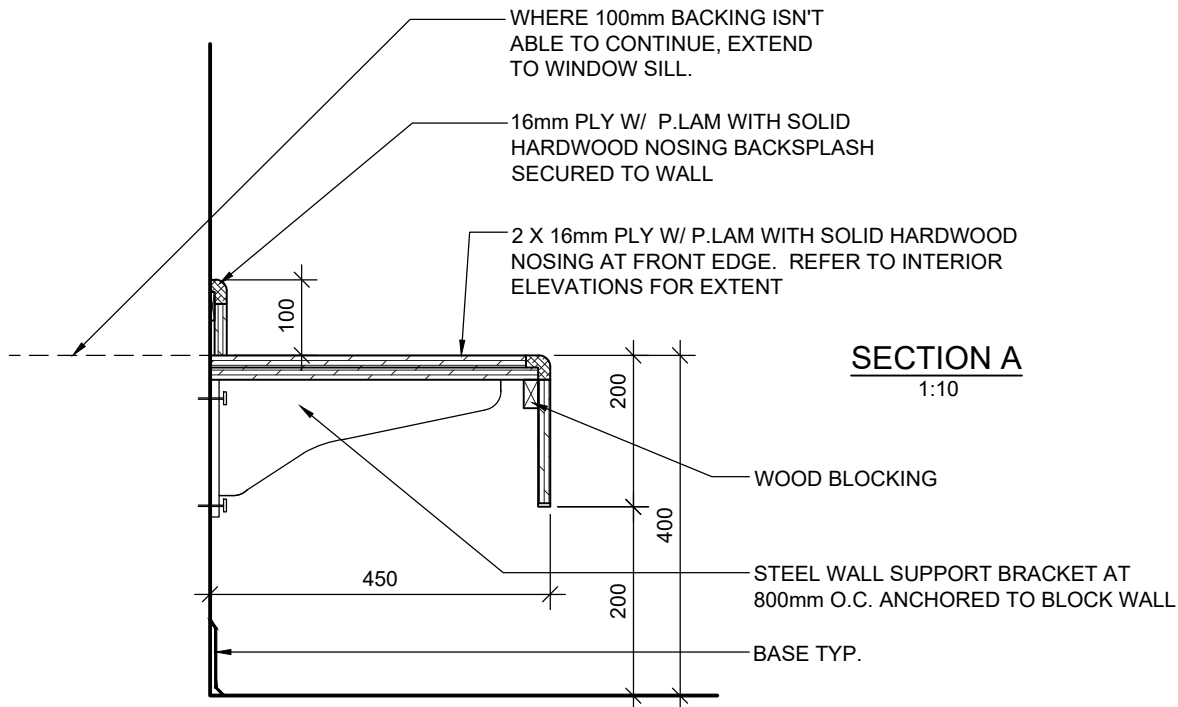
AD
520

- NOTES:**
- REFER TO SPECIFICATIONS FOR MILLWORK CONSTRUCTION AND HARDWARE.
 - CONFIRM LOCATION AND QUANTITIES WITH PLANS AND INTERIOR ELEVATIONS.
 - CONFIRM UNIT SIZE WITH INTERIOR ELEVATIONS. TYP.
 - NO BACKSPLASH AT WINDOWS

CO-LAB WOOD BENCH - M7

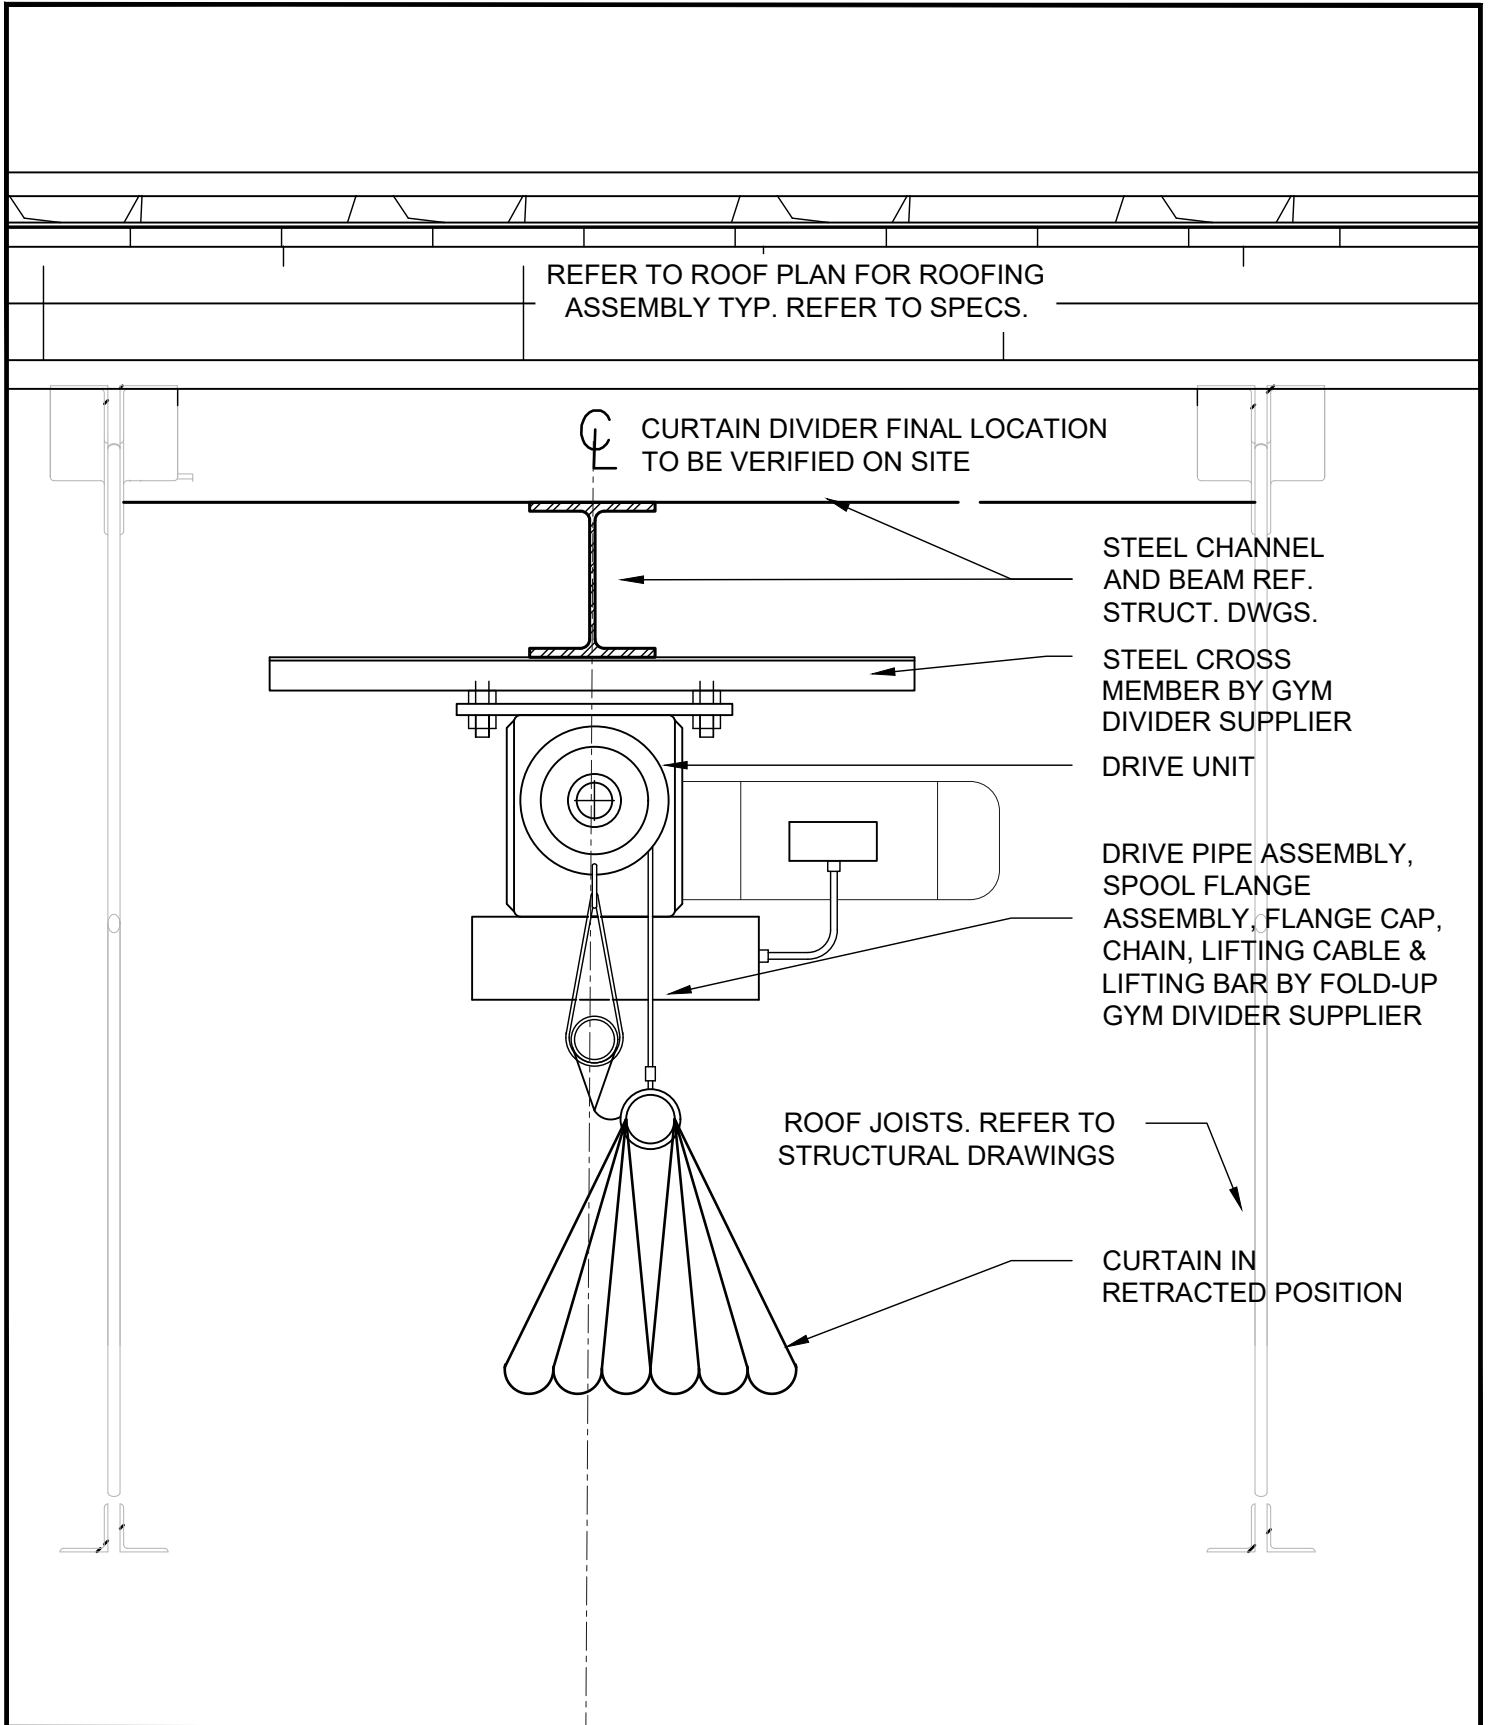
GYM DIVIDER CURTAIN DETAIL

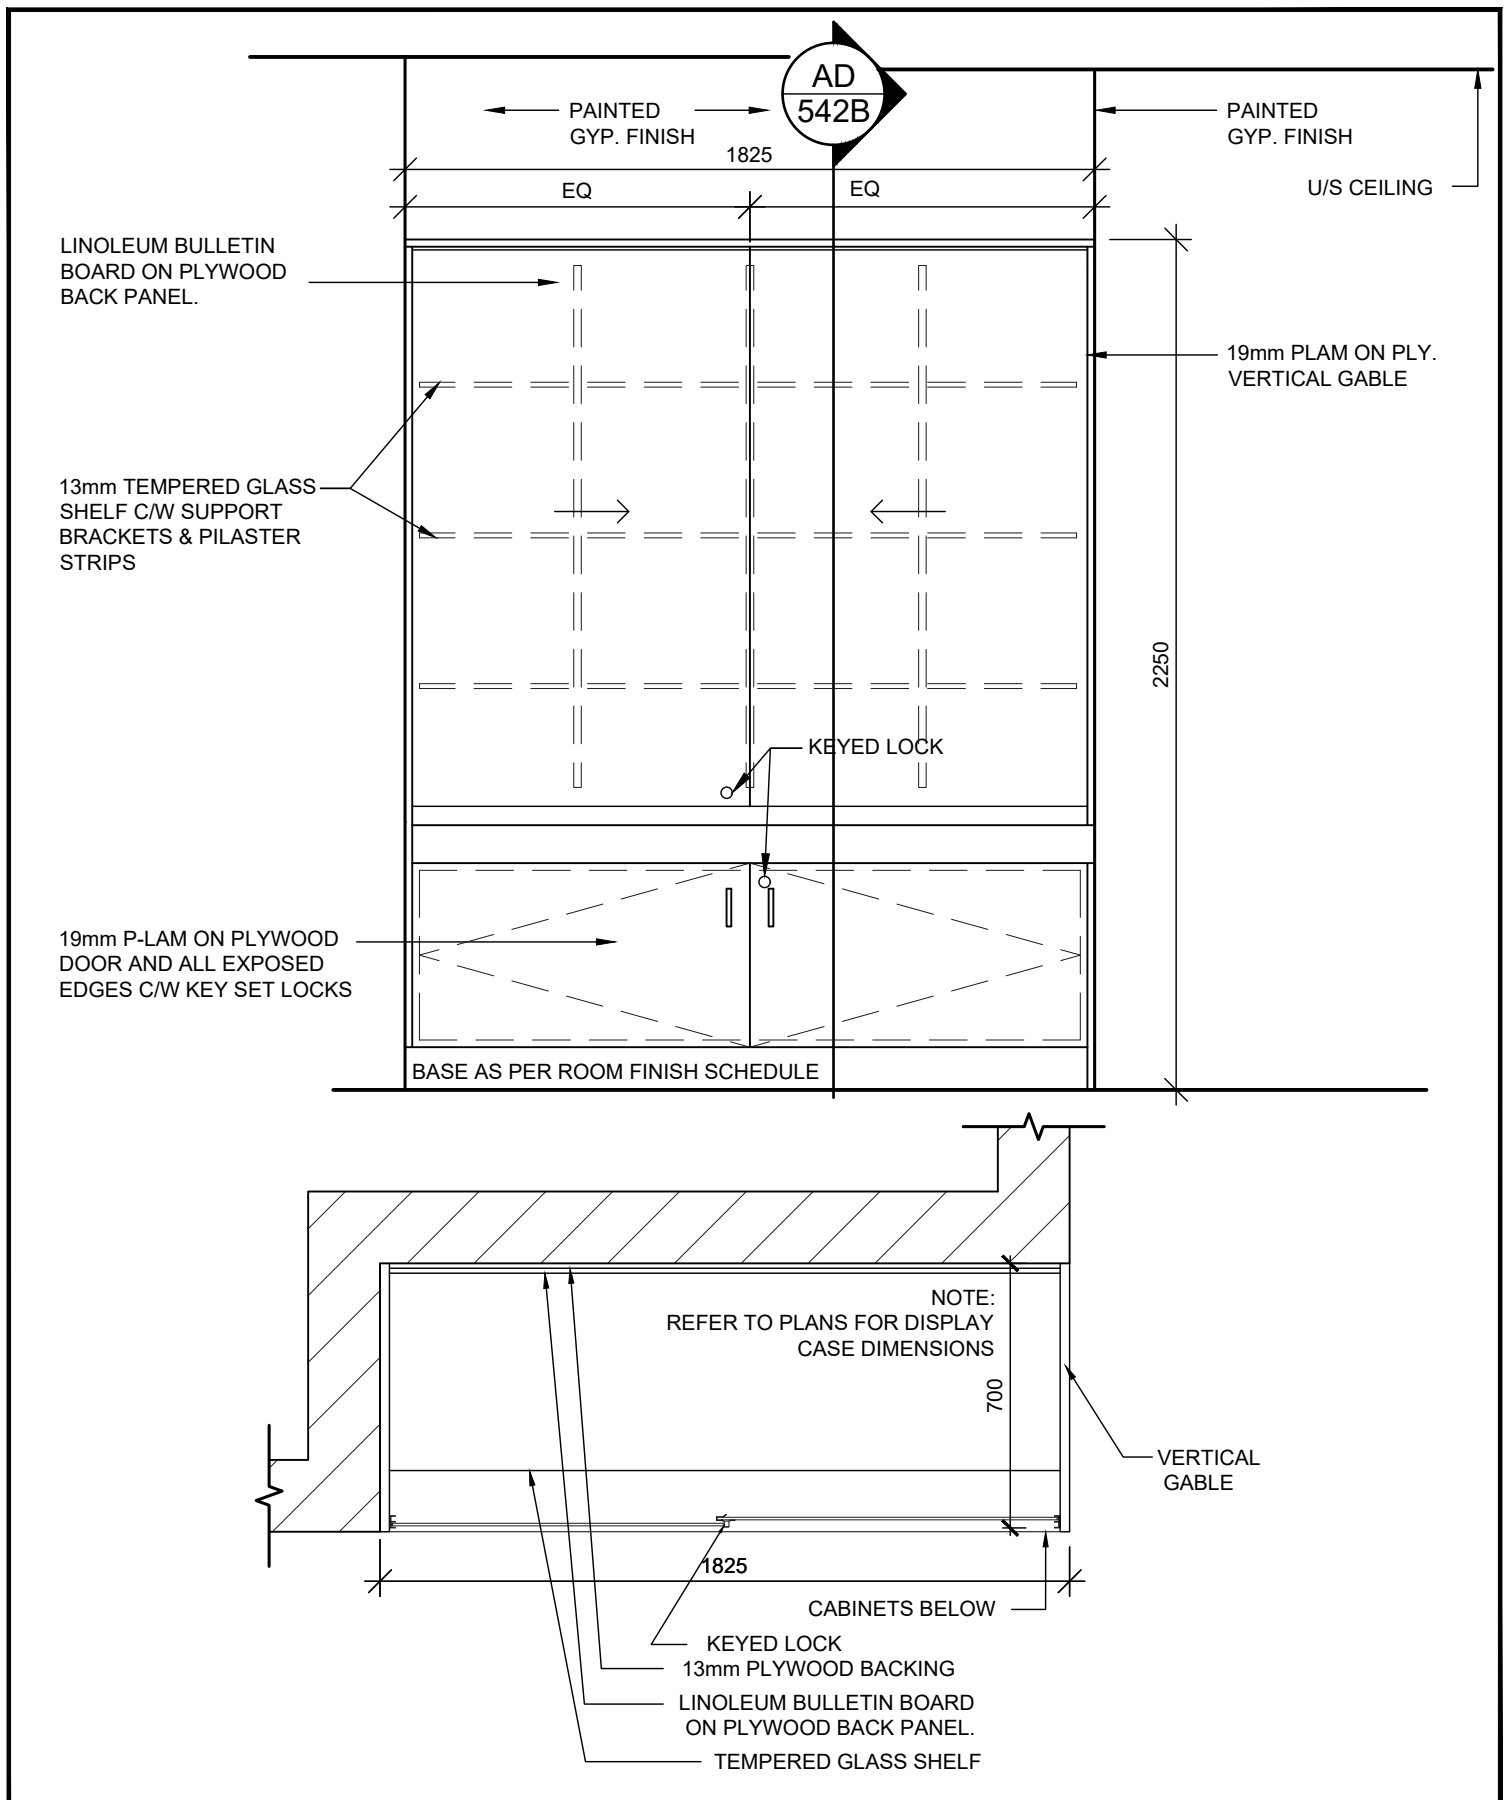
AD
542A

D2 - ART DISPLAY CASE
REFER TO FLOOR PLAN FOR LOCATIONS

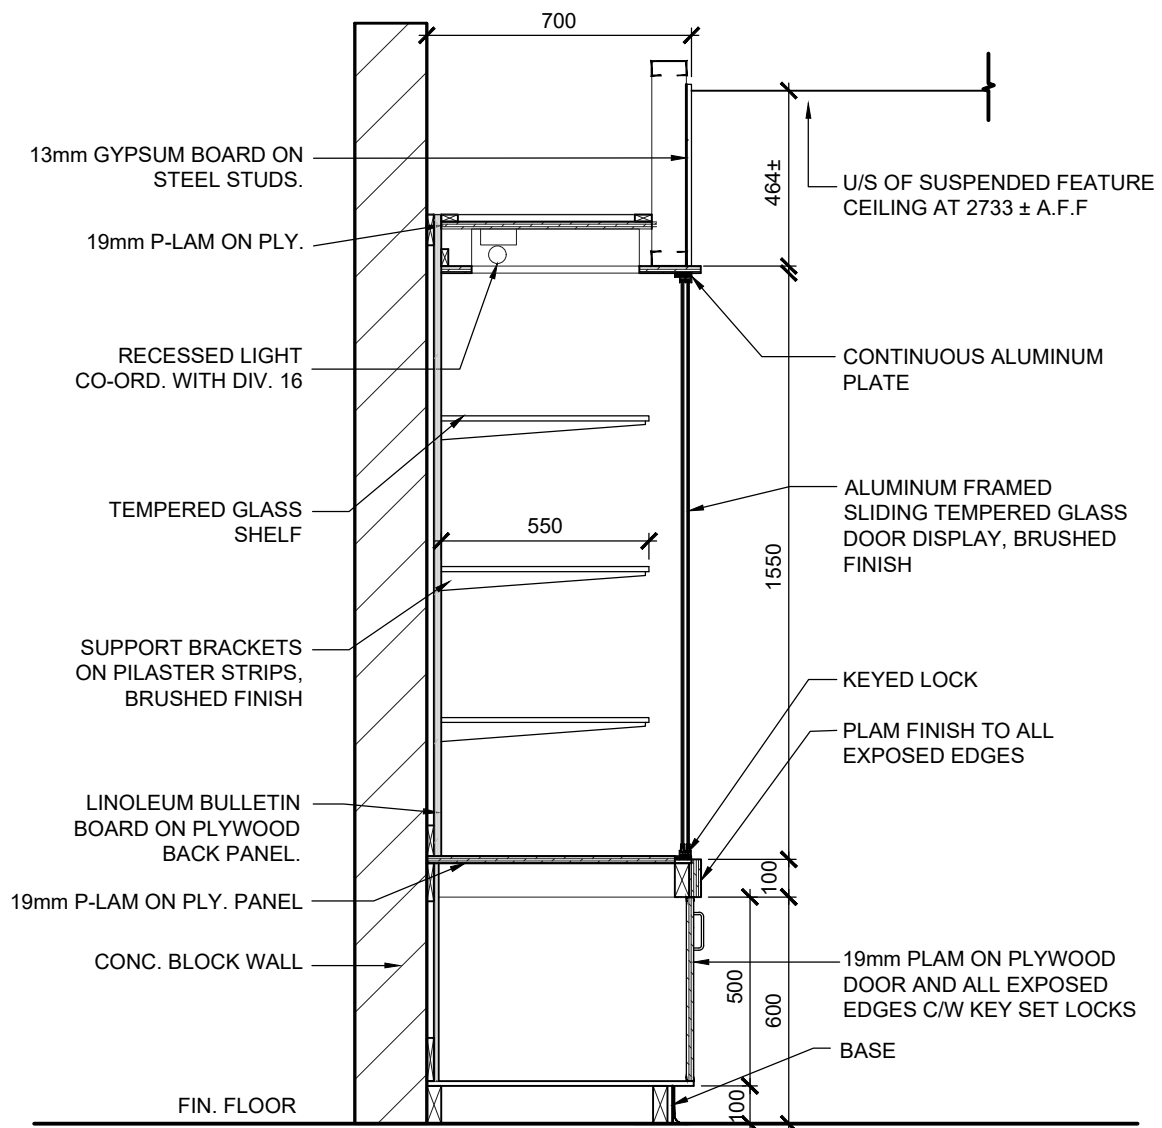
AD
542B

D2 - ART DISPLAY CASE - SECTION
REFER TO FLOOR PLAN FOR LOCATIONS

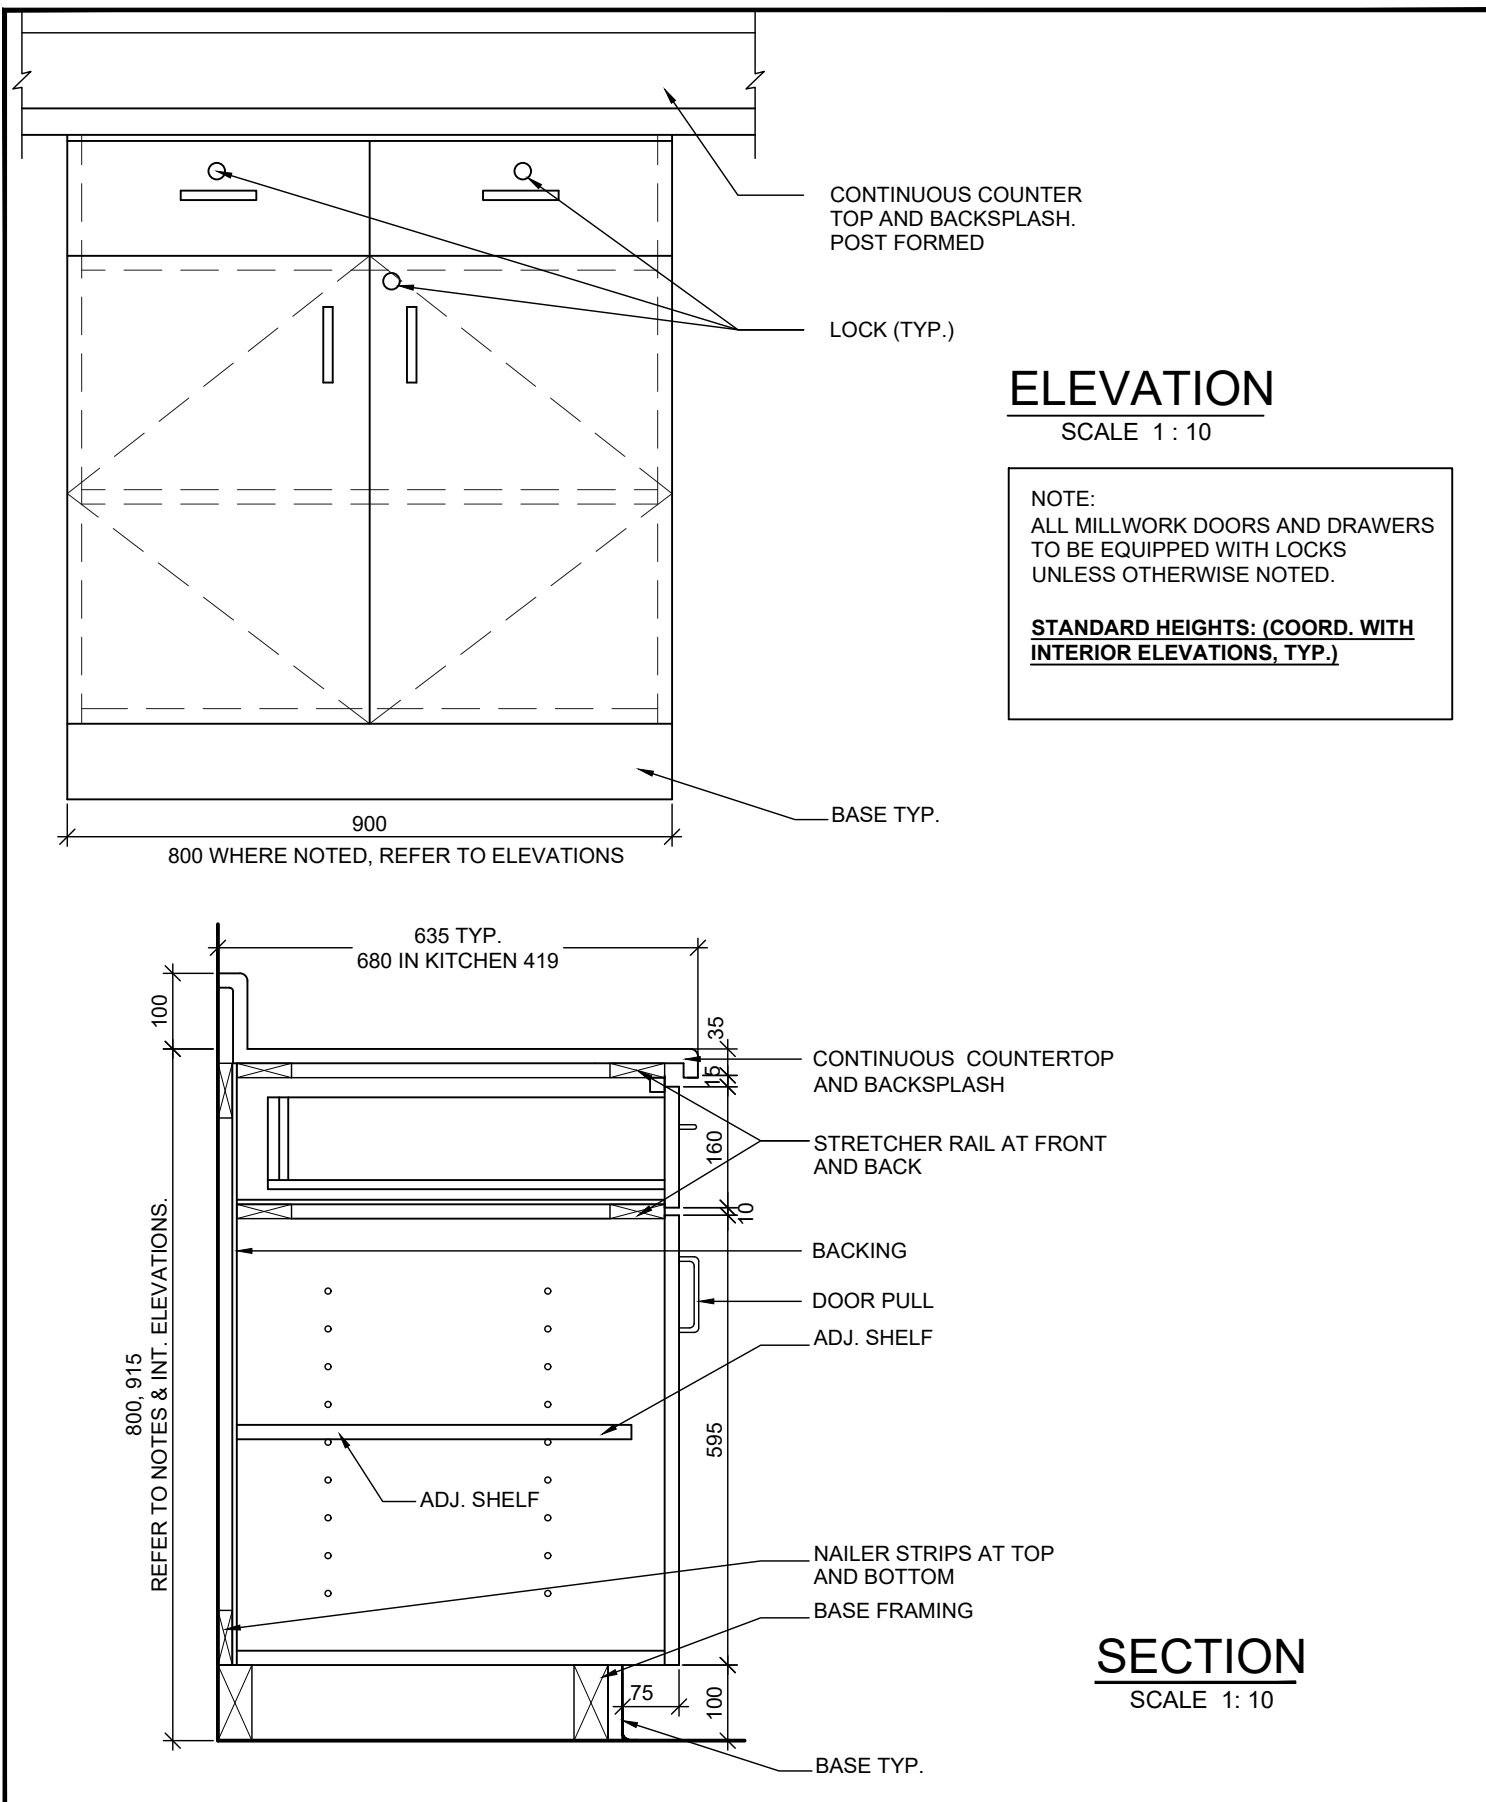
AD
602

NOTE:
ALL MILLWORK DOORS AND DRAWERS TO
BE EQUIPT WITH LOCKS. ALL MILLWORK
TO BE OF 19mm MELAMINE FACED
PARTICLE BOARD UNLESS OTHERWISE
NOTED.

SECTION
SCALE 1: 10

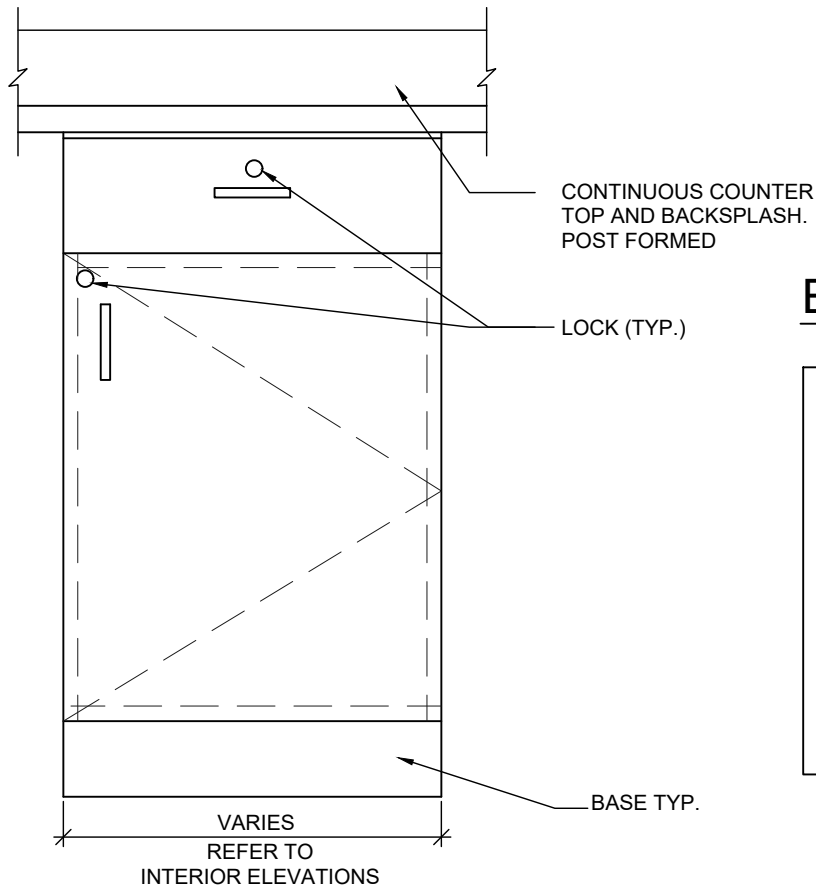
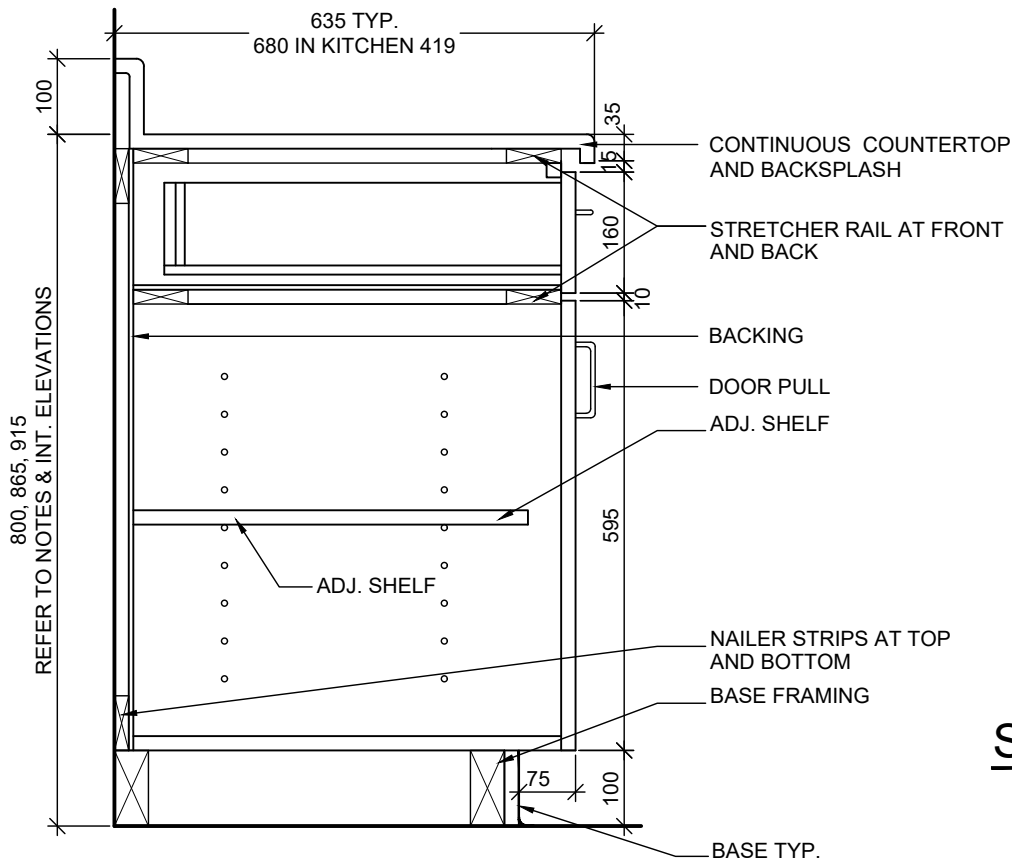
AD
606

TYPE B6 - LOWER CABINET WITH DRAWERS

ELEVATION

ALL MILLWORK DOORS AND DRAWERS TO BE EQUIPPED WITH LOCKS UNLESS OTHERWISE NOTED.

865 - KITCHENETTE 151

915 - KITCHEN 419, KITCHENETTE 159, LAUNDRY 418.

SECTION

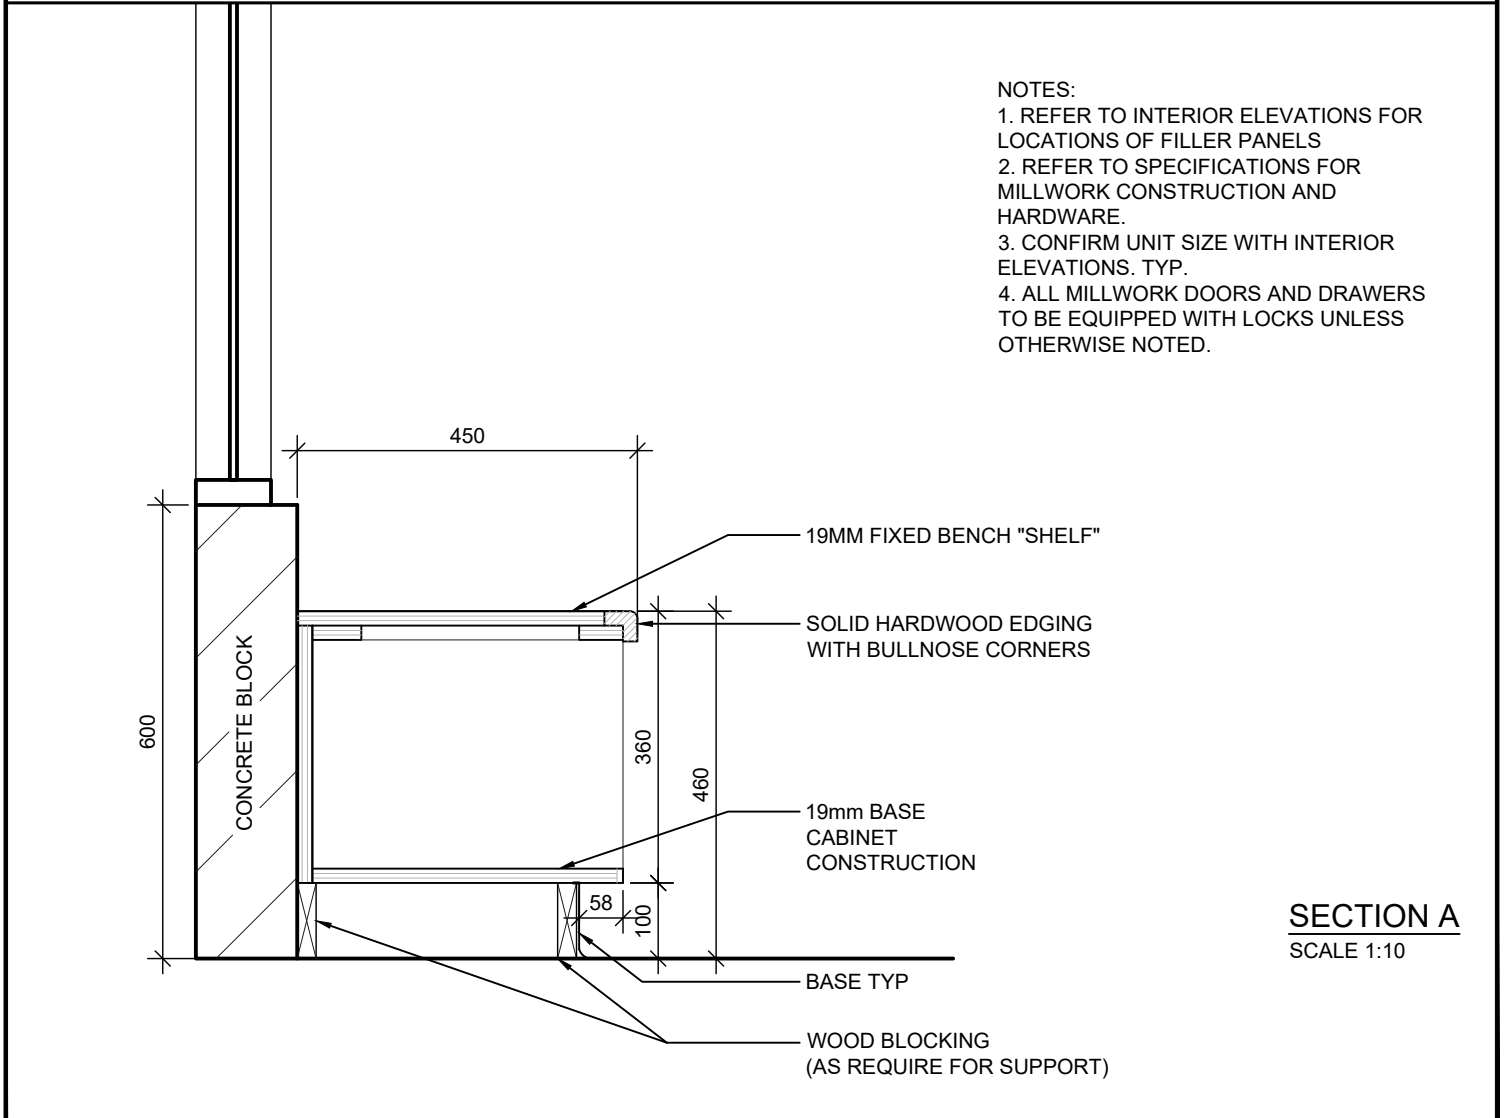
NOTE:
-REFER TO FLOOR PLANS FOR QUANTITIES AND LAYOUT
-COORDINATE HEIGHT OF CABINET WITH INSTALLATION OF STB IN CLASSROOMS WHERE APPLICABLE

CABINET TYPE B9

AD 213	Light Standard
AD 214	Job Site Sign
AD 215	Job Site Sign
AD 257A	Job Site Signage
AD 257B	Job Site Signage
AD 302	Roof Concrete Paver Detail
AD 303	Conduit Roof Paver Detail
AD 304	Pipe Roller Roof Paver Detail
AD 305	Pipe Support Roof Paver Detail
AD 400	Firestopping Detail at Cavity Wall
AD 401	Exterior Cavity Wall Control Joint Detail
AD 411	Wall Control Joint Details Interior Side
AD 412	Brick Vent Details
AD 450	Top of Wall Construction at non-fire rated assemblies
AD 455	Mechanical Curb
AD 459	Vent Stack Detail
AD 460	Gooseneck Curb Detail
AD 501	Porcelain Tile Base
AD 503	Drinking Fountains Mounting Heights
AD 517	Roof Access Ladder
AD 520	Co-Lab Wood Bench - M7
AD 525	Gym Divider Curtain Detail
AD 542A	D2 – Art Display Case
AD 542B	D2 – Art Display Case - Section
AD 601	Cabinet Type B1
AD 602	Cabinet Type B2
AD 606	Cabinet Type B6
AD 608	Cabinet Type B8
AD 609	Cabinet Type B9
AD 617A	Cabinet Type B13 – Co-lab Bench

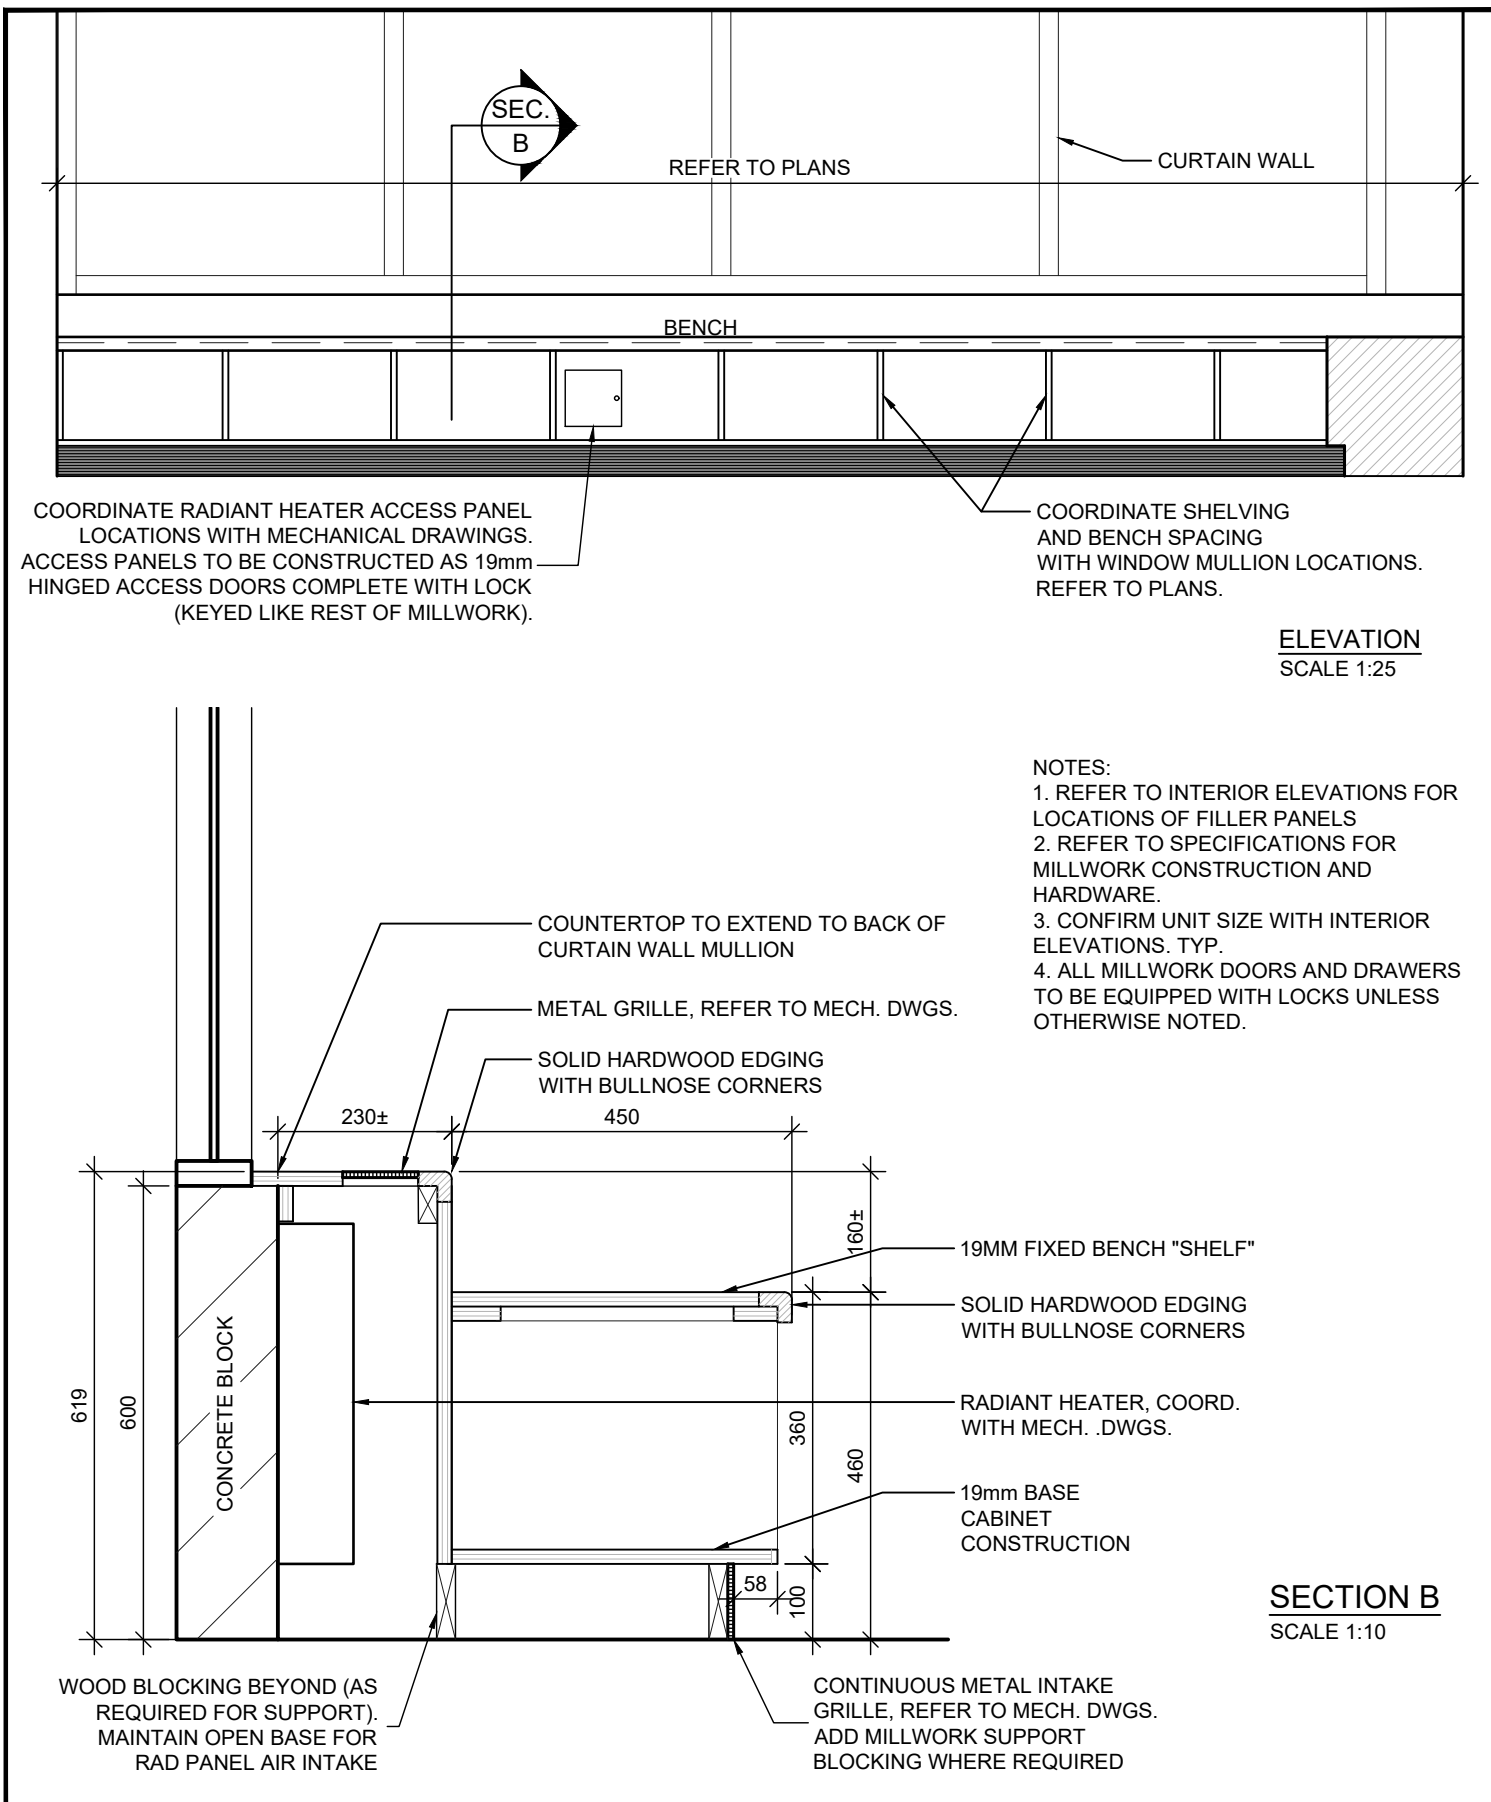
AD
617A

CABINET TYPE B13 - CO-LAB BENCH

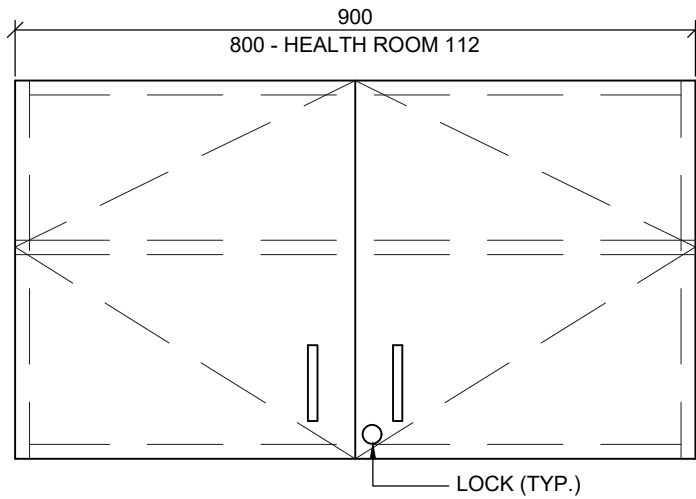
CABINET TYPE B14 CO-LAB BENCH @ RAD

ELEVATION

SECTION

NOTE:
ALL MILLWORK DOORS AND DRAWERS TO
BE EQUIPT WITH LOCKS. ALL MILLWORK
TO BE OF 19mm MELAMINE FACED
PARTICLE BOARD UNLESS OTHERWISE
NOTED.

AD 617B	Cabinet Type B14 – Co-lab Bench @ Rad
AD 621	Cabinet Type U1
AD 622	Cabinet Type U2

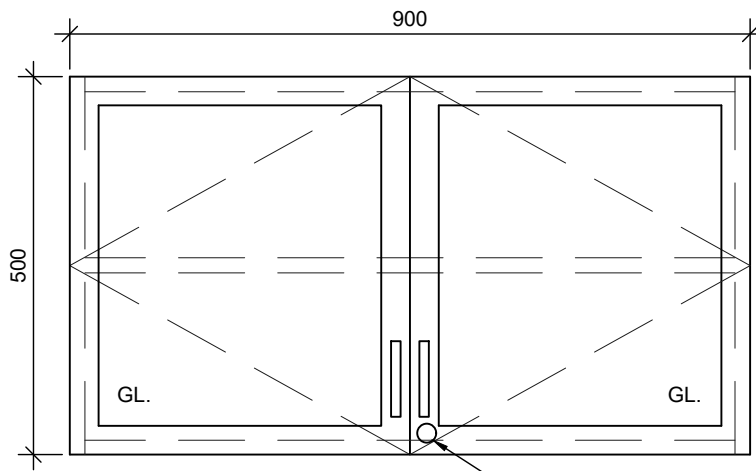
CABINET TYPE U5-A

ELEVATION

SECTION

<u>No. of Pages</u>
AD 623 Cabinet Type U3	
AD 624 Cabinet Type U4	
AD 625A Cabinet Type U5-A	
AD 625B Cabinet Type U5-B	
AD 627 Cabinet Type B34	
AD 629 Cabinet Type B36	
AD 631 Kindergarten Closet and Doors - Type K1	
AD 634 Child Care Cubbies – Type K5	
AD 635 Child Care Cubbies – Washrooms – Type K6	
AD 638A Mail Slots – C8 – Elevation	
AD 638B Mail Slots – C8 – Section	
AD 639 Kindergarten Cabinet – Type K9	
AD 642 Type C3 – Storage Cabinet	
AD 650 Modular Control Panel	
AD 651 Modular Control Panel Sections	
AD 652 Interior Signage Panel	
AD 653 Teacher’s Closet Type C1	
AD 654 Cabinet Type C4	
AD 661 Millwork Filler Strip Detail	
AD 725 Top of Wall Fire Separation Assembly	
AD 800 Door Types	
AD 801A Hollow Metal Frames and Screens	
AD 801B Hollow Metal Frames and Screens	
AD 801C Hollow Metal Frames and Screens	
AD 802 Door Jamb Sections	
AD 904 Locker Base Detail	
AD 1000 Washroom Fixture Mounting Heights

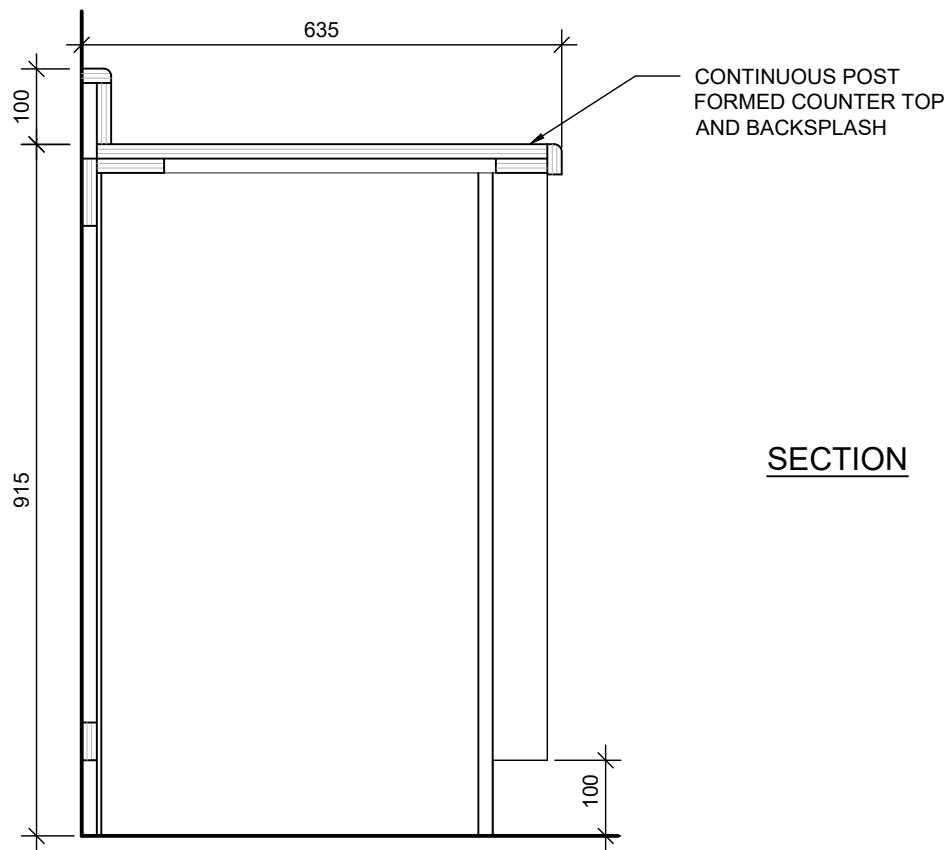
AD
625B

CABINET TYPE U5-B

ELEVATION

SECTION
