PROJECT: OUR LADY OF VICTORY
CATHOLIC ELEMENTARY SCHOOL
ADDITION & RENOVATION

BINDER: **C** ARCHITECTURAL DETAILS,
GEOTECHNICAL REPORT &
DESIGNATED SUBSTANCE REPORT

SPECIFICATIONS BINDER “C”

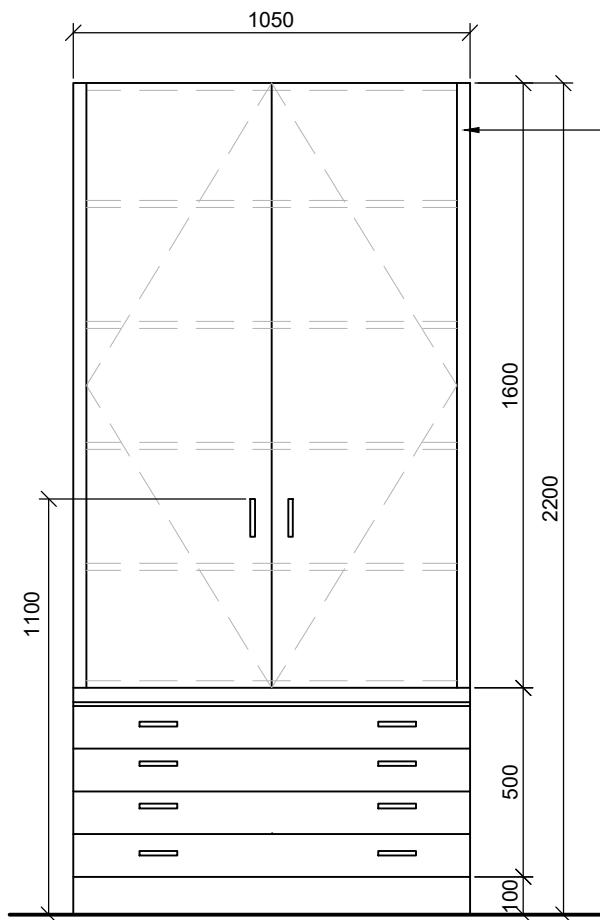
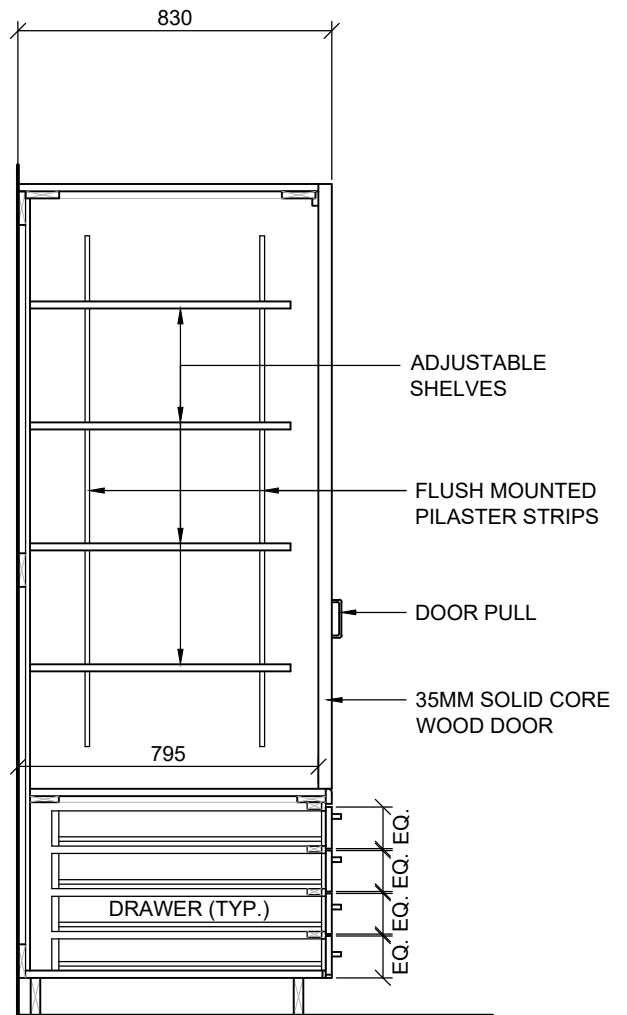
AD
629

TO BE EQUIPPED WITH LOCKS
UNLESS OTHERWISE NOTED.
REFER TO SPECIFICATION FOR
MILLWORK CONSTRUCTION AND
HARDWARE.

ELEVATION

SECTION

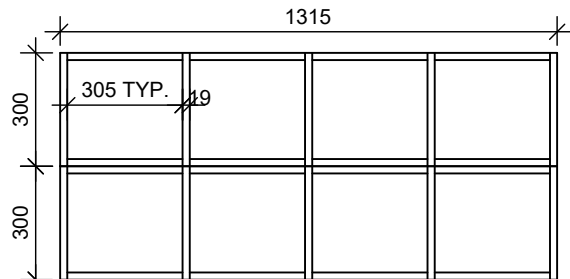
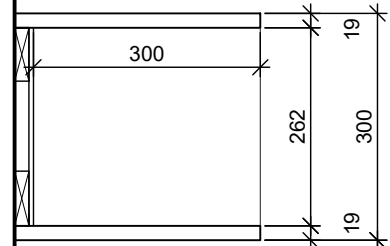
INFANT WASHROOM

ELEVATION B
SCALE 1:20

SECTION
SCALE 1:10

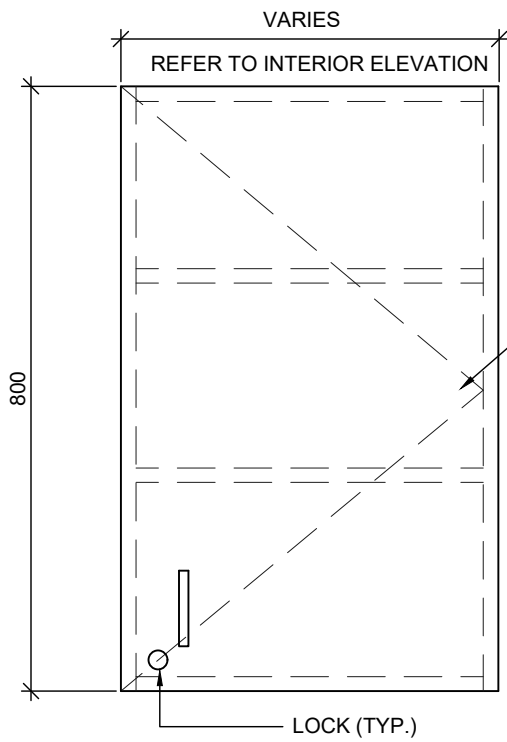
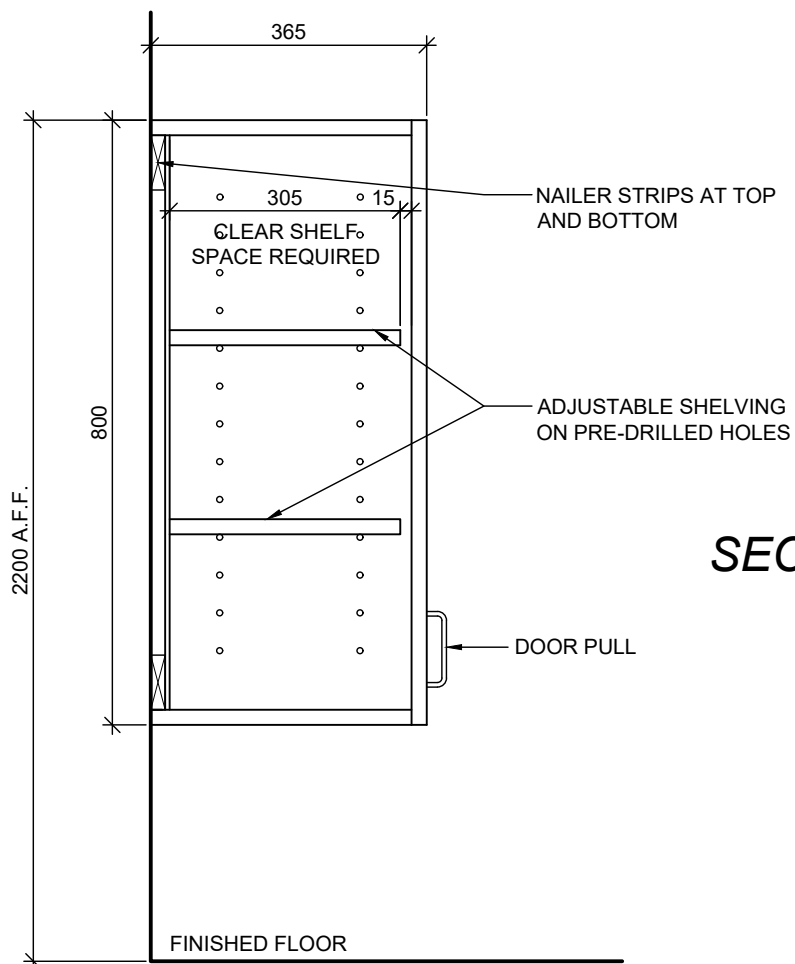
ELEVATION

NOTE:
ALL MILLWORK DOORS AND DRAWERS
TO BE EQUIPT WITH LOCKS.
UNLESS OTHERWISE NOTED.

SECTION

UPPER CABINET TYPE U3

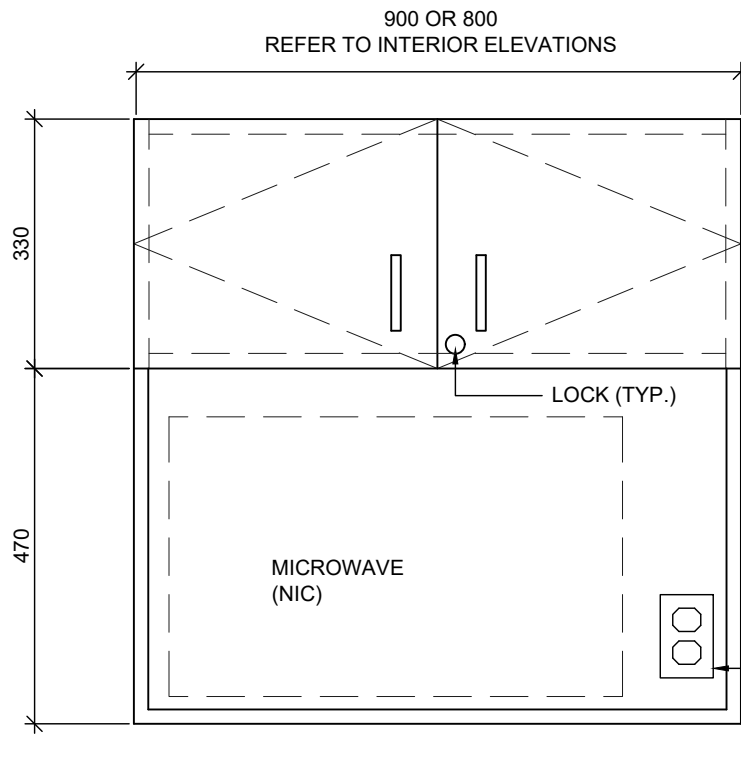
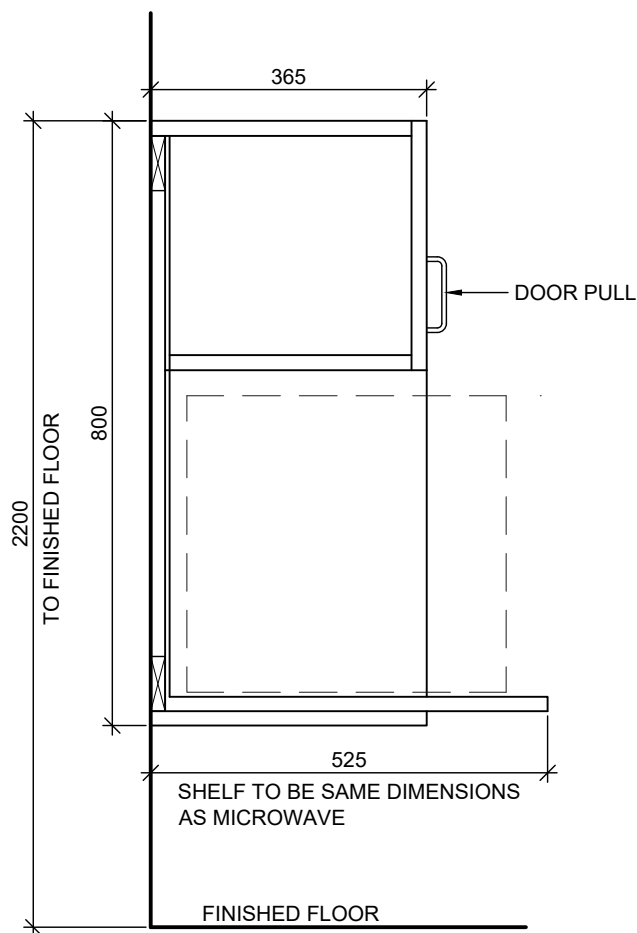
NOTE:
ALL MILLWORK DOORS AND DRAWERS
TO BE EQUIPT WITH LOCKS.
UNLESS OTHERWISE NOTED.

ELEVATION

SECTION

UPPER CABINET TYPE U4

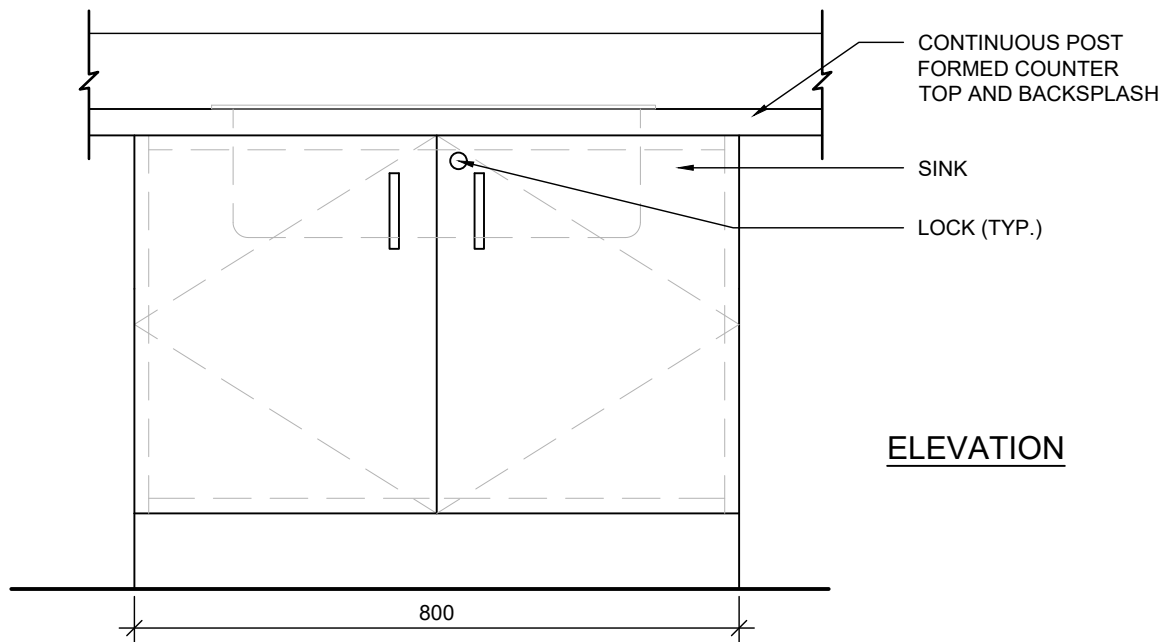
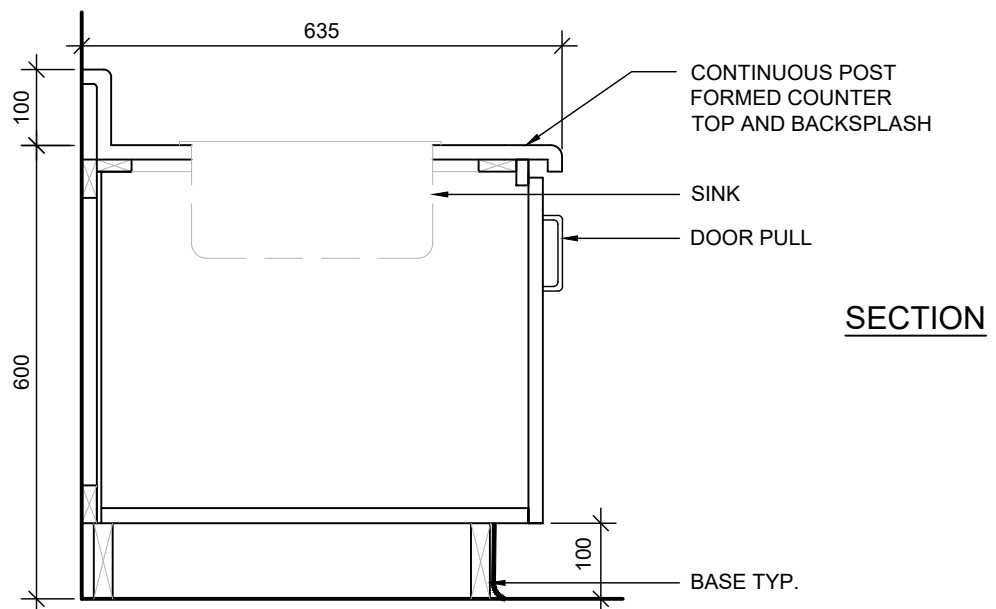
CHILD CARE LOWER CABINET WITH SINK
TYPE K9

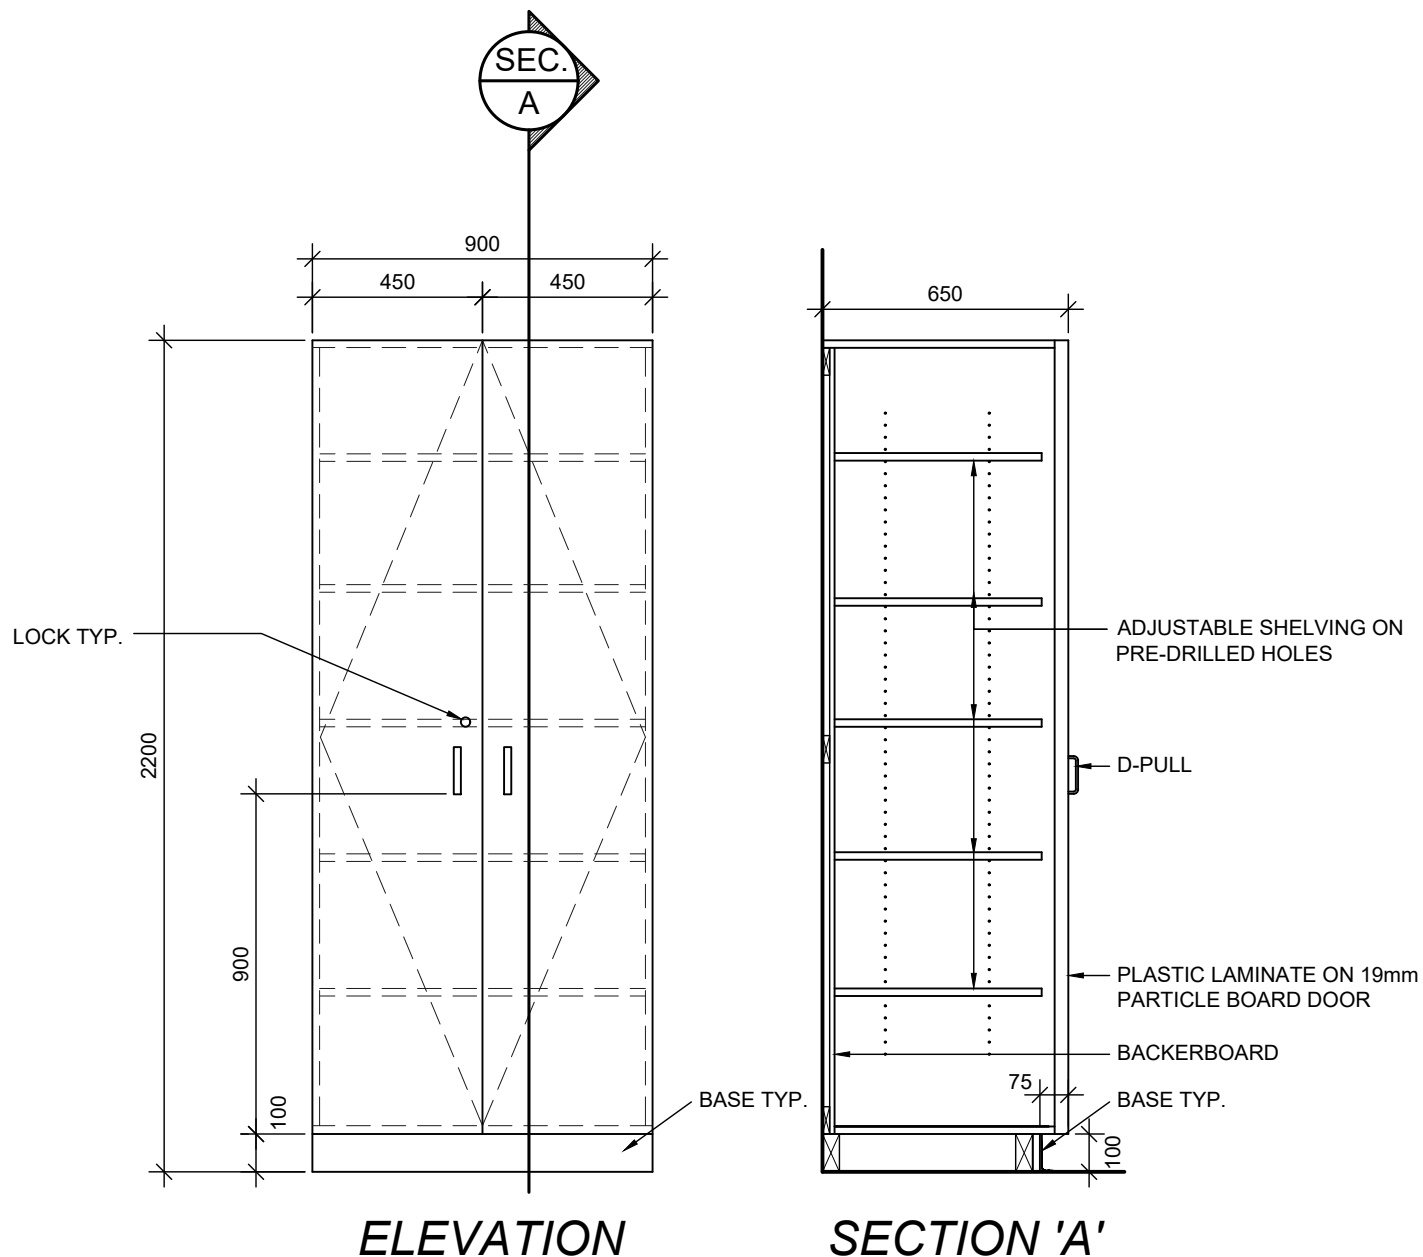
TYPICAL SIZE - 900 WIDE x 650 DEEP

REFER TO PLANS & ELEVATIONS.

TYPE C3 - STORAGE CABINET

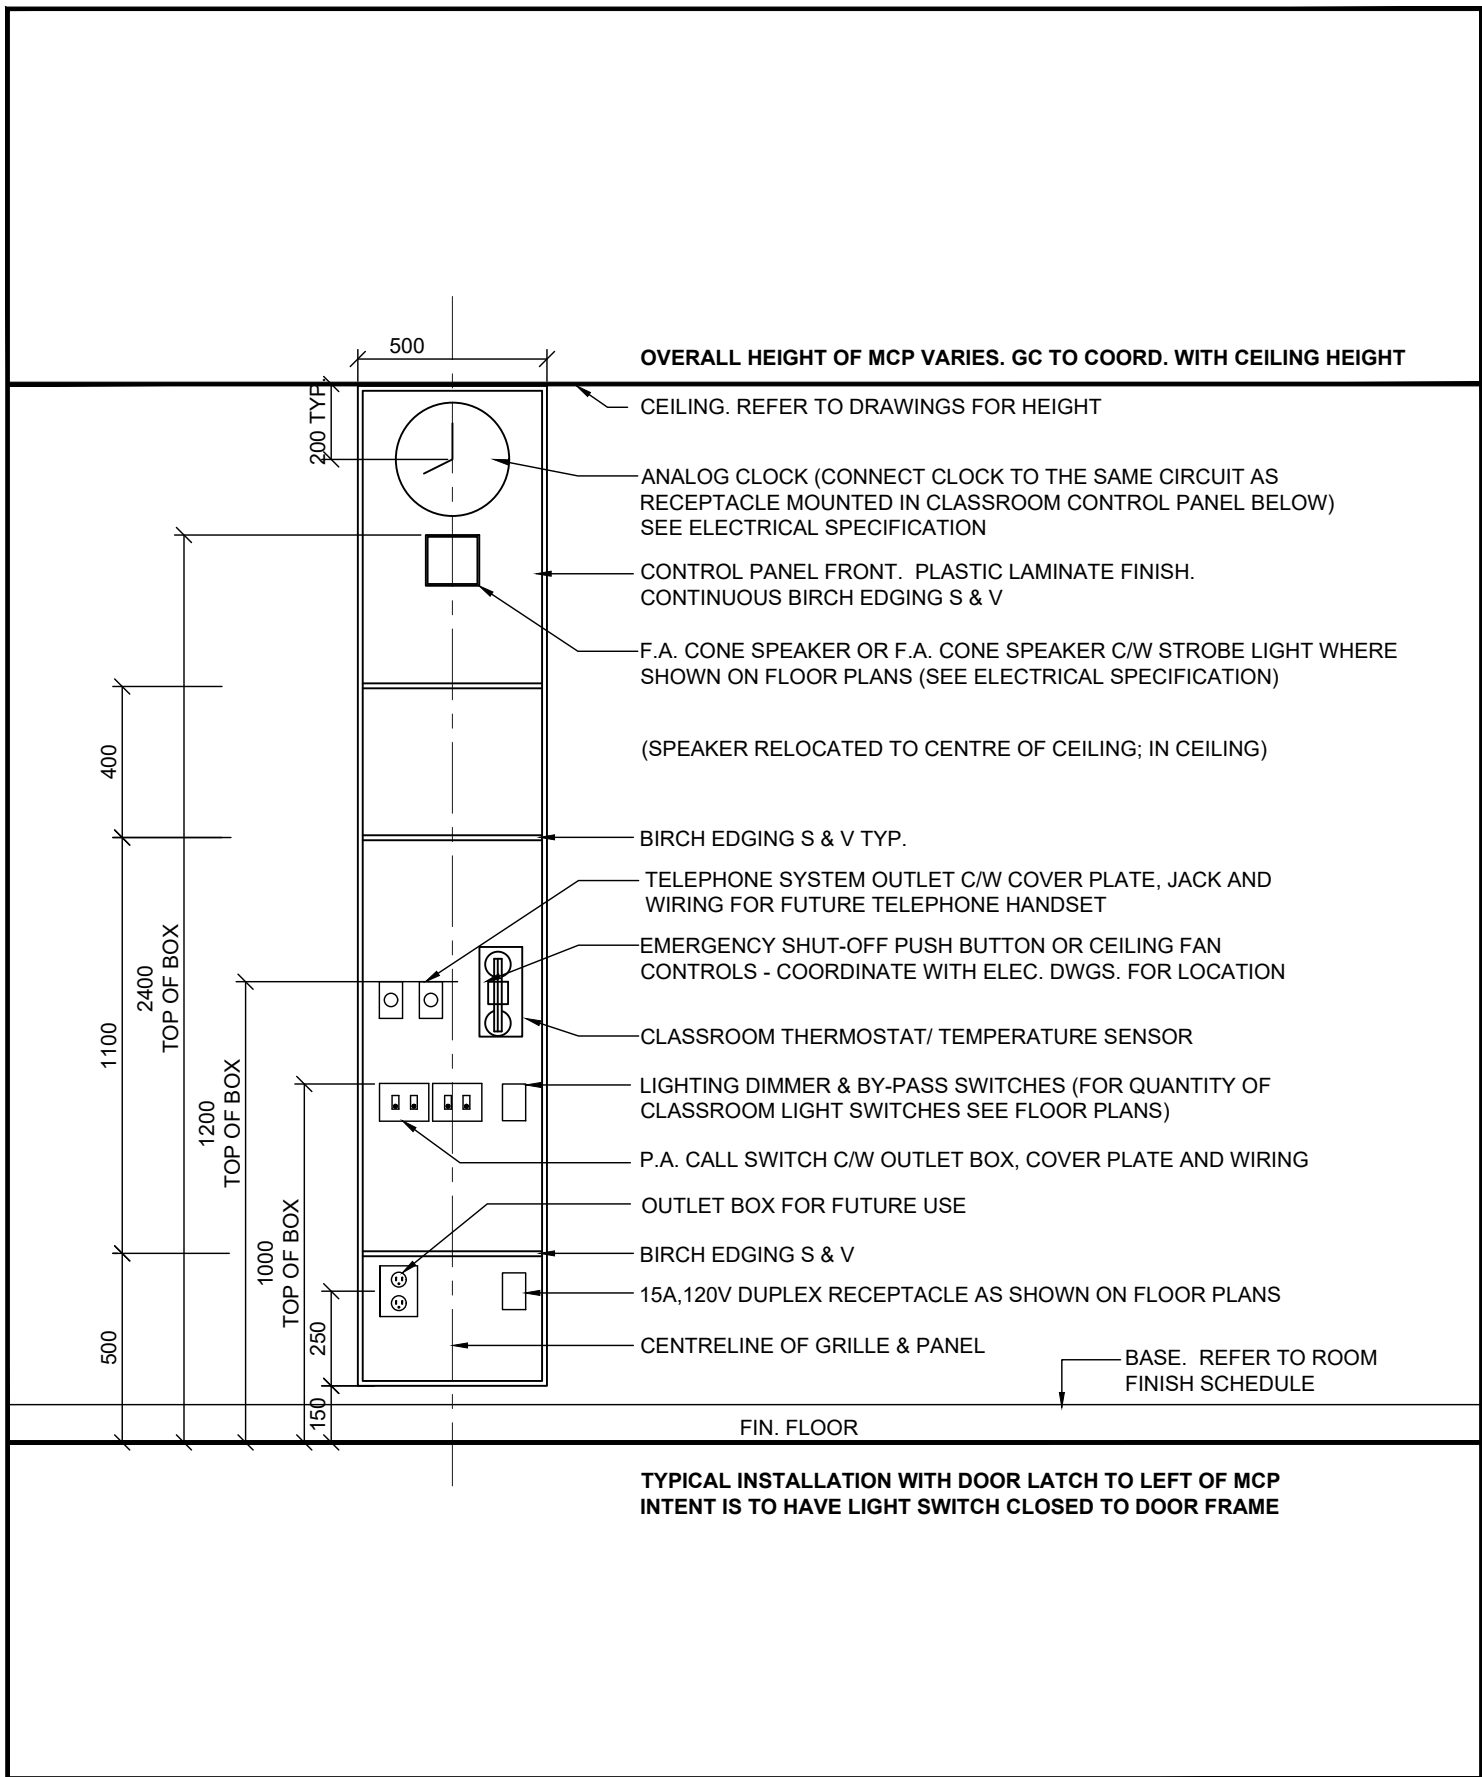
MODULAR CONTROL PANEL

DOOR LATCH LEFT OF MCP

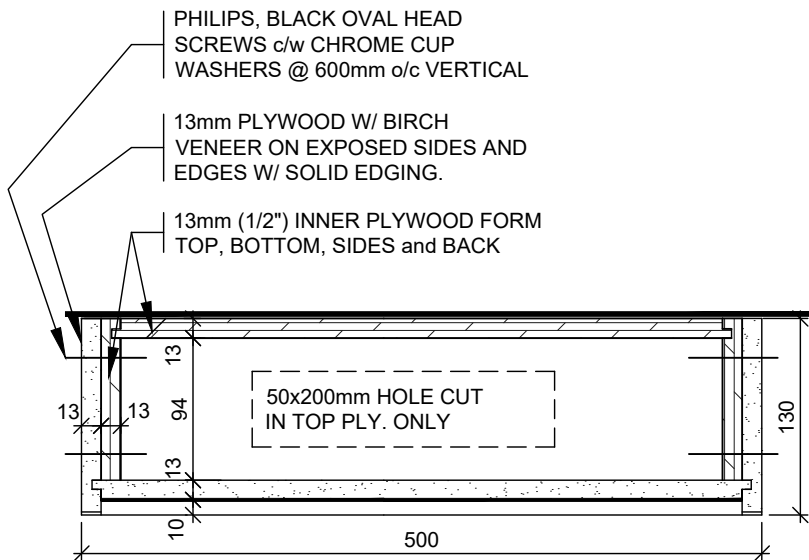
1 SECTION
650 PLAN VIEW

MODULAR CONTROL PANEL SECTIONS

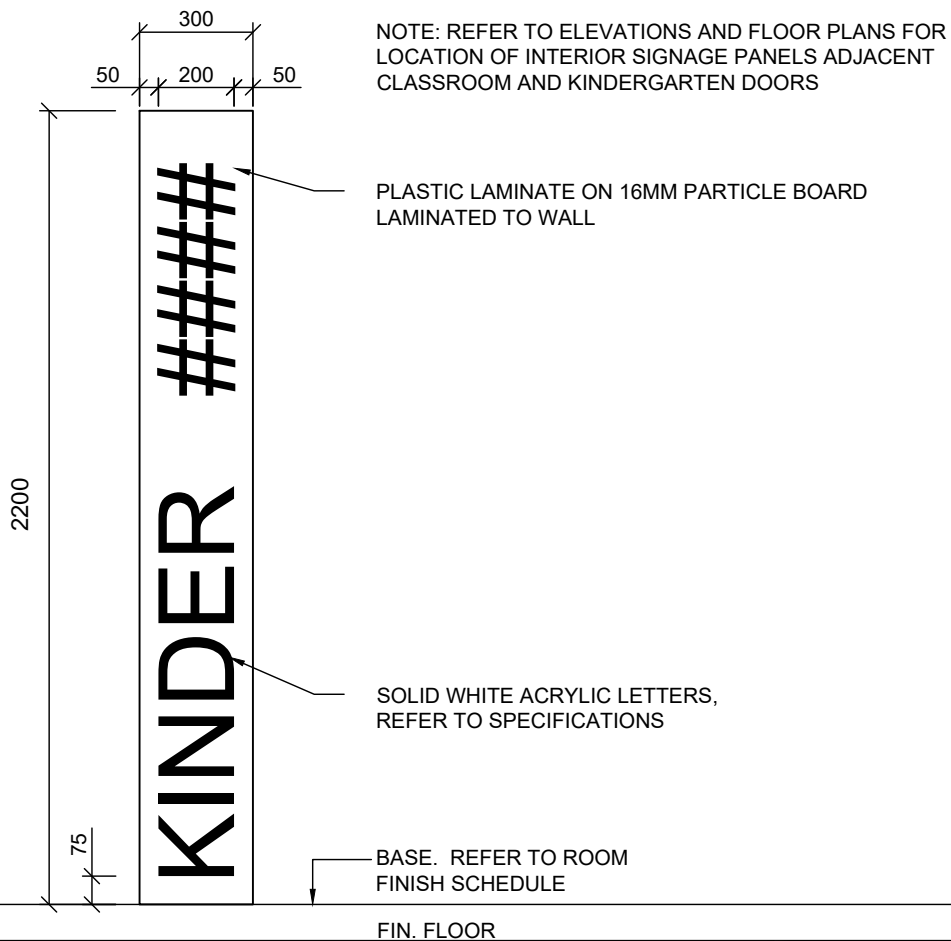
INTERIOR SIGNAGE PANEL (ISP)

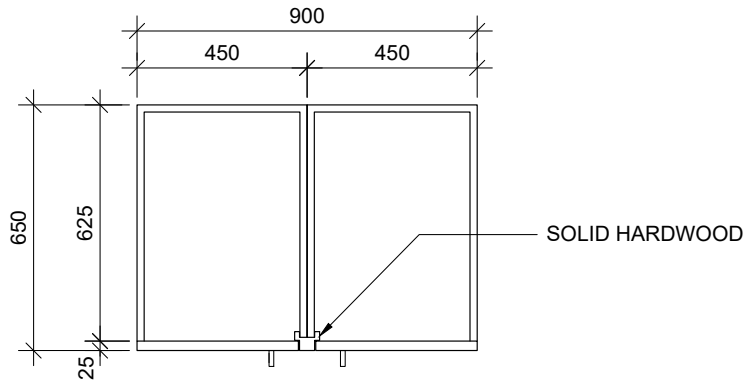
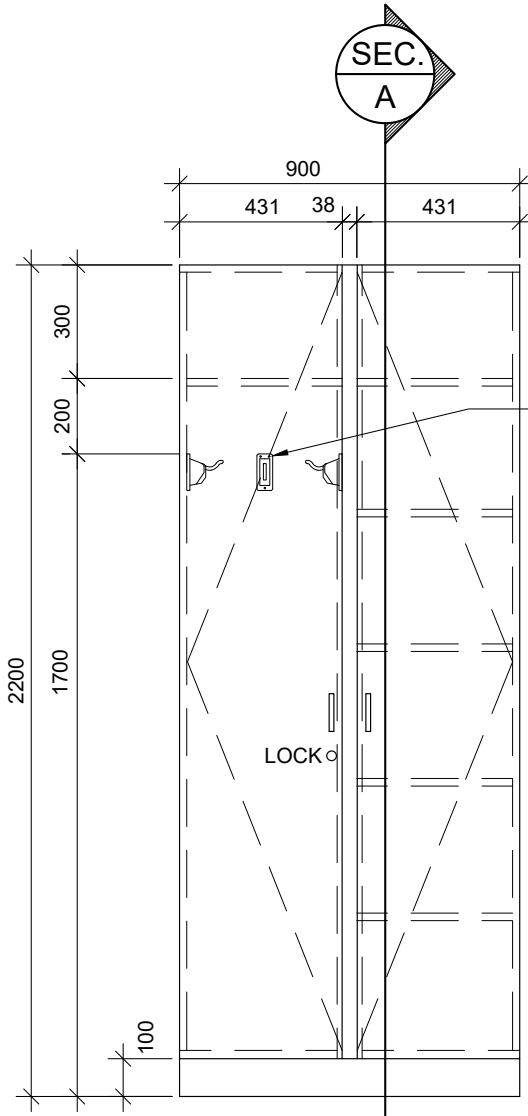
TEACHER'S CLOSET TYPE C1

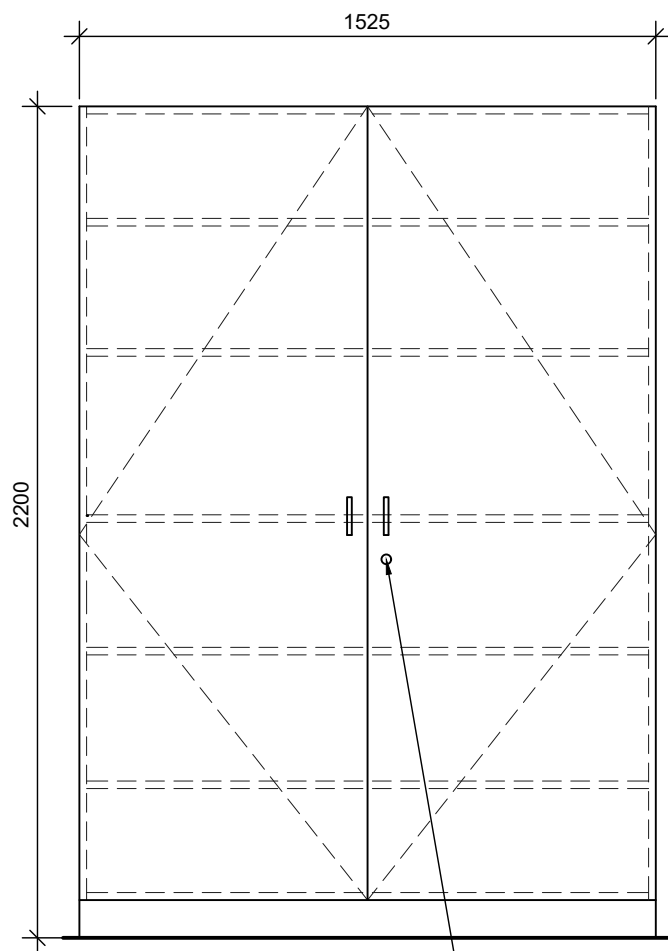
AD
653

ELEVATION
SCALE 1:20

LOCK (TYP.) ALIKE TO
ALL CABINETS WITHIN
THE SAME
CLASSROOM

SECTION
SCALE 1:20

FLUSH MOUNTED
PILASTER STRIPS

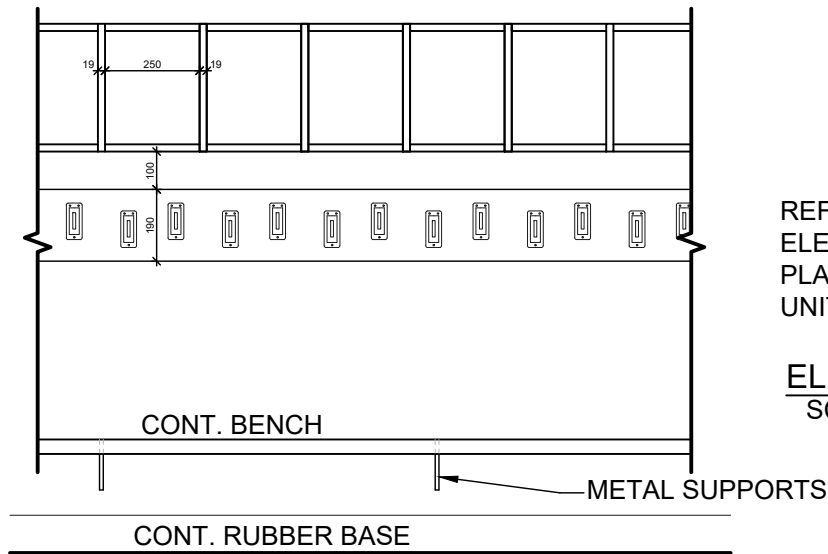
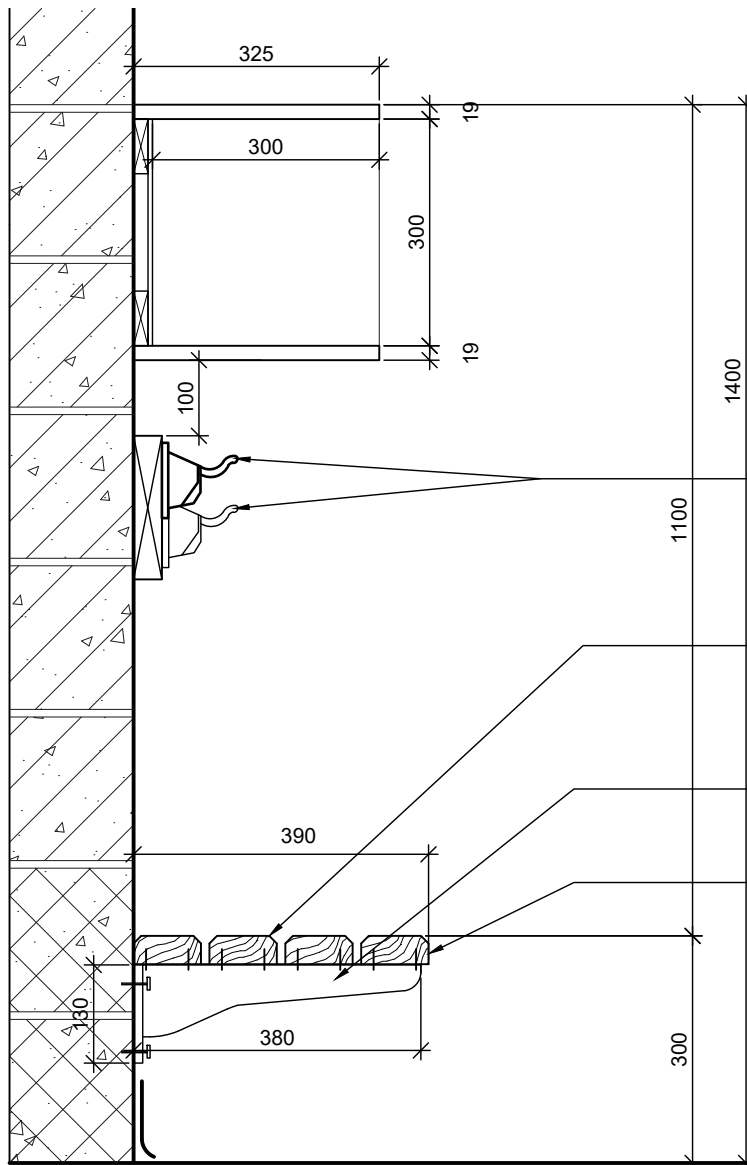
AD
654

REFER TO INTERIOR
ELEVATIONS & FLOOR
PLANS FOR QUANTITY OF
UNITS

ELEVATION
SCALE 1:20

NOTE:
FOR LENGTH OF CUBBIES, REFER TO
INTERIOR ELEVATIONS.

BREAK AWAY COAT HOOKS FASTENED TO
CONTINUOUS 38X190mm SOLID WOOD -
CLEAR URETHANE FINISH. HOOKS ON TOP
AND BOTTOM ROW STAGGERED

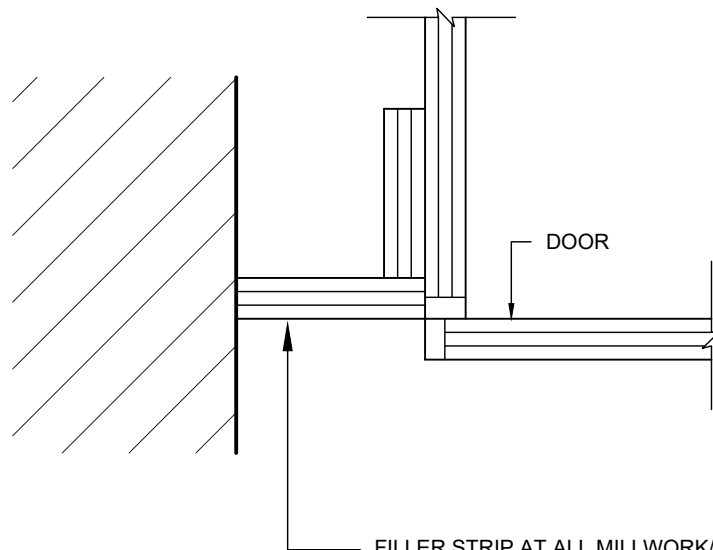
AD
655

FILLER STRIP AT ALL MILLWORK/
WALL CONNECTIONS. (TYPICAL).

UPPER CABINETS: PROVIDE AT FRONT, UNDERSIDE AND TOP

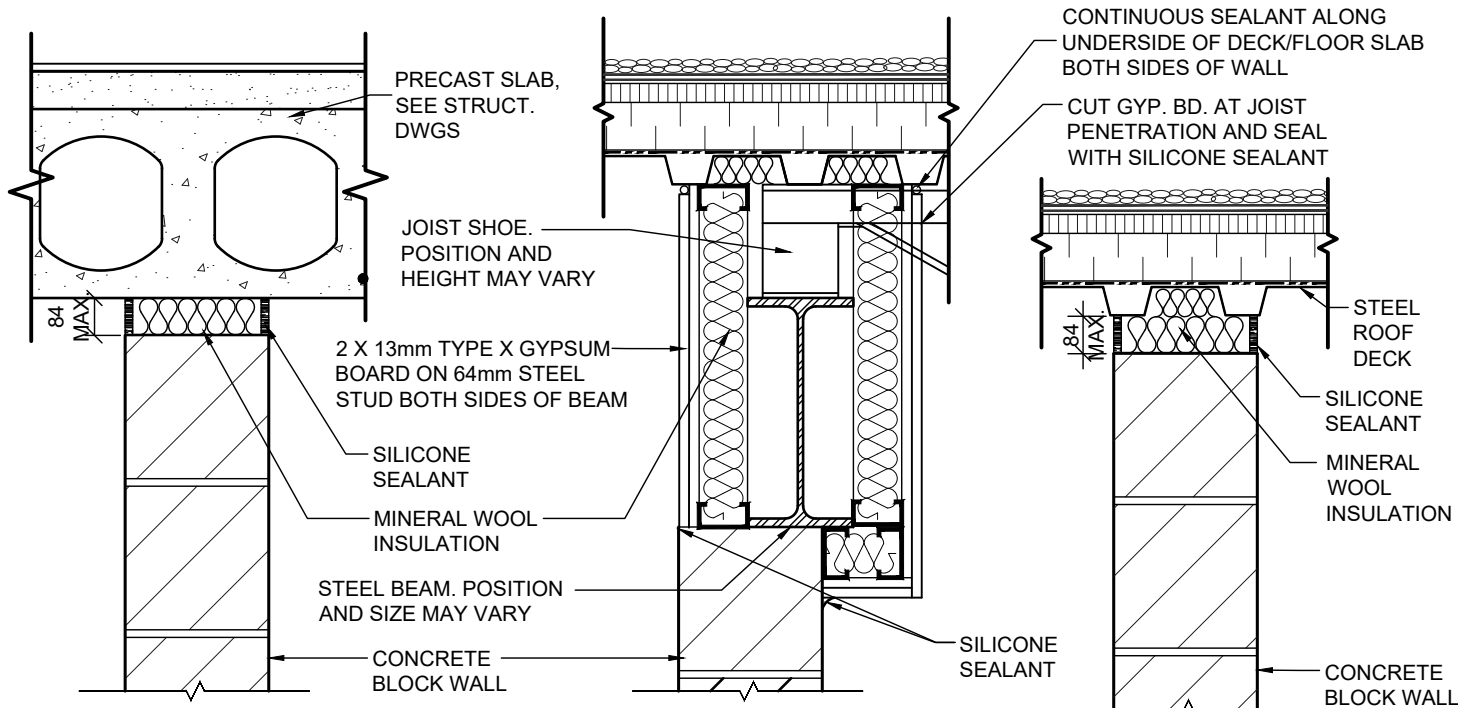
AD
661

CONDITION AT FLOOR

CONDITION AT OFFSET BEAM / JOIST AT ROOF

CONDITION AT ROOF

CONDITION AT PARALLEL JOIST OR BEAM

NOTE: ADJUST STEEL STUD SIZES TO SUIT BLOCK WALL CONDITION.
MIN. 64mm STUD AT MAX. 400 O.C.
REF. SPECS FOR FIRE-RATED SEALANTS

CONDITION AT PERPENDICULAR JOIST OR BEAM

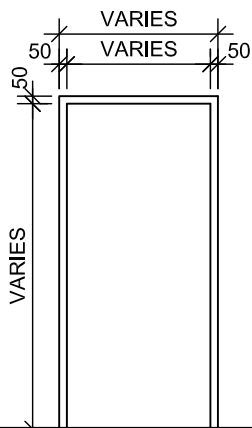
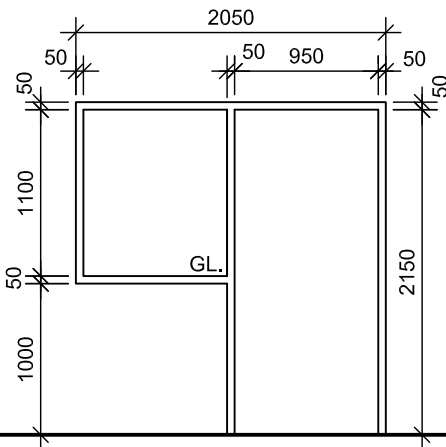
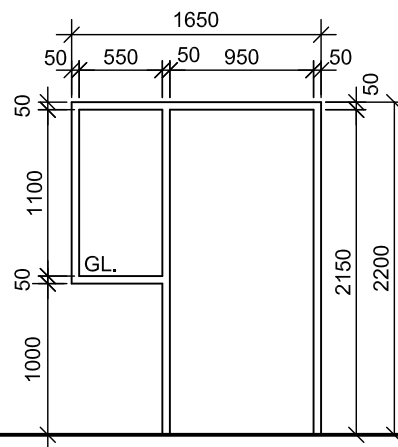
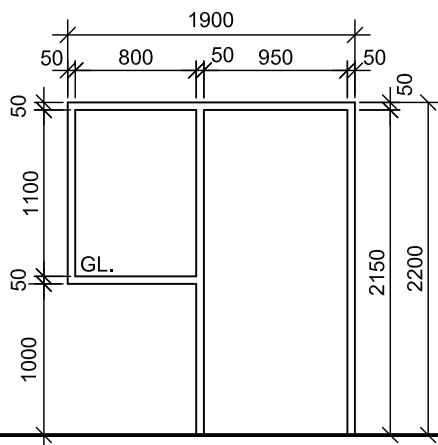
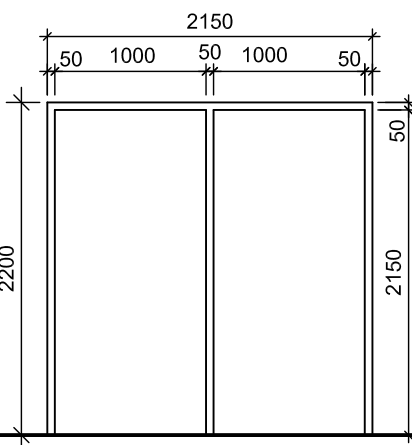
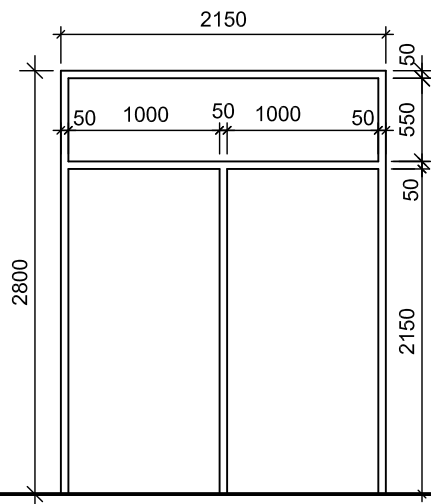
AD
800

TYPE 1
H.M. INT/EXT

TYPE 2
H.M. INT

TYPE 3A
H.M. INT

TYPE 3B
H.M. INT

TYPE 4A
H.M. INT

TYPE 4B
H.M. EXT

TYPE 5A
H.M. INT/EXT
KEYED REMOVEABLE MULLION BEYOND

TYPE 5B
H.M. EXT
KEYED REMOVEABLE MULLION BEYOND

TYPE 5C
H.M. EXT

HOLLOW METAL FRAMES

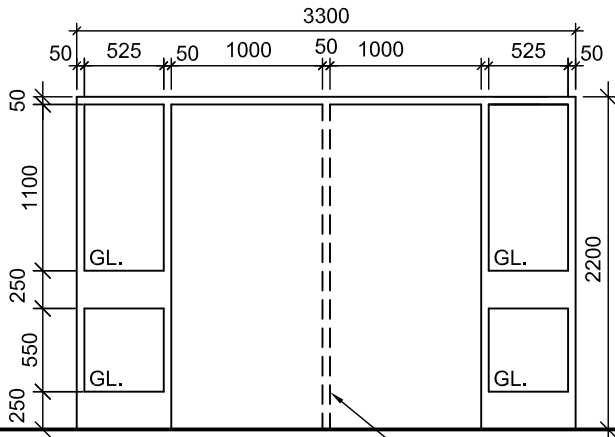
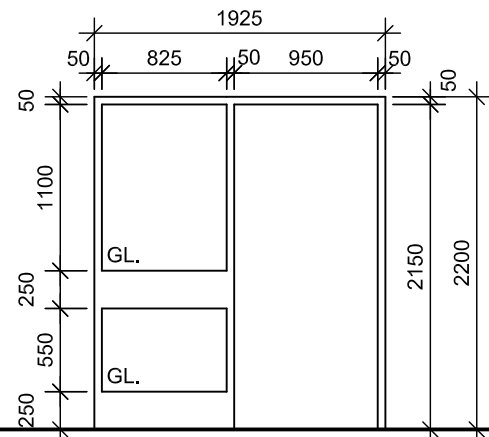
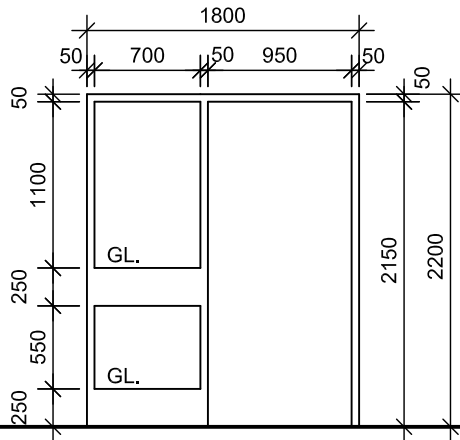
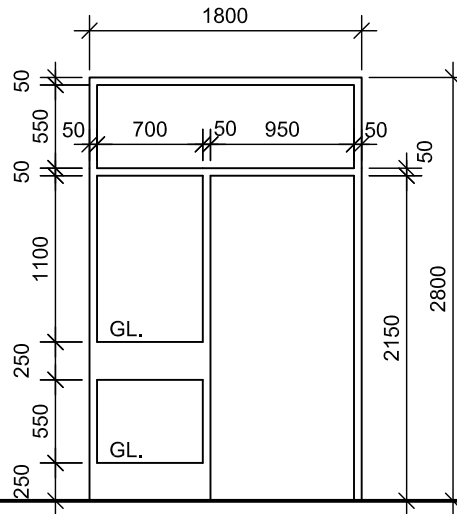
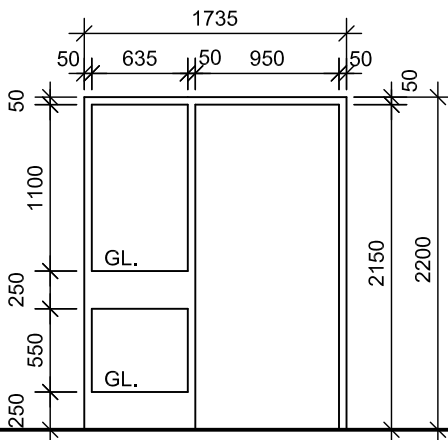
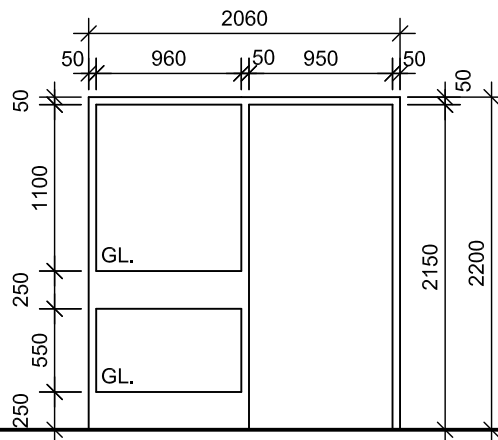
AD
801A

TYPE 6
H.M. INT

KEYED
REMOVEABLE
MULLION
BEYOND

TYPE 7
H.M. INT

TYPE 8A
HM INT

TYPE 8B
HM EXT

TYPE 9A
H.M. INT

TYPE 9B
H.M. EXT

HOLLOW METAL FRAMES

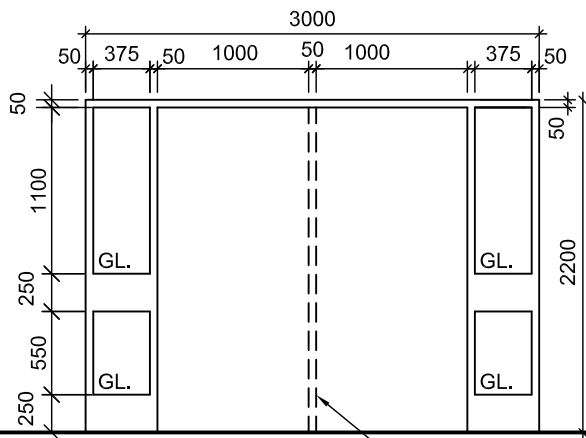
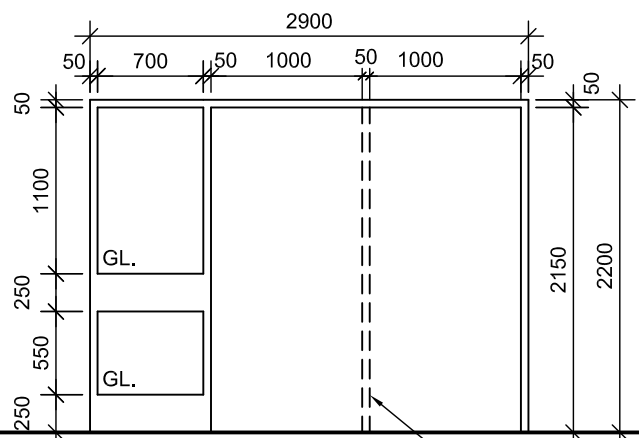
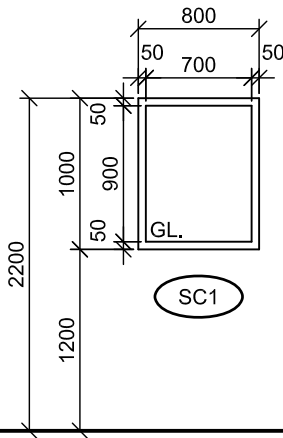
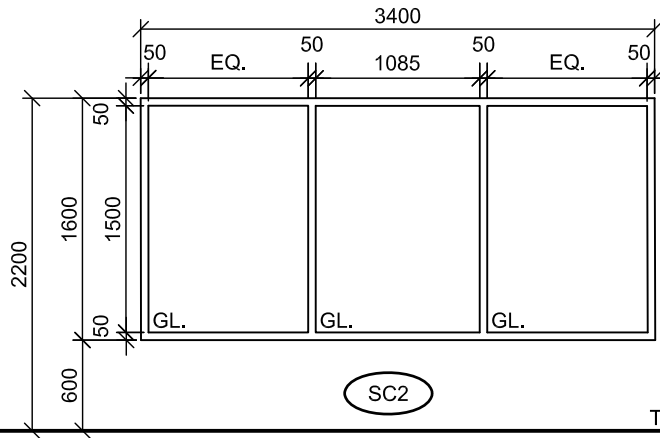
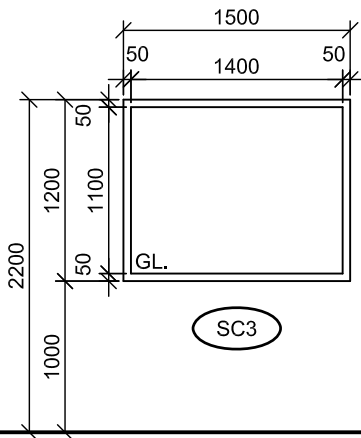
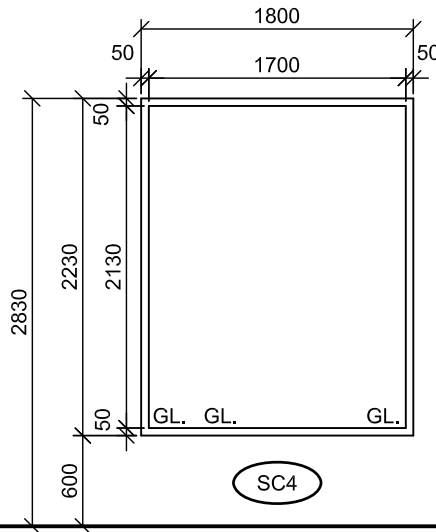
AD
801B

TYPE 10
HM INT/EXT

KEYED
REMOVEABLE
MULLION
BEYOND

TYPE 11
H.M. INT

SC1

SC2

SC3

SC4

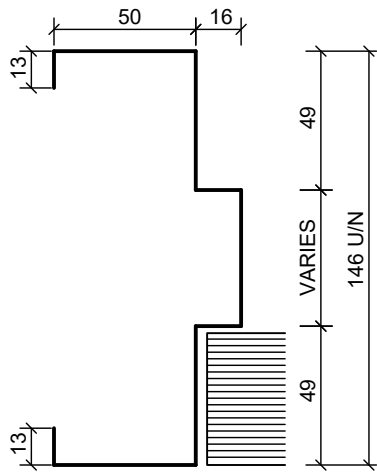
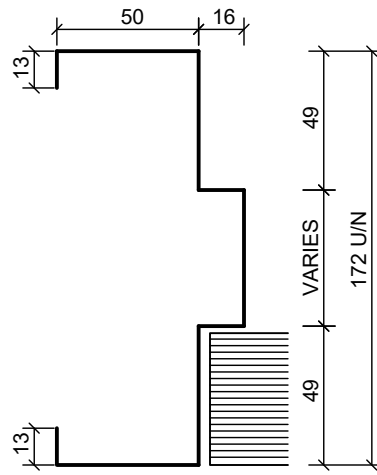
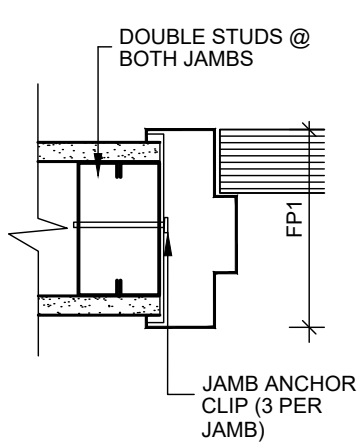
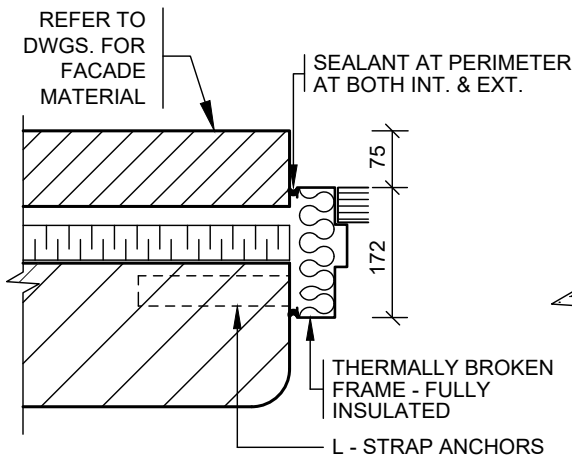
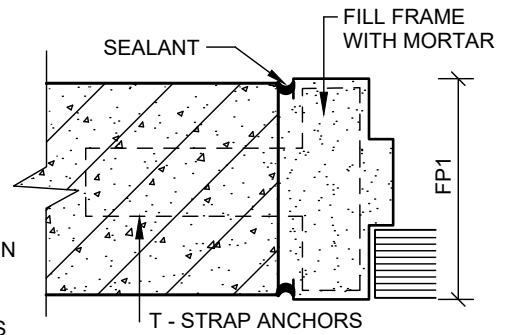
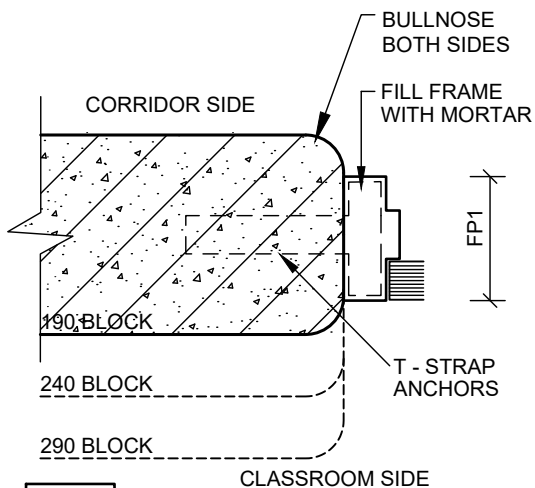
AD
801C

FRAME PROFILE FP1

METAL FRAME SECTION (MASONRY WALLS)
(NTS)

FRAME PROFILE FP2

J1 (NTS)

MF1 (NTS)

MF2 (NTS)

MF3 (NTS)

MF4 (NTS)
INTERIOR WALLS
WITH MASONRY VENEER

DOOR JAMB SECTIONS

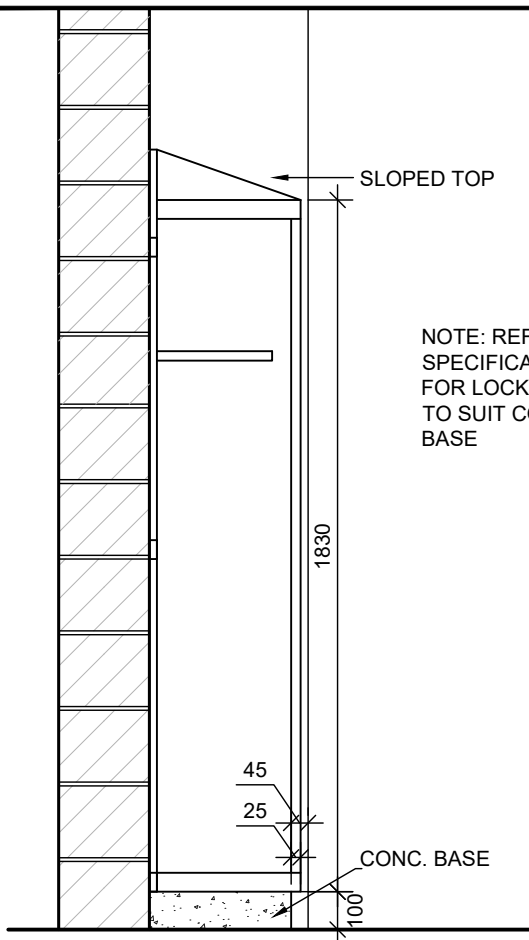
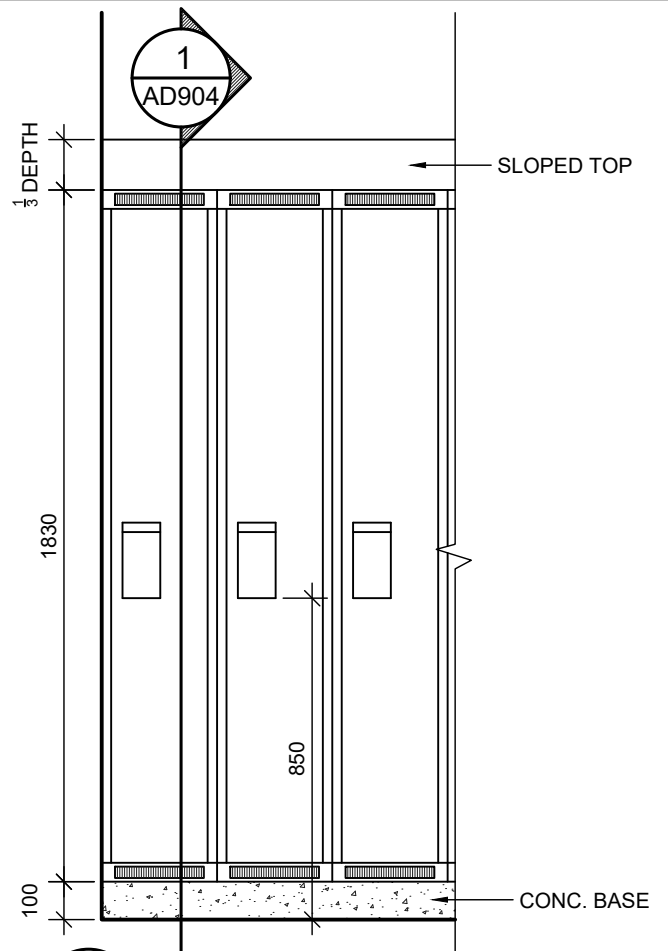
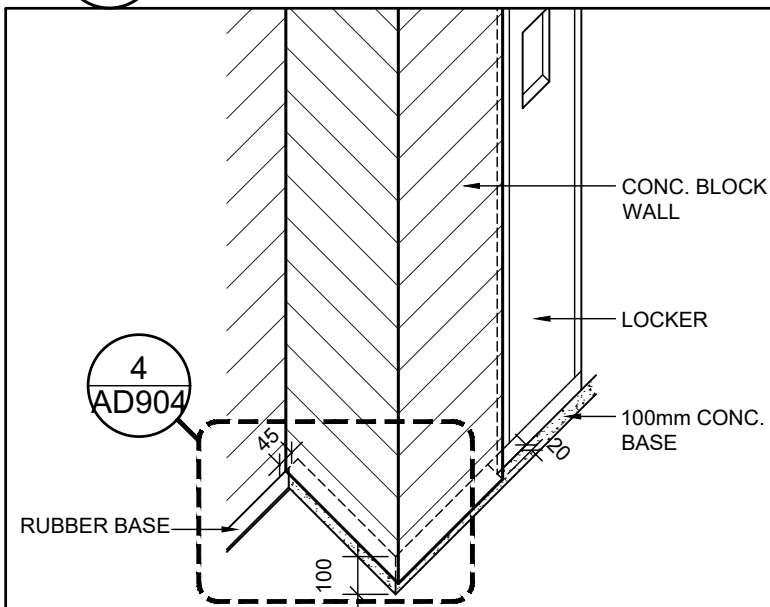
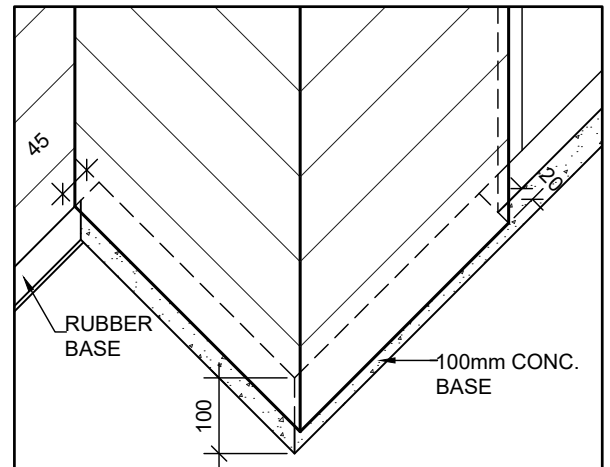
AD
802

1 LOCKER SECTION
AD904 SCALE 1:20

2 LOCKER ELEVATION
AD904 SCALE 1:20

3 LOCKER ISOMETRIC
AD904

4 LOCKER BASE ISOMETRIC
AD904

LOCKER BASE DETAILS
