PROJECT: OUR LADY OF VICTORY
CATHOLIC ELEMENTARY SCHOOL
ADDITION & RENOVATION

BINDER: **C** ARCHITECTURAL DETAILS,
GEOTECHNICAL REPORT &
DESIGNATED SUBSTANCE REPORT

SPECIFICATIONS BINDER “C”

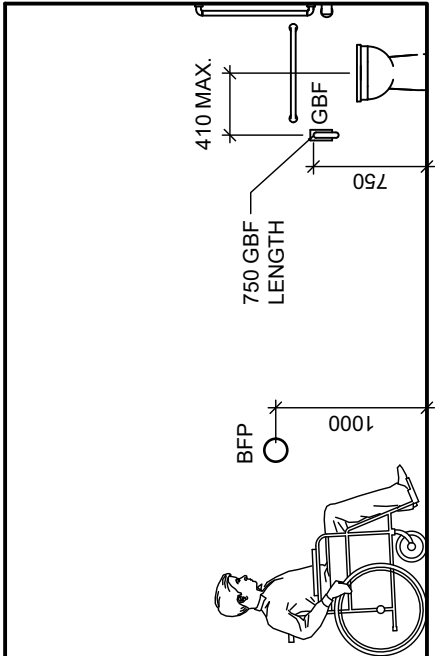
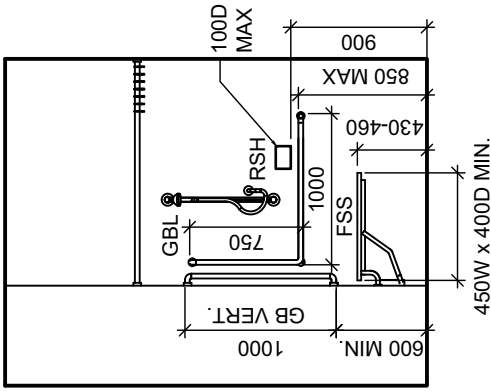
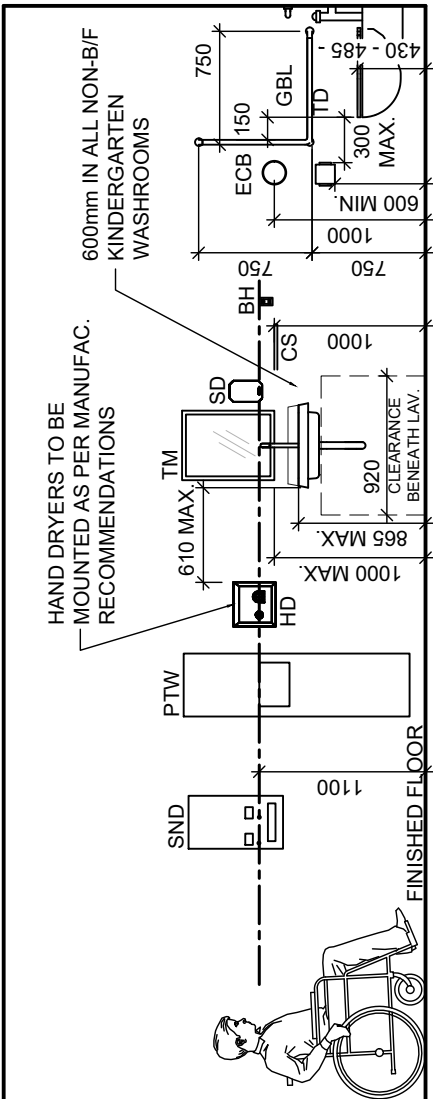
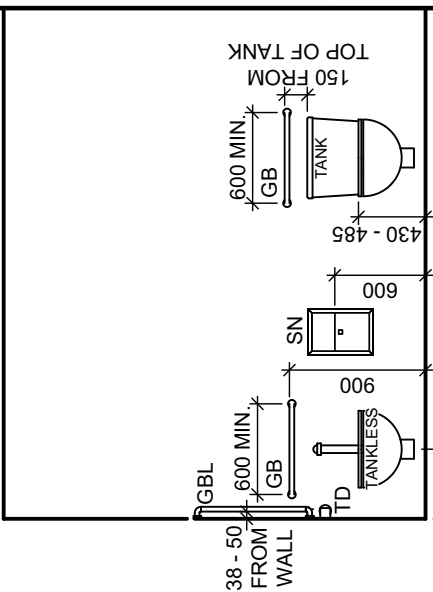
AD
1000

- NOTES:
1. THE DIMENSION IS TO THE CENTRE OF THE OPERATOR.
 2. REFER TO PROJECT FLOOR PLANS AND INTERIOR ELEVATIONS FOR WASHROOM FIXTURE LAYOUT

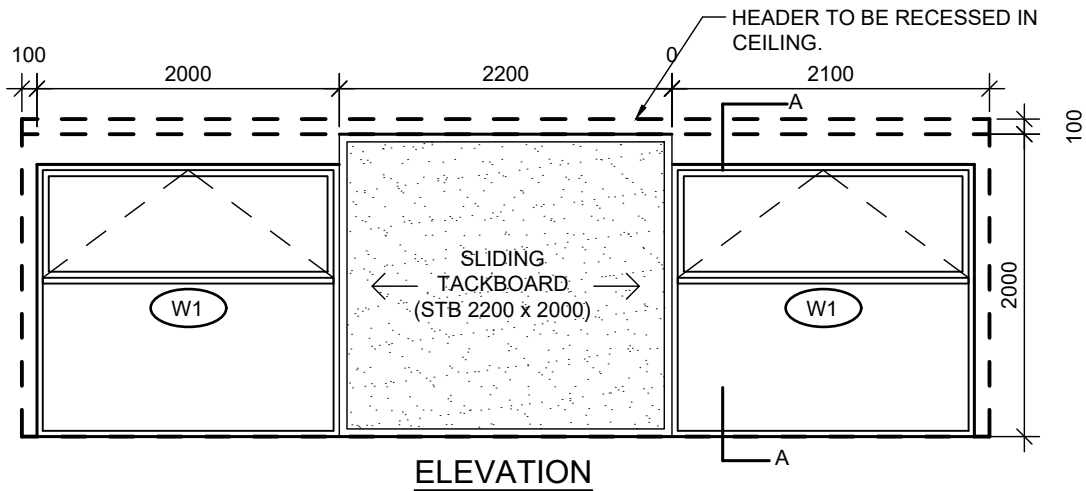
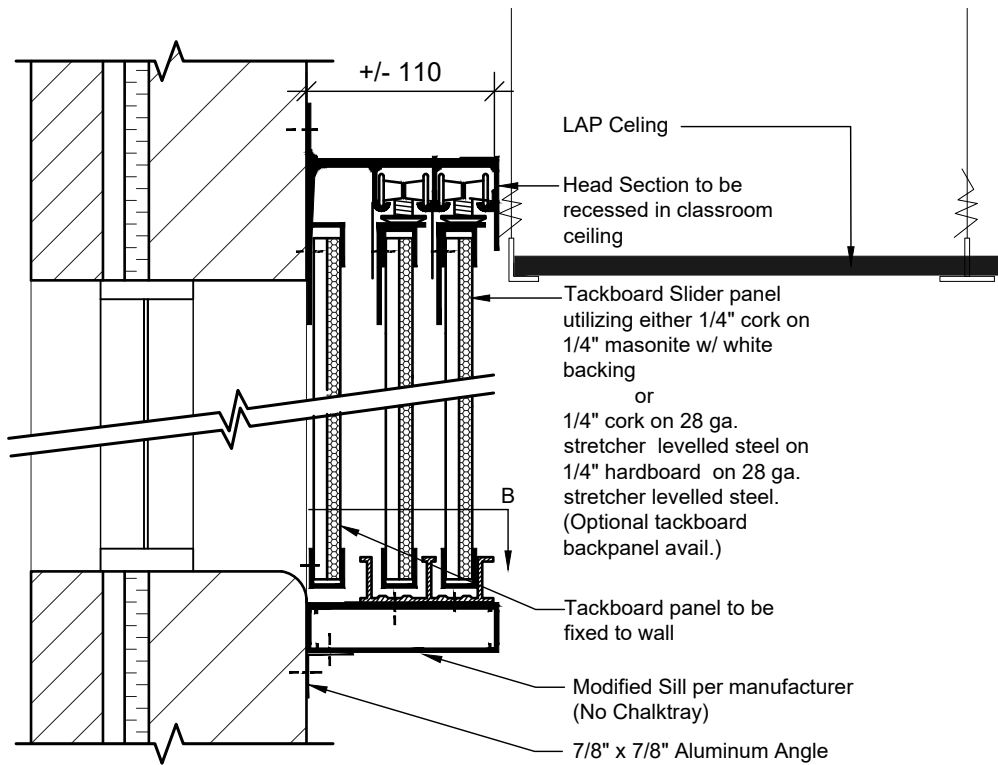
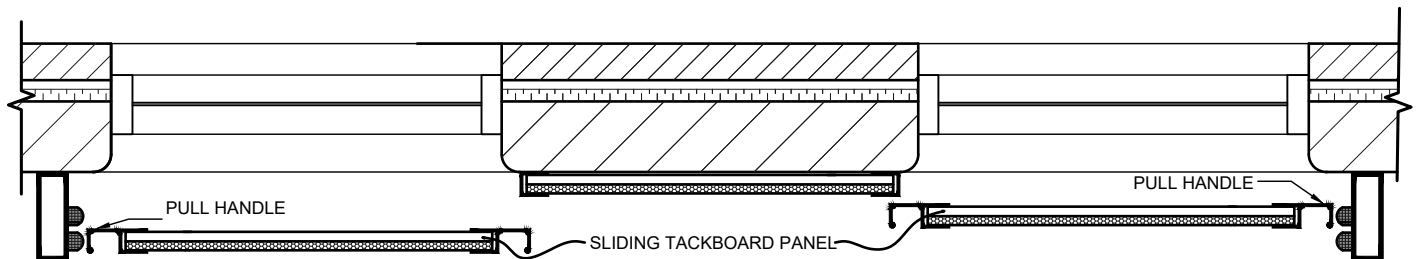
AD
2001

SECTION A - A

REFER TO SPECIFICATIONS FOR DOUBLE SLIDING TRACK INFO.

PLAN SECTION B

**SLIDING BOARDS DETAILS
(CLASSROOM)**

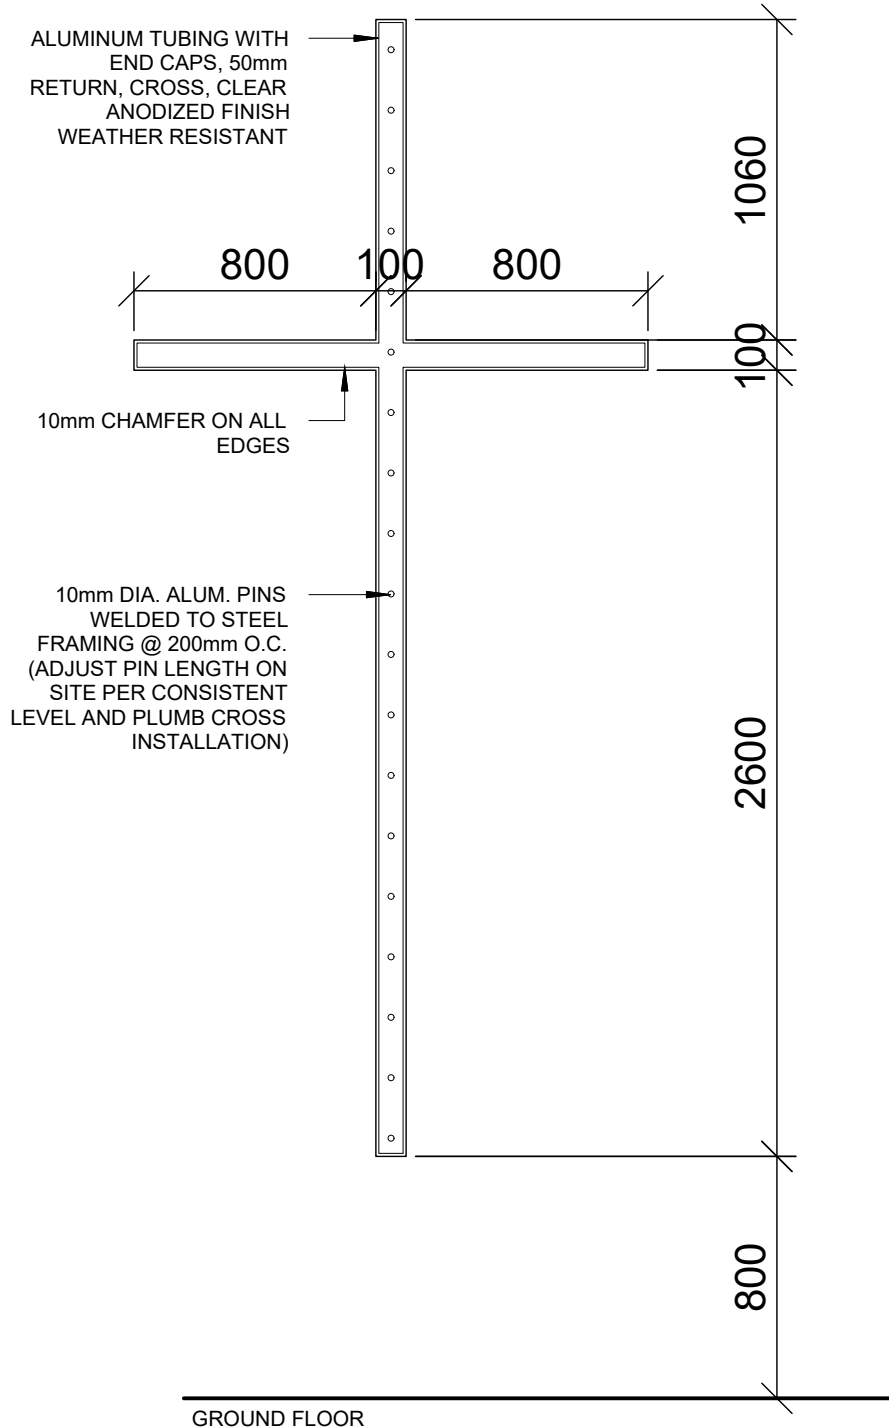
ALUMINUM CROSS DETAIL

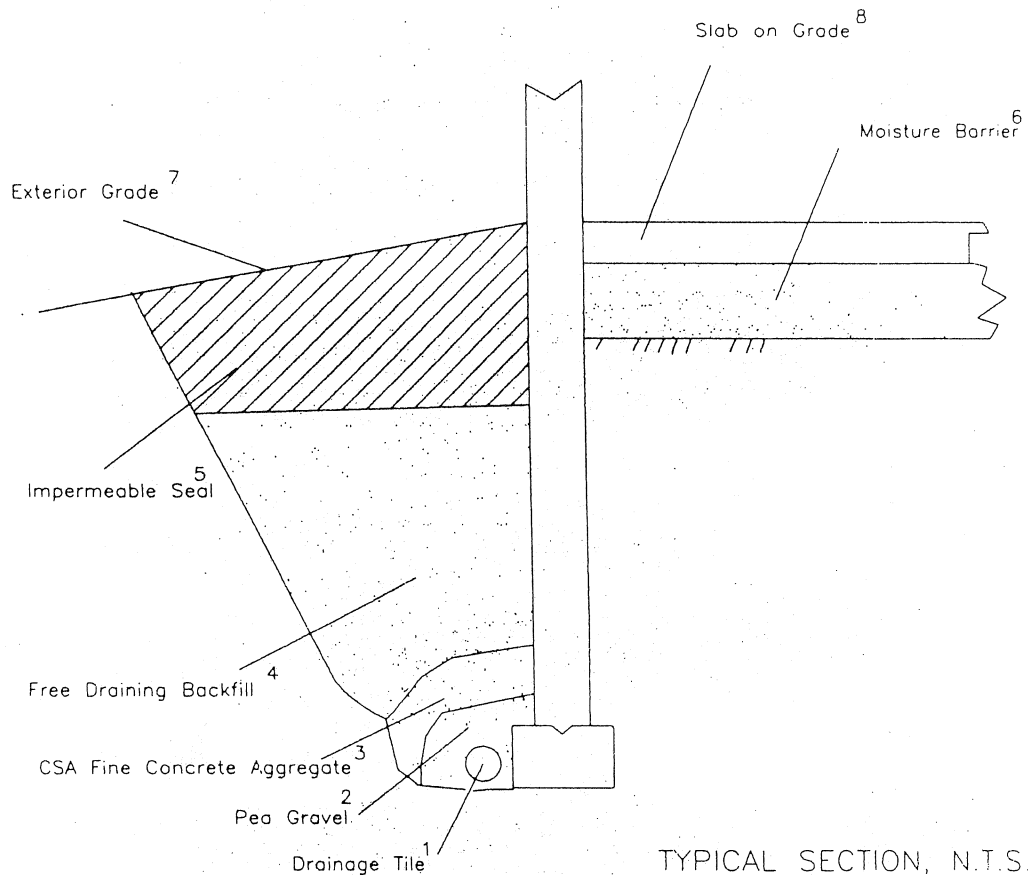
DRAINAGE AND BACKFILL RECOMMENDATIONS

1. Drainage tile to consist of 100 (4") diam. Weeping tile or equivalent perforated pipe leading to a positive sump or outlet. Invert to be minimum 150mm (6") below underside of floor slab.

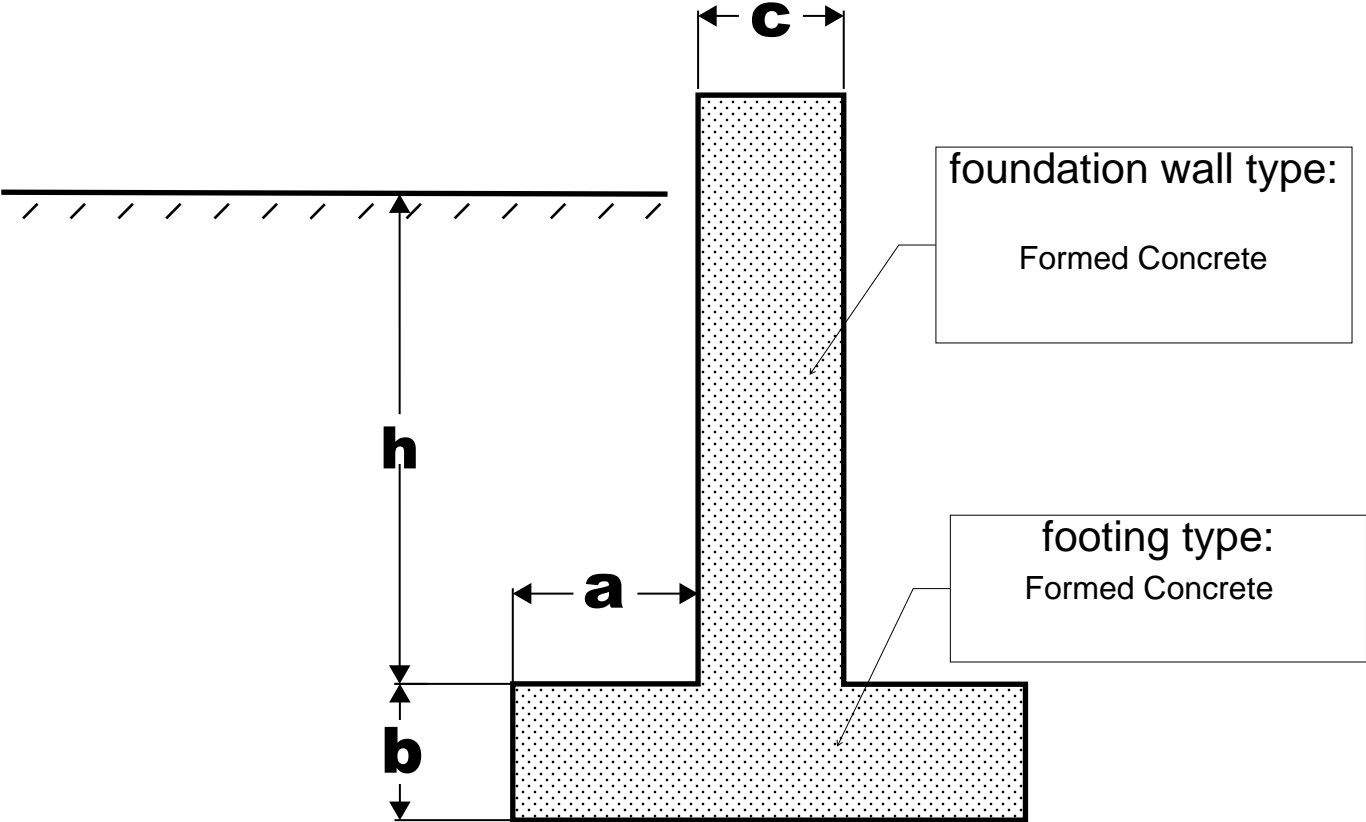
TEST PIT OBSERVATION & EXISTING FOOTING SKETCH SHEET

Test Pit No.	a mm	b mm	c mm	h mm	Founding Material	Water Comment	test pit ground surface elevation (m)
TP1	150	180	N/A	1115	Clayey Silt Till	Water quickly entering from saturated gravel and fill	196.45
TP2	150	180	N/A	1080	Clayey Silt Till	Dry	196.40
TP3	180	150	N/A	1140	Clayey Silt Till	Dry	196.55

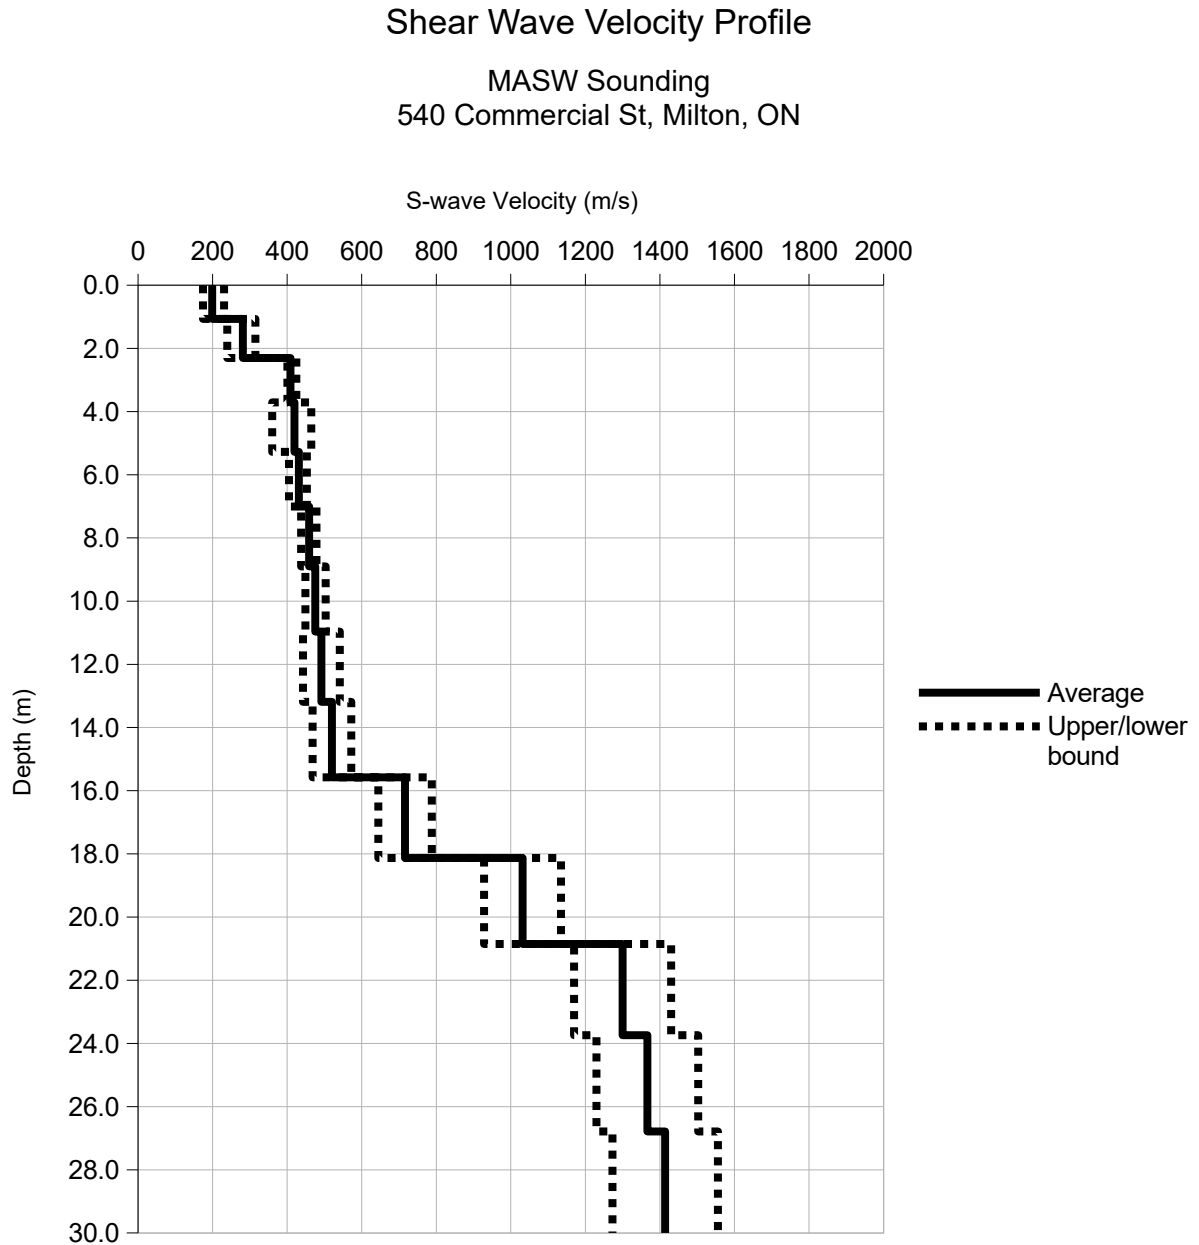
The results of the MASW sounding are presented in Figure 4. The average shear wave velocity profile from the active shot records and passive data is plotted in the chart as a solid line. The dashed lines represent the upper and lower bound S-wave velocity profiles.

Figure 4 Shear wave velocity profile from MASW sounding.
